WMSC Commissioner Brief: W-0127 – Runaway Maintenance Vehicle – Southern Ave. Station – July 9, 2021

Prepared for Washington Metrorail Safety Commission meeting on December 7, 2021

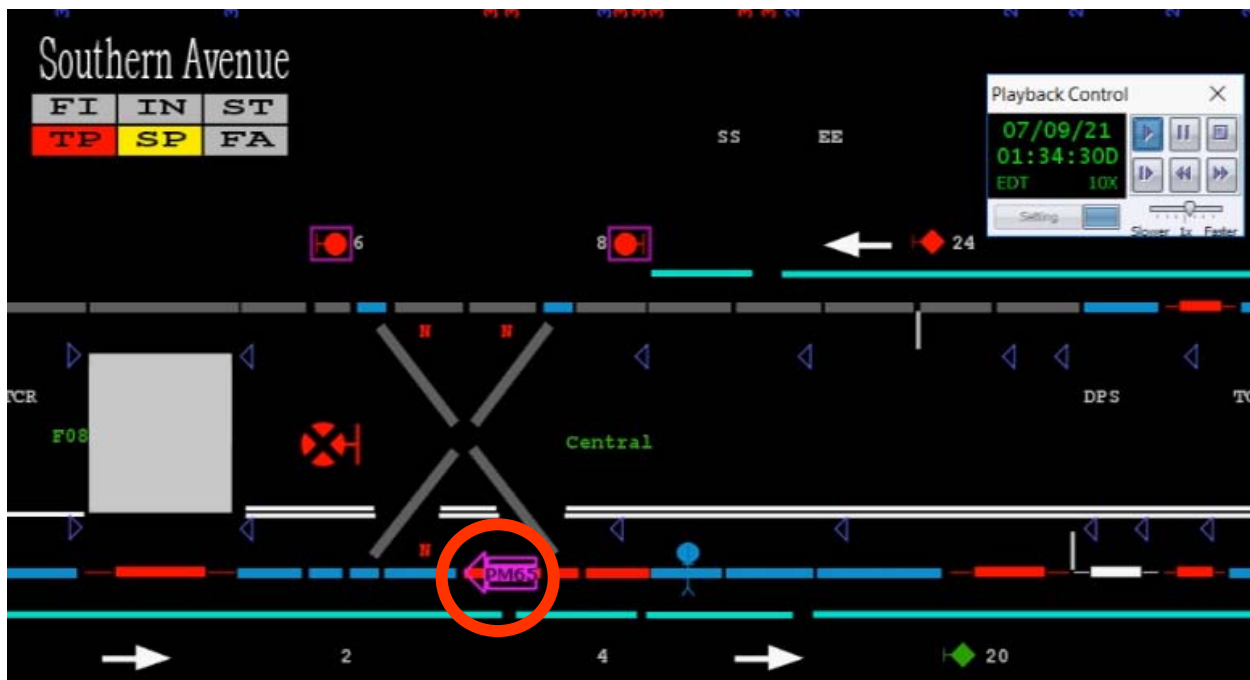
Diagram 1 – At 01:34 hours, the AIMS playback reflected third rail power was de-energized, blue block, and human form status was in place in the TRST work area. Additionally, the AIMS playback showed PM65 moving in the direction of Southern Avenue Station, Track 1.

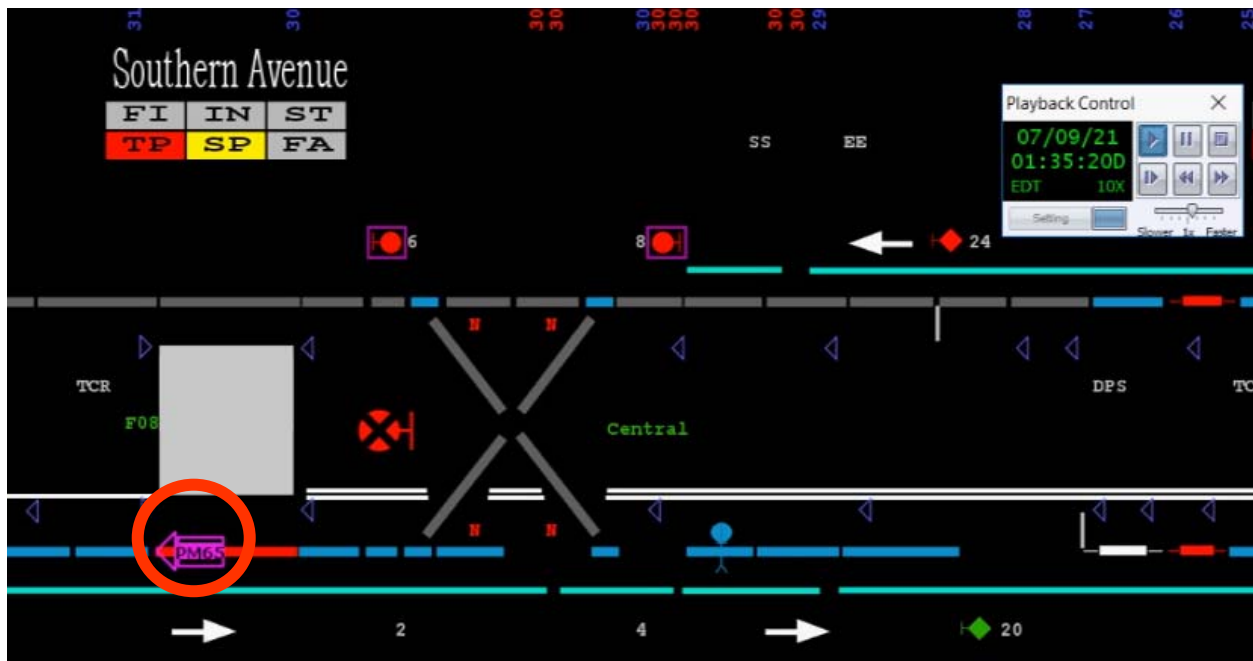
Diagram 2 - Based on the AIMS playback, at 01:35 hours, PM65 berthed at Southern Avenue Station, Track 1.

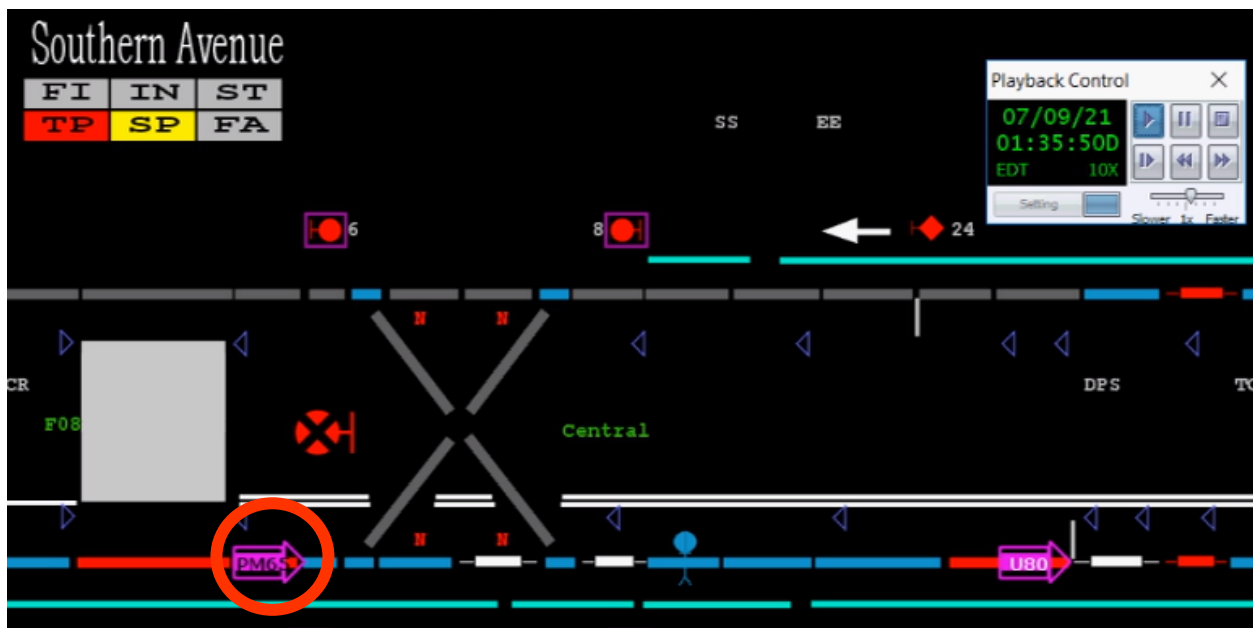
Diagram 3 - Based on the AIMS playback, at 01:35:50 hours showed PM65 was moving in the direction of Congress Heights Station, Track 1.

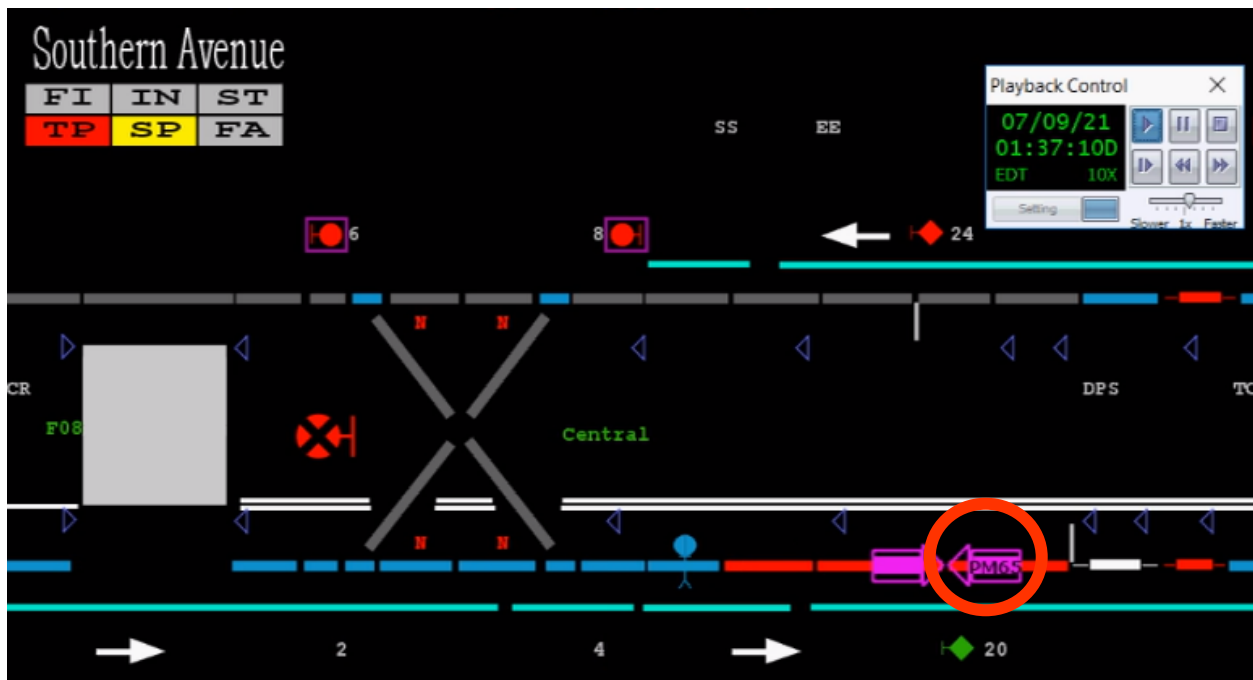
Diagram 4 - Based on the AIMS playback, at 01:37:10 hours, PM65 came to a stop. There was no further movement identified on the AIMS playback.

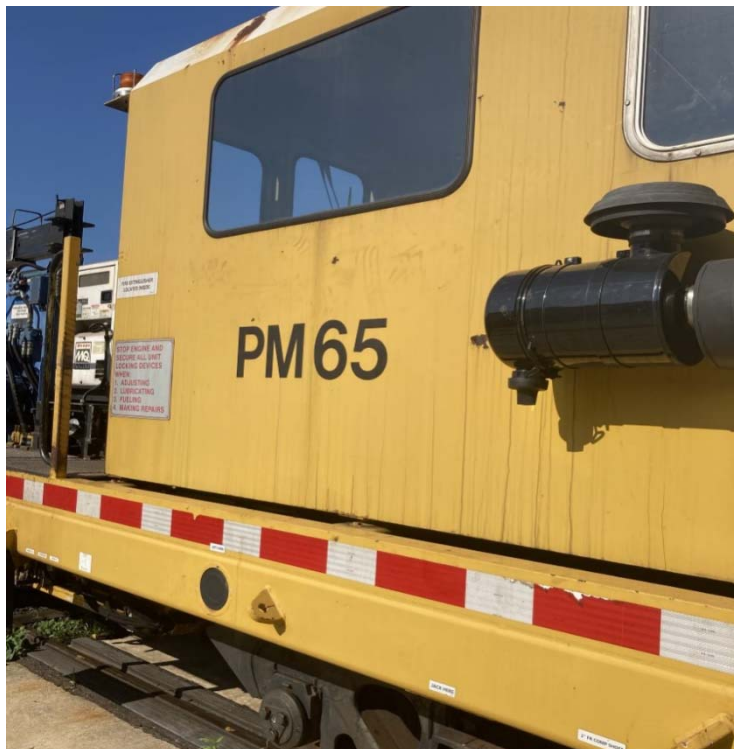
Figure 1 – Plasser PM65.

PM 65 struck the Geismar Track Torquing Machine that was attached to the running rail, causing significant damage to the torquing machine, then came to a stop. The collision also damaged the prime mover.

- CTEM Mechanics identified a damaged electrical box on the left rear of PM65 and the Geismar Track Torqueing Machine damaged.
- During the post-incident inspection performed at Branch Avenue Yard, CTEM identified a 15-second delay between the full parking brake application and the brake indicator light activation.

Metrorail repaired PM 65.

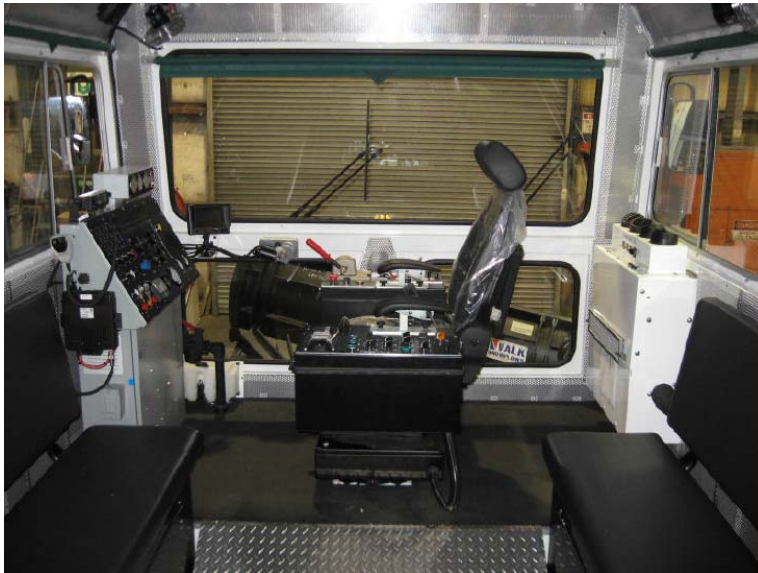
Figure 6 – This is a view of the work cab looking forward toward the operator's seat.

Once these steps are applied, the parking brake light will illuminate, which means the parking brake is set and it is safe to exit the operator's seat to the Remote Operating Station. Note: During the virtual interview, the Equipment Operator stated they followed the correct sequence when switching to the Remote Operating Station. **Note:** Below are the figures of the B51 panel located on the left side of the operator's seat and the B52 panel located on the right side of the operator's seat. Both figures are labeled with the correct sequence from the PMC-50 Operation Manual when switching from Travel Mode to Remote Operating Station.

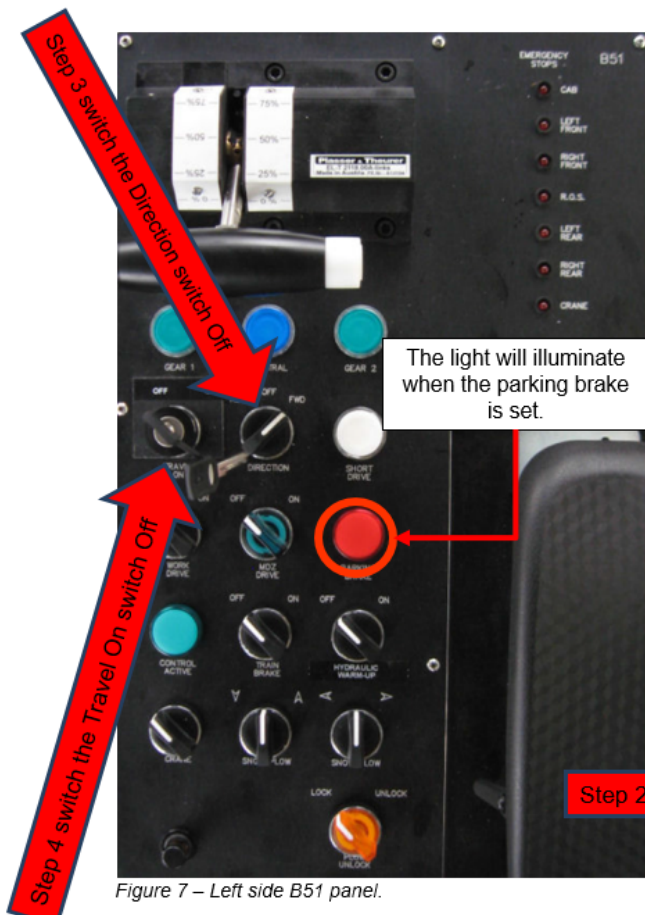
Figure 7 – Left side B51 panel.

- At the main cab operator's seat:
 - On the B51 panel, select 1st Gear, ensure all axles have engaged.
 - On the B52 panel, set the 'Parking Brake.'
 - On the B51 panel, switch the 'Direction' switch to the "Off" position.
 - On the B51 panel, switch the 'Travel On' switch "Off" and remove the key. This will de-select the B51 travel desk.

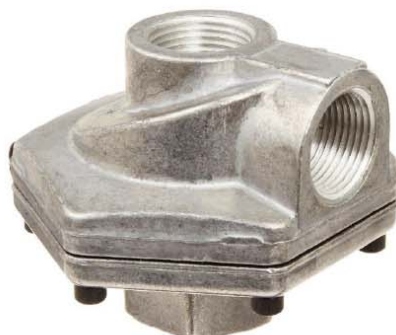
- CTEM performed a brake pneumatic system inspection and identified that both valves contained a build-up of contaminants. CTEM replaced both valves on PM65, which corrected the delayed application of braking and indicator light illumination.

Truck mounted quick release valves, Parker OR50, Plasser 167-827

Frame mounted quick release valves, Parker OR37, Plasser 167-819
