WMSC Commissioner Brief: W-0132 – Improper Roadway Worker Protection – L’Enfant Plaza Station – July 26, 2021

Washington Metro Area Transit Authority
Department of Safety and Environmental
Management (SAFE)
FINAL REPORT OF INVESTIGATION A&I E21324

Date of Event:	07/26/2021
Type of Event:	Improper Roadway Worker Protection
Incident Time:	01:08 hours
Location:	L'Enfant Plaza Station, at CM F1-037+00 to F1-060+00
Time and How received by SAFE:	01:30 hours. SAFE/IMO In-Person Notification
WMSC Notification Time:	03:01 hours
Responding Safety Officers:	WMATA: No WMSC: No Other: No
Rail Vehicle:	No
Injuries:	No
Damage:	No
Emergency Responders:	None
SMS I/A Number	20210727#94675

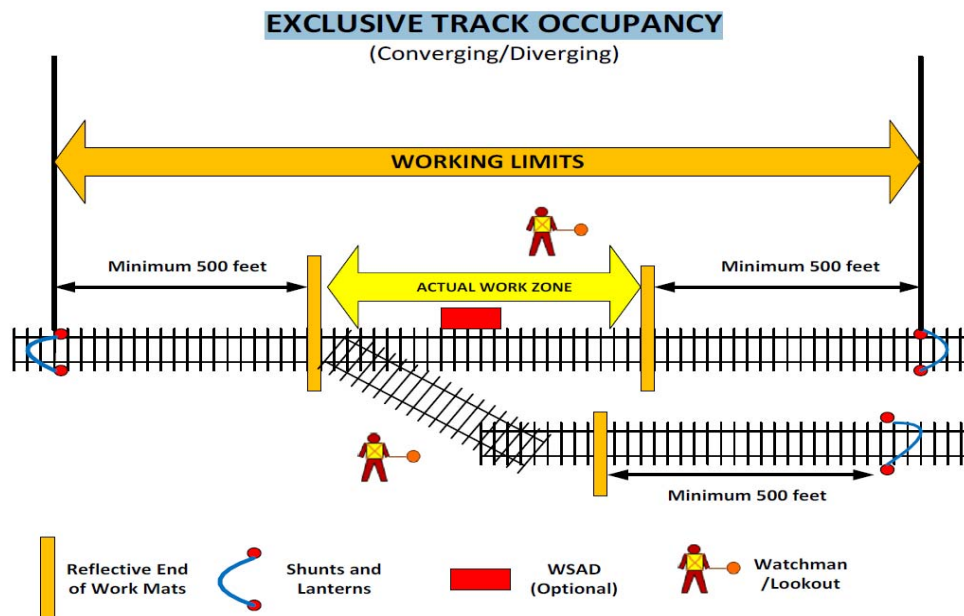
Diagram 1 –Example ETO protection diagram.

Per MSRPH RWP, as detailed in section 5.13.7. An ETO RWP setup requires shunts to be located at 500 feet outside of each end of the working zone, red lanterns, or e-flares, "END Work AREA" mats, and Warning Strobes Alarm Devices (WSADS)
