# WMSC Commissioner Brief: W-0133 – Improper Roadway Worker Protection – near Forest Glen Station – August 6, 2021

Prepared for Washington Metrorail Safety Commission meeting on December 7, 2021

## FINAL REPORT OF INVESTIGATION A&I E21345

## Forest Glen – Improper Roadway Worker Protection

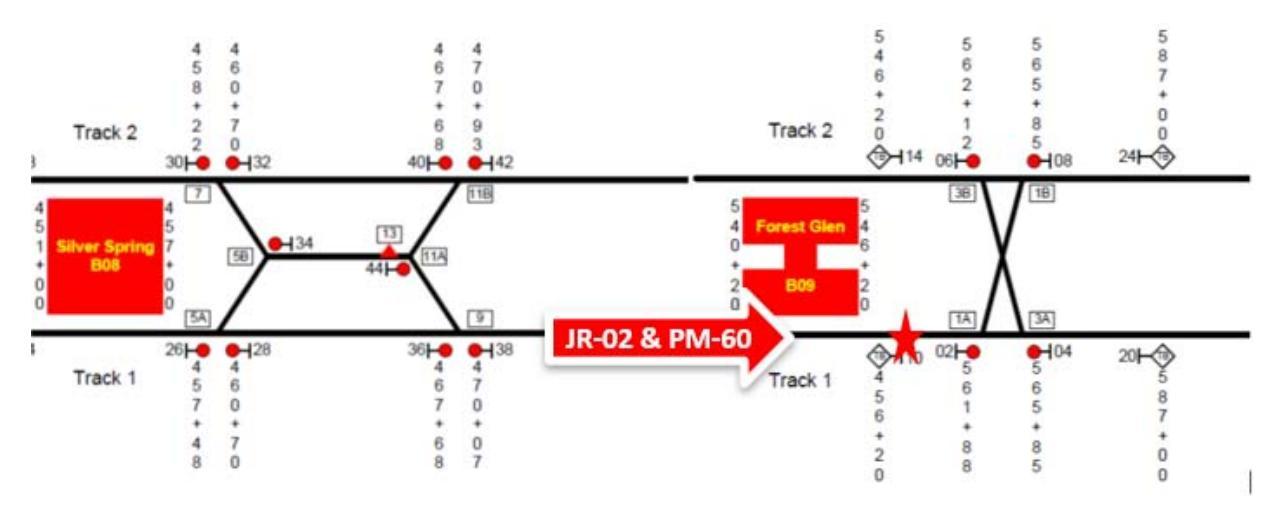
## Field Sketch/Schematics

Forest Glen Station, Track 1 at CM B1 547+00

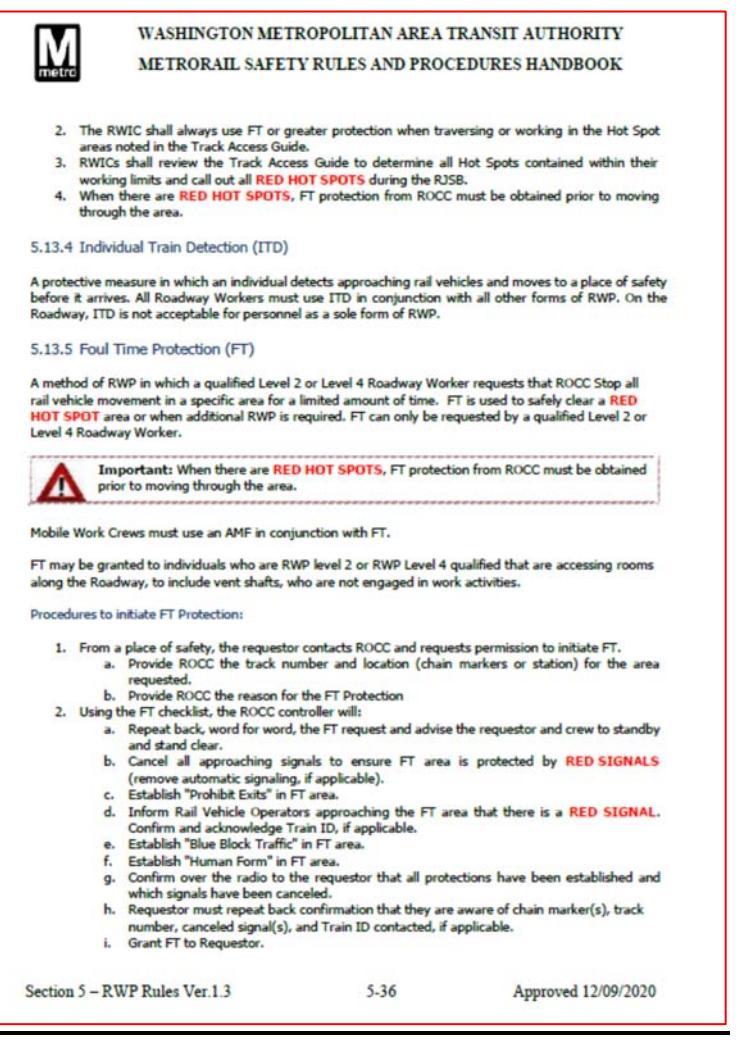
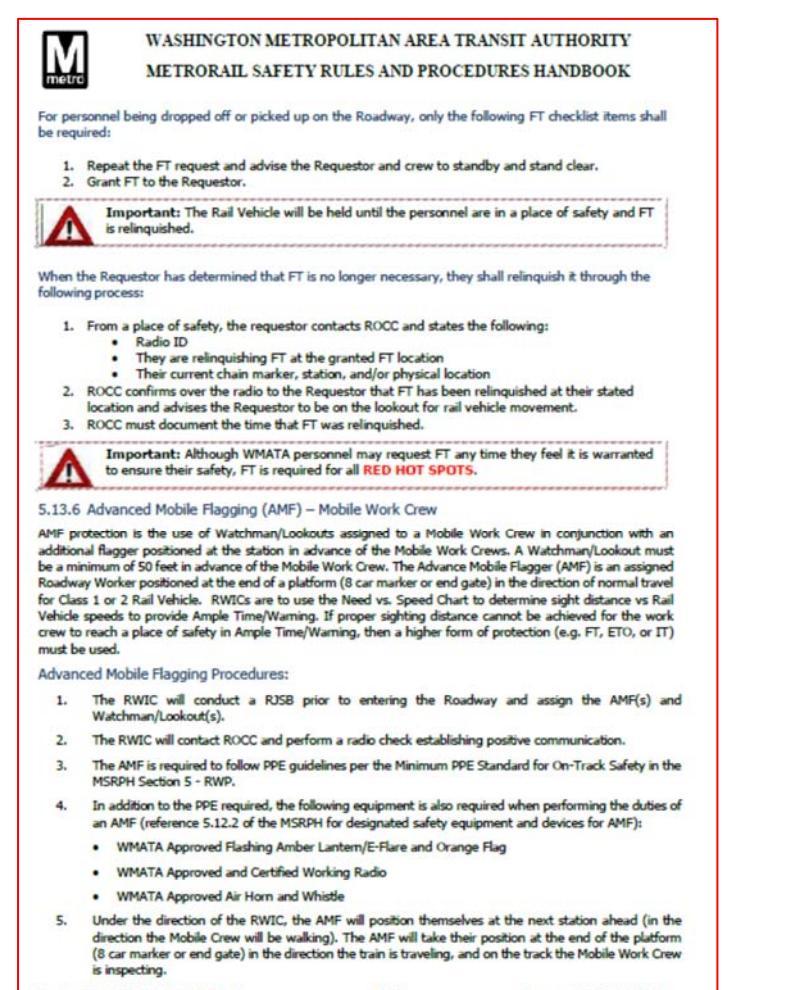
# Appendix B –Foul Time Protection – Metrorail Safety Rules and Procedures Handbook (MSRPH), Section 5 RWP 5.13.5

It was at this time that the Radio RTC confused the two Power Maintenance Crews that were working at Forest Glen Station and Wheaton Station. The Power Unit located at Forest Glen Station had not relinquished their foul time. The Radio RTC confirmed during the interview that they advised the Buttons RTC that the Power Maintenance Crew that was located at Forest Glen Station had relinquished their foul time causing the Buttons RTC to remove the human form protection from the AIMS Display at Forest Glen as well. This action was a violation of MSRPH Section 5 - RWP, 5.13.5 Foul Time Protection.

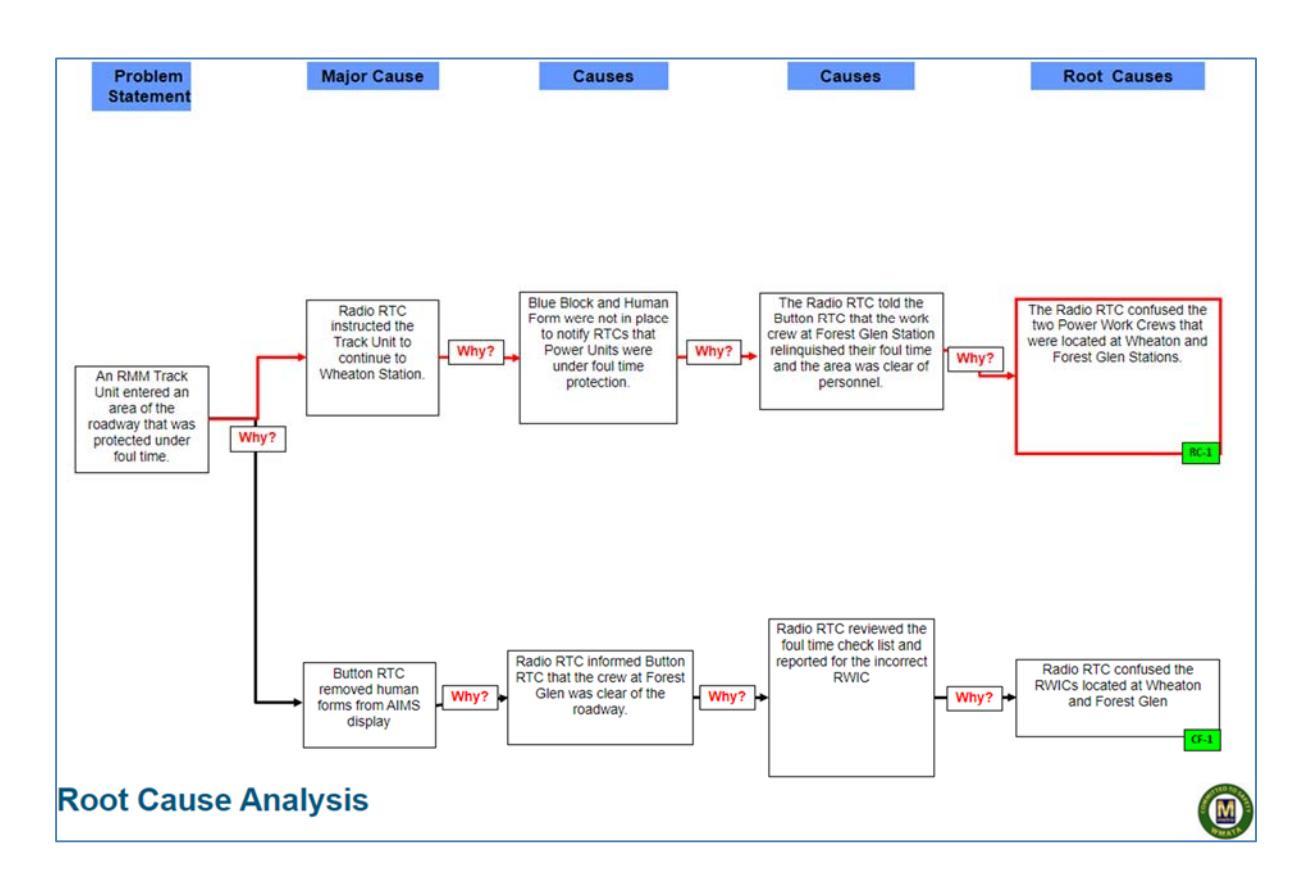
#### Appendix E – Root Cause/Why Tree

The probable cause of the Improper RWP event was a human factors failure of the Radio RTC to track and document the number and call ID of work crews under Foul Time protection. This resulted in confusing the work crew at Wheaton Station with the work crew at Forest Glen Station.

A contributing factor to the event was a miscommunication by the Radio RTC, providing inaccurate information to the Buttons RTC, caused the removal of the human forms from the AIMS display. This action subsequently caused the Radio RTC to give permission to the Track Unit to move through the area under Foul Time protection.
