WMSC Commissioner Brief: W-0140 – Red Signal Overrun – Twinbrook Station – September 28, 2021

Washington Metro Area Transit Authority Department of Safety and Environmental Management (SAFE) FINAL REPORT OF INVESTIGATION A&I E21471

Twinbrook Station Interlocking at A13-02 Signal Red Signal Overrun September 28, 2021 **Table of Contents**

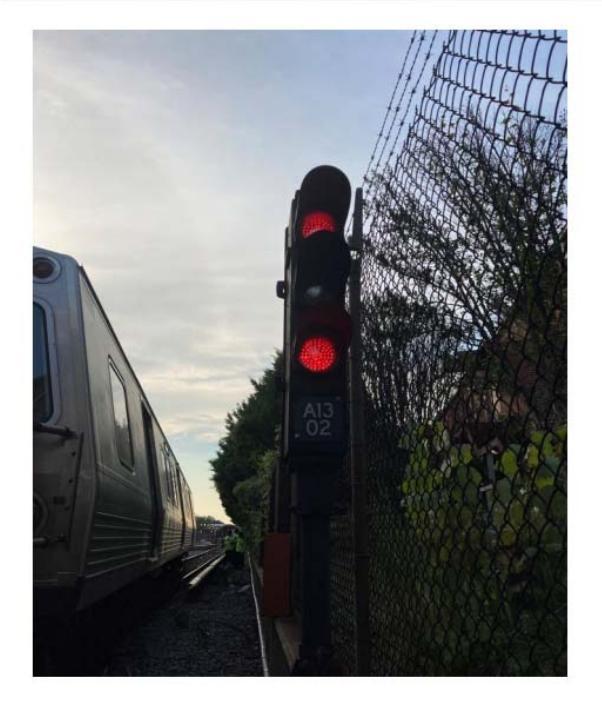
Attachment 11 – Page 1 of 2.

What happened	What should have happened
The operator did not verify a	The operator <u>should have</u>
lunar signal, correct rail	verified a lunar signal, correct
alignment, and speed readouts	rail alignment, and speed
prior to departing.	readouts prior to departing.
The operator entered stop and proceed mode without receiving an absolute or permissive block from ROCC.	The operator should have contacted ROCC and advised them that they did not have speed commands before entering stop and proceed.
The train was not thoroughly	The train should have been
checked and verified clear of	thoroughly checked and verified
customers.	clear of customers, per SOP #45.
