WMSC Commissioner Brief: W-0147 – Evacuation for Life Safety Reasons – Yellow Line – October 22, 2021

Washington Metro Area Transit Authority
Department of Safety and Environmental
Management (SAFE)
FINAL REPORT OF INVESTIGATION A&I E21513

Date of Event:	10/22/2021
Type of Event:	Evacuation for Life Safety Reasons
Incident Time:	14:11 hours.
Location:	Between Gallery Place and Mt Vernon Station's, Track 2
Time and How received by SAFE:	14:16 hours. SAFE/IMO On-call Phone
WMSC Notification Time:	14:16 hours.
Responding Safety Officers:	WMATA SAFE: Yes WMSC: No Other: N/A
Rail Vehicle:	Train ID 302 L-3040-3041.3091-3090. 3283-3282-T
Injuries:	No
Damage:	Car 3040 Interior Windscreen Glass Broken, Extensive Over-Heated Damage to Cables and Wires on Car 3283, and Signs of Arc Flash on Car 3282.
SMS I/A Incident Number:	20211022#96319MX

Gallery Place Station
Evacuation for Life Safety Reasons
October 22, 2021

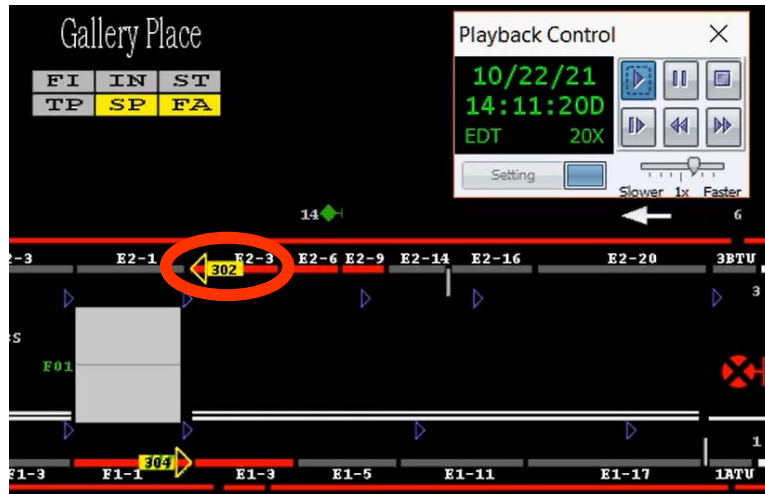
Diagram 1 - Based on the AIMS display at 14:11:20 hours, revenue Train ID 302 Train Operator came to a halt right before entering Gallery Place Station, Track 2.

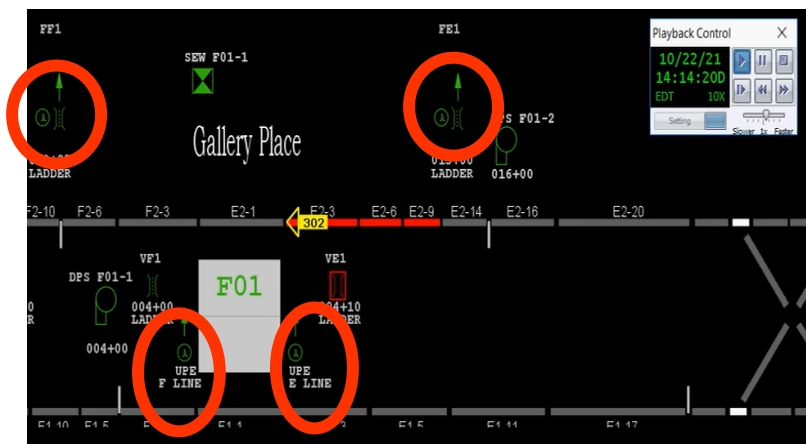
Diagram 2 - Based on the AIMS display at 14:14:20 hours, the FF1, FE1, F Line, and E Line fans were configured in auto on exhaust mode.

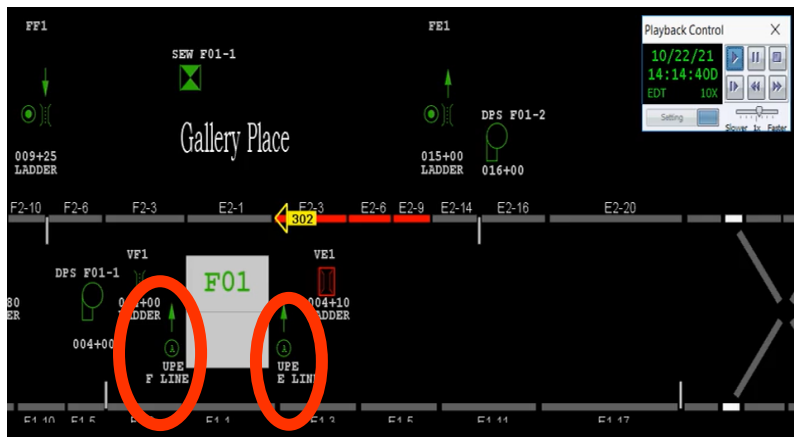
Diagram 3 - Based on the AIMS display at 14:14:40 hours, the ROCC activated the ventilation fans. The FF1 fan was configured in supply mode moving air in the system. The FE1 fan was configured in exhaust mode, moving air out of the system.

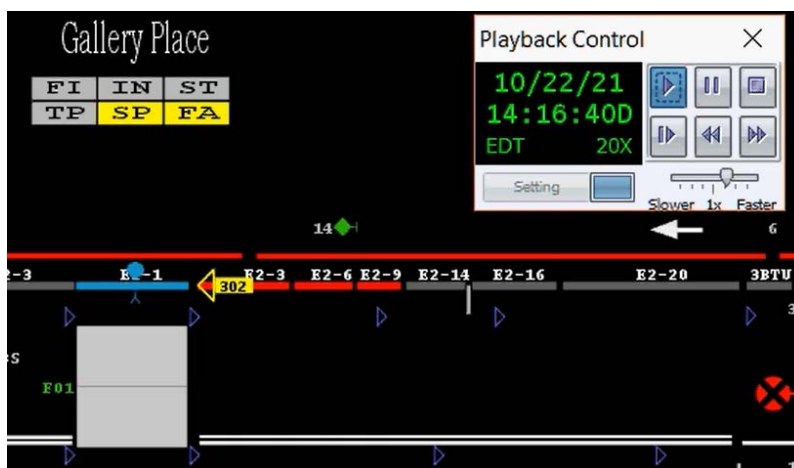
Diagram 4 - Based on the AIMS display at 14:16:40 hours, human form status representing the WMATA personnel was in place at Gallery Place Station Track 2.

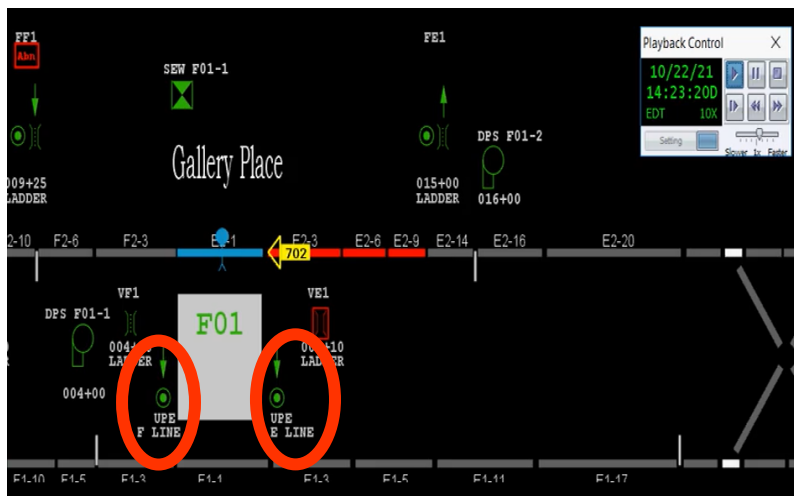
Diagram 5 - Based on the AIMS display at 14:23:20 hours, the ROCC activated the F Line and E Line platform fans in supply mode, moving air in the system.

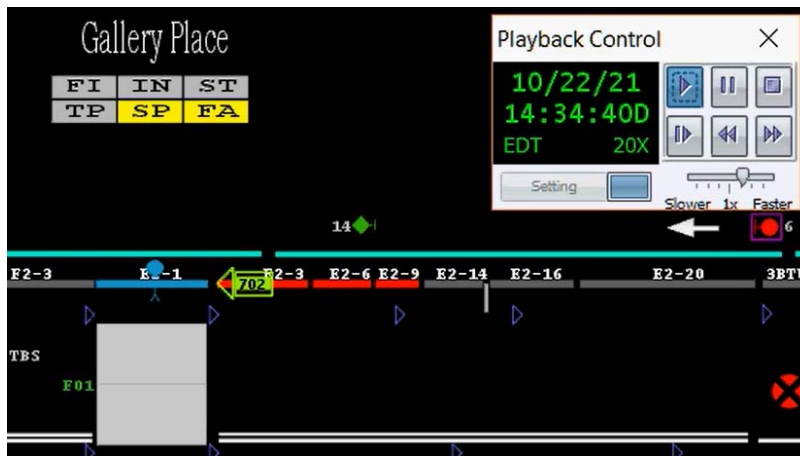
Diagram 6 - Based on the AIMS display at 14:34:40 hours, it showed blue block status was in place, and third-rail power was de-energized at Gallery Place Station Track 2.

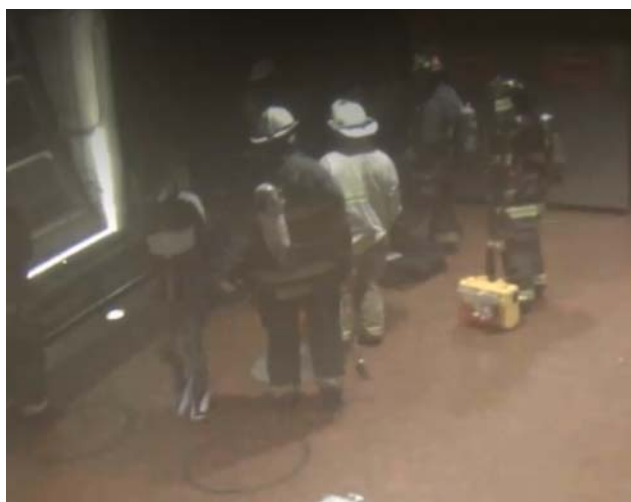
Figure 4 - Based on the CCTV footage at approximately 14:35 hours, the first self-evacuated customers safely entered the Gallery Place Station platform. The other self-evacuated customer entered the platform shortly after.

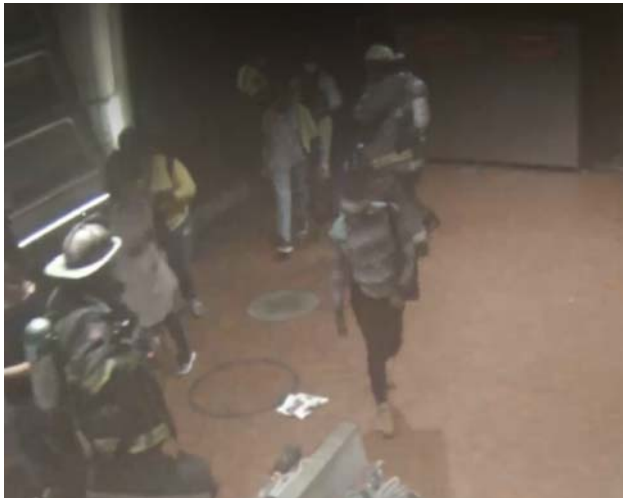
Figure 5 - Based on the CCTV footage at approximately 14:47 hours, customers started to enter the Gallery Place Station platform escorted by the emergency responders.

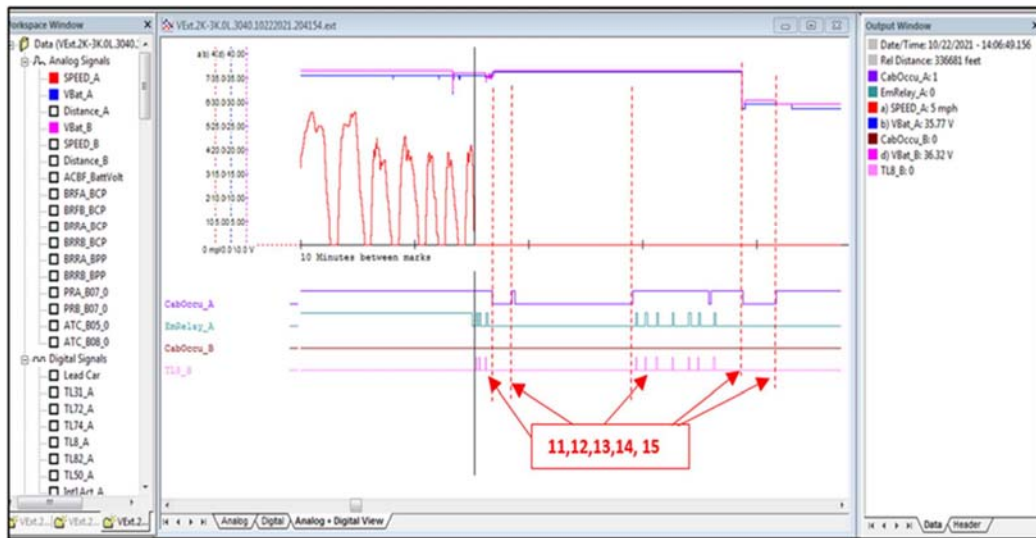
Figure 3. VMS Data Analysis Car 3040

CMOR IIT analysis of the downloaded VMS and ER data revealed that at approximately 14:10:30 hours, Train ID 302, Lead Car 3040, was traveling 35 MPH. The consist brake pipe on Car 3040 did not dump, but the belly cars' (3090-3091) brake pipe had dumped. The trailing vehicle of the incident train was Car 3282. CMOR IIT reported that at this time, the battery voltage in Car 3282 dropped to 24.83VDC, which triggered the battery breaker tripping on Car 3283. As a result, the brake pipe on Cars 3090 and 3091 had dumped, causing the emergency relay to open, which forced a BIE condition and caused all equipment on Car 3282 to go dark. CMOR IIT reported it appeared that the battery voltage being fed through the car wiring and trainline box from Car 3091 to Car 3283 has a ~4VDC drop. The VMS measured 28.7VDC on the B Car and only 24.8VDC on the A Car. CMOR IIT reported that the battery voltage on Car 3283 was not being charged by the LVPS. On Car 3091, the battery voltage was measured at 36.1VDC, and the battery voltage on Car 3090 was 33.5VDC. All VMS signals on Cars 3282 and 3283 had flatlined as soon as the battery breaker tripped.

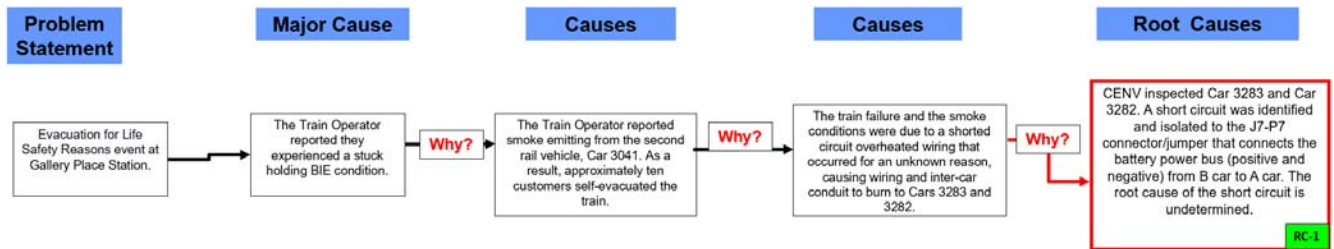
Root Cause Analysis

The probable cause of the Evacuation for Life Safety Reasons event was an electrical event on rail car 3283 that resulted in an immobile train. The root cause of the malfunctioning rail vehicle was due to cables and inter-car conduit burning when a short circuit occurred at the ER box of car 3283. The short circuit was identified and isolated to the J7-P7 connector/jumper that connects the battery power bus (positive and negative) from B car to A car. The root cause of the short circuit is undetermined; CENV is still investigating the root cause. Some possible contributing factors are a burnt cable ET007-10 (one of the negative wires) was found to have black marks in the wire strands. These wire strands may have been partially melted before this incident. The P7 connector shell has signs of extensive rust compared to other connectors within the ER box. Two parallel 1/0-gauge cables (2 for negative and 2 for the positive) must hold the full load at normal temperature. With approximately 60-70% of the ET007-10 cable being damaged, this cable becomes the weak point of the circuit. Under the previously mentioned condition, high temperatures are generated and transmitted during the incident, thereby damaging the cable's insulation within the connector.
