**WMSC Commissioner Brief: W-0150 – Collision, Evacuation – Blue/Orange/Silver Line – November 12, 2019**

Washington Metro Area Transit Authority  
Department of Safety and Environmental  
Management (SAFE)  
**FINAL REPORT OF INVESTIGATION A&I E21579**

**Federal Center SW Station  
Evacuation for Life Safety Reasons  
November 14, 2021**

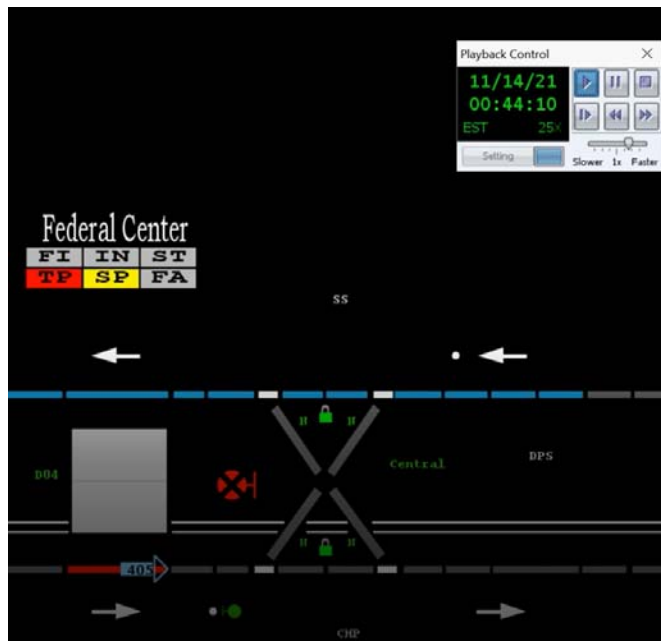
Diagram 1 - Based on the AIMS playback, Train ID 405 berthed at Federal Center SW Station, Track 1, at 00:44:10 hours.

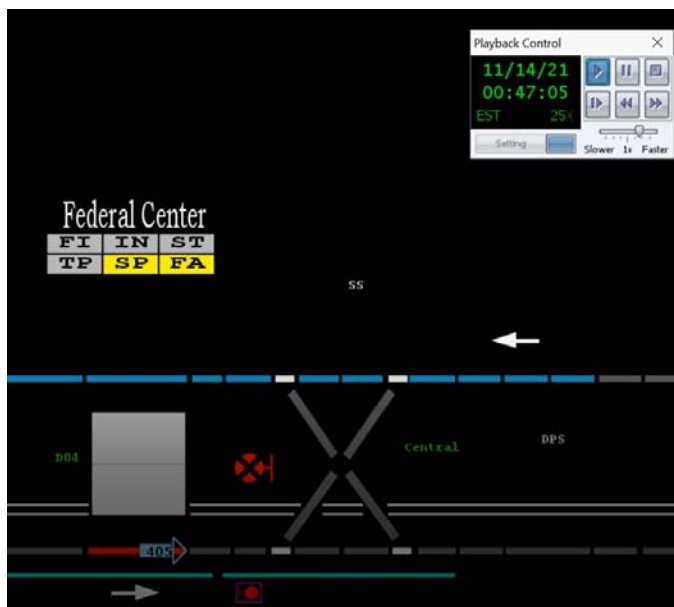
Diagram 2 - Based on the AIMS playback, Federal Center SW Station, Track 1, third rail power was de-energized at 00:47:05 hours.

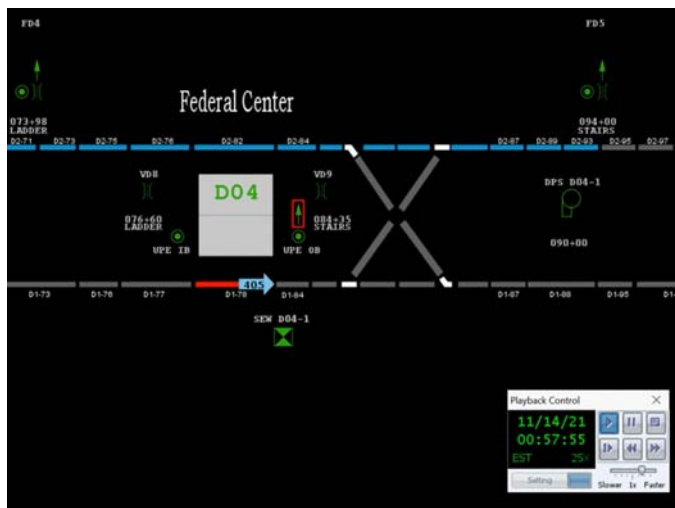
Diagram 3 - Based on the AIMS playback, the ROCC activated Federal Center SW Station fans in exhaust mode at 00:57:55 hours.

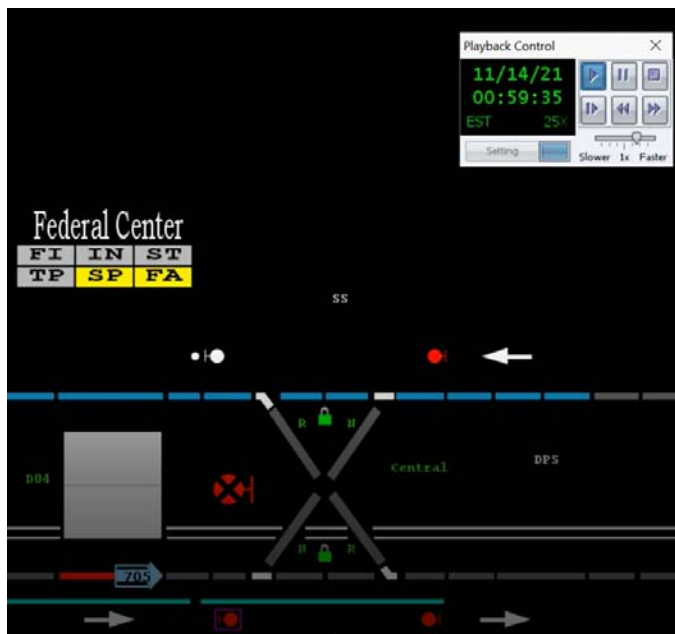
Diagram 4 - Based on the AIMS playback, Train ID 405 was re-blocked to non-revenue Train ID 705 00:59:35 hours.

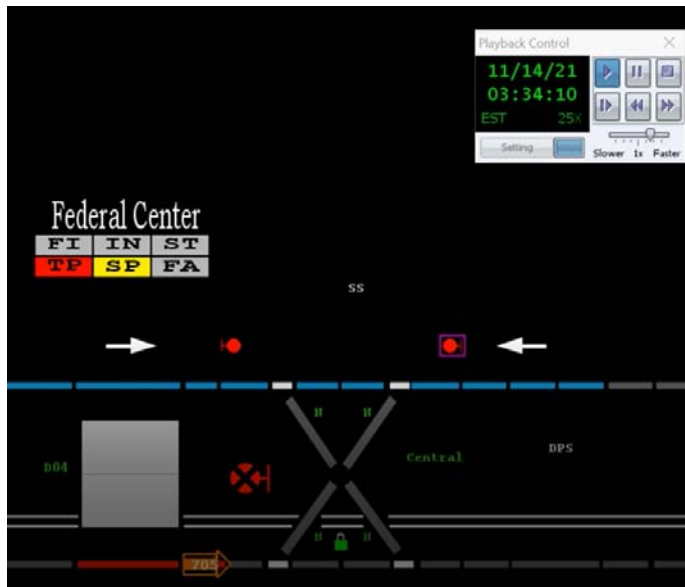
Diagram 5 – Based on the AIMS playback, non-revenue Train ID 705 continued down the line to New Carrollton Yard at 03:34:10 hours.
