WMSC Commissioner Brief: W-0151 – Improper Movement, Red Signal Overrun – Alexandria Rail Yard – October 19, 2021

Washington Metro Area Transit Authority
Department of Safety and Environmental
Management (SAFE)
FINAL REPORT OF INVESTIGATION A&I E21510

Alexandria Rail Yard – Red Signal Overrun

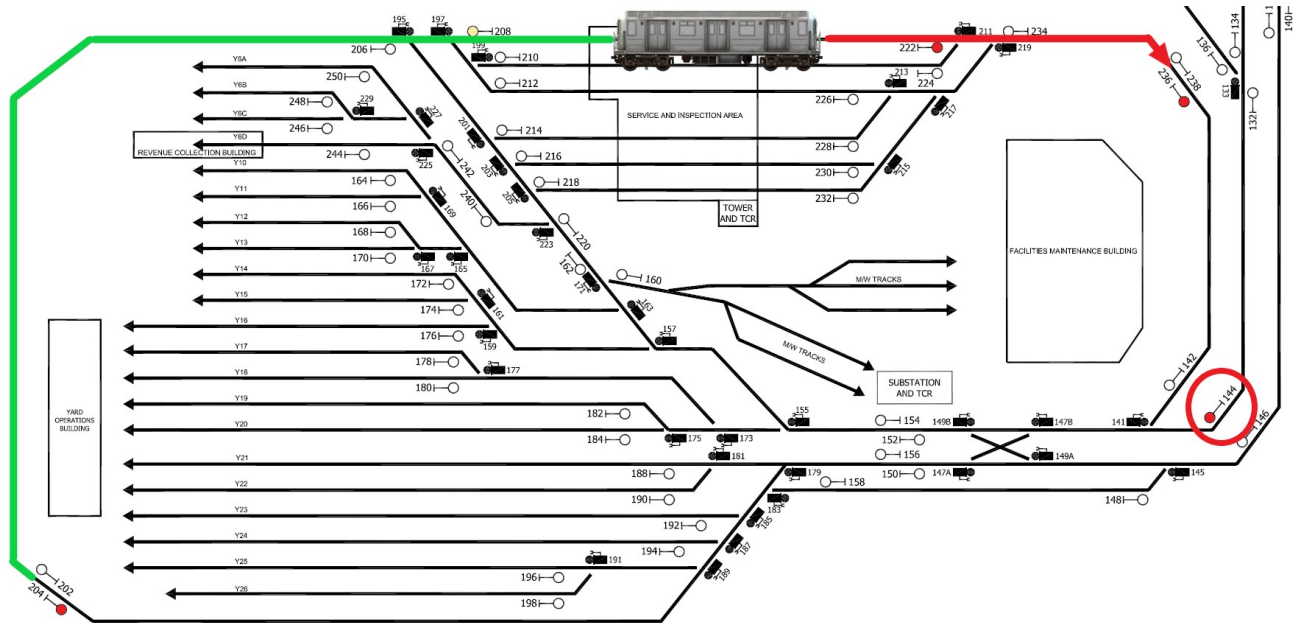
Field Sketch/Schematics

Alexandria Rail Yard, Signal C99-222

At approximately 05:14 hours, the Train Operator began to exit the car wash moving the train eastbound, in approach of C99-222 signal red. At approximately 05:17 hours, the train stopped approximately 11 feet ahead of C99-222 signal red for approximately 5 seconds. The train then continued, passing C99-222 signal red, trailing switch 211, before coming to a stop at the C99-236 signal. This action is a violation of the Metro Rail Safety Rules and Procedures Handbook (MSRPH) – Sec. 3 OR 3.67, which states “Rail vehicles shall not be operated past or closer than

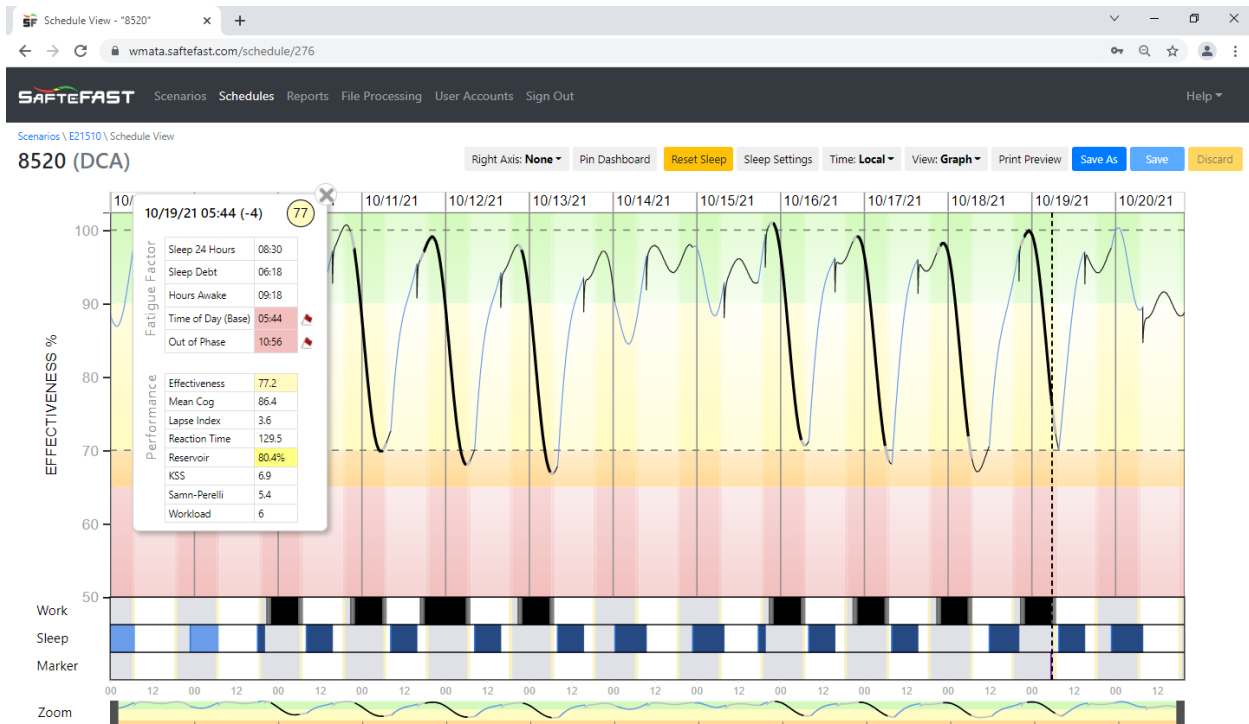
A biomathematical fatigue modelling application (SAFTE-FAST WebSFC) was used to further evaluate fatigue risk factors that may have been present in the Interlocking Operator's schedule. The analysis was based on the Interlocking Operator's work schedule, bed, and wake times from the day before the incident and reported habitual sleep durations. Estimated performance effectiveness at the time of the incident was 77.2%. Specifically, the analysis identified the circadian effects of night work as a factor contributing to an increased risk of fatigue at the time of the incident.

Modeling analysis output shows estimated performance effectiveness during the incident work shift and for the week leading up to the work shift, based on the employee work and reported sleep schedule. Estimates were based on the Interlocking Operator's work schedule, bed, and wake times from the day before the incident and reported habitual sleep durations (7.5 hours a day). Bold portions of the modeled curve show work (in black) and sleep times (in blue). Effectiveness is shown on the vertical axis, with colored fields in the chart background signifying ranges of effectiveness scores including high effectiveness (>90%) in green, and low effectiveness (<65%) in red. Time is shown on the horizontal axis. Markers for work and sleep times are shown in the lanes above the time of day on the horizontal axis.

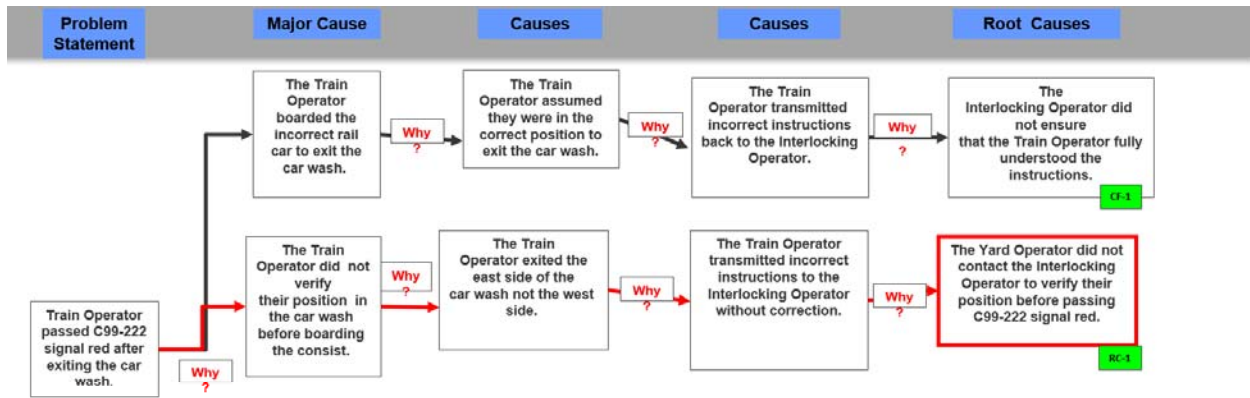
Appendix E - Root Cause Analysis

The probable cause of the Red Signal Overrun incident was a failure to adhere to established rules and procedures when in approach of a red signal, as identified in the Metro Rail Safety Rules and Procedures Handbook (MSRPH) – Sec. 3 OR 3.67, which states, “*Rail vehicles shall not be operated past or closer than a point 10 feet in approach of an interlocking signal or lamp displaying a red aspect, a red flag, or a dark interlocking signal, except at a bump post or entering a pocket track, or unless authorized by ROCC or the Interlocking Operator and the move is consistent with customer safety as specified in Rule 3.1.*” The Train Operator appears to have lost their situational awareness, as they reported receiving a ride to the shop area and possibly due to having to normalize the train doors prior to moving, leading to their failure to observe and report the red signal to the Interlocking Operator before passing. Additionally, the inadequate oversight of the Interlocking Operator when they failed to establish 100% repeat back after the Train Operator transmitted the incorrect instruction before exiting the car wash was a contributing factor to the incident.
