WMSC Commissioner Brief: W-0152 – Collision – Greenbelt Yard – November 16, 2021

FINAL REPORT OF INVESTIGATION A&I E21583

Greenbelt Yard – Collision

November 16, 2021

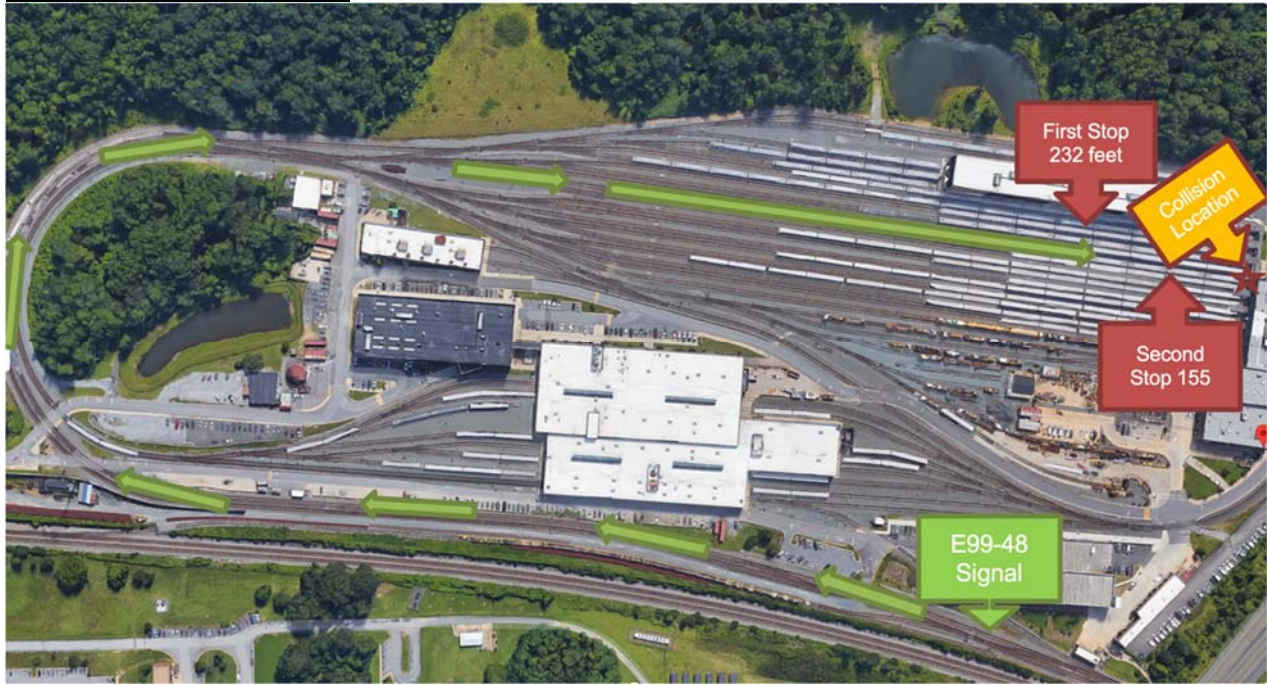
Field Sketch/Schematics

Greenbelt Yard, Track 13 Bump Post

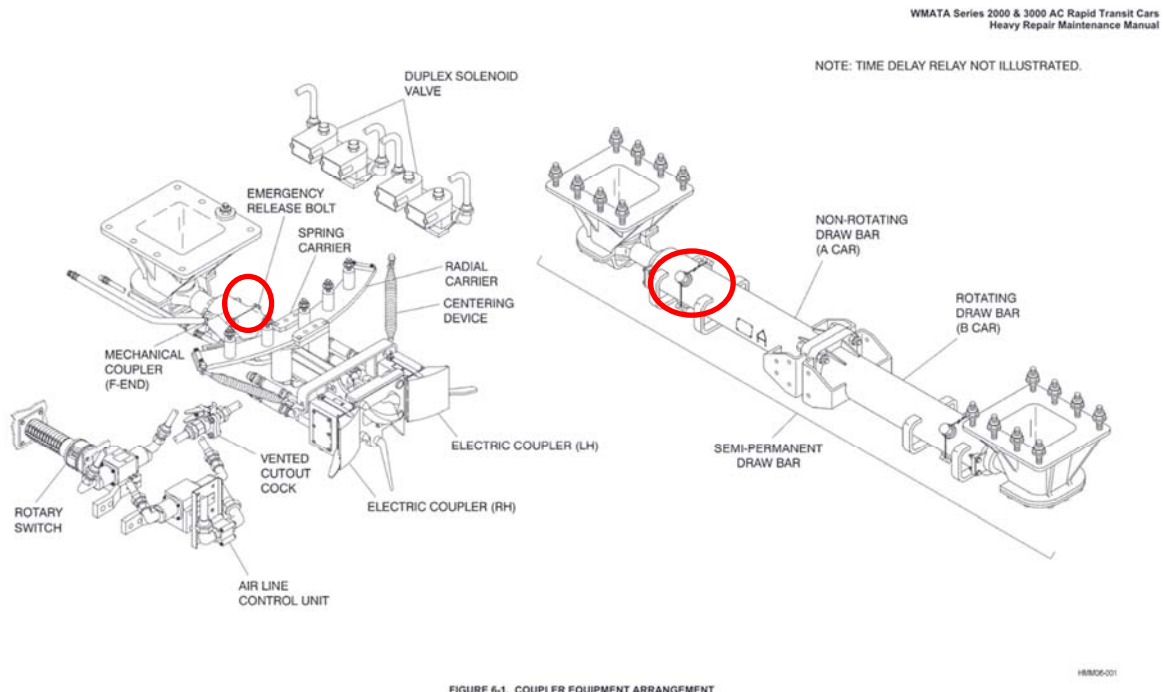
Figure 6 - Diagram of Front Coupler and Semi-Permanent Drawbar.

Shear bolts [emergency release bolts] are installed on the body of the semi-permanent drawbars and front couplers shaft housing. These bolts shear as a safety function at approximately 125,000 lbs. of force to help minimize the damage to the coupler system and reduce impact.

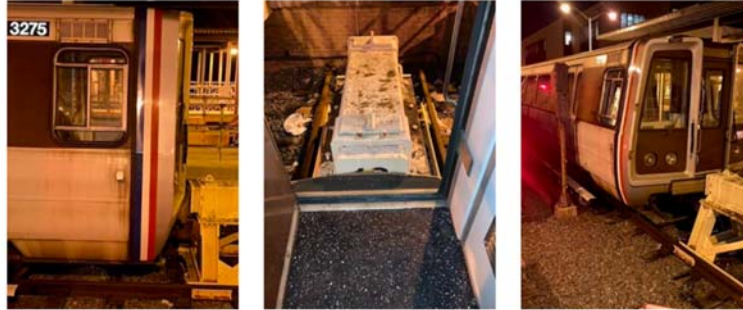
"Based on a walk-around inspection upon arrival to the yard, the train collision was on track 13 bump post. The consist "Lead 3275/74X 3067/66X 3200/3201 T" ran into the bump post and pressed the post-spring into the housing. As a result, the following car consist damages were observed:

- Car 3275 coupler head damage and shear bolts broken.
- Car 3274 Drawbar damage and all cap screws came off. Both A-car and B-car shock absorbers joined together.
- Car 3067 shear bolts broken with cap screws came off.
- Cars 3066, 3067, 3275, and 3275 front and rear floorboards bumped up.

INCIDENT PHOTOS: ATTACH ANY SIGNIFICANT PHOTOS BASED ON THE INITIAL INCIDENT INVESTIGATION.

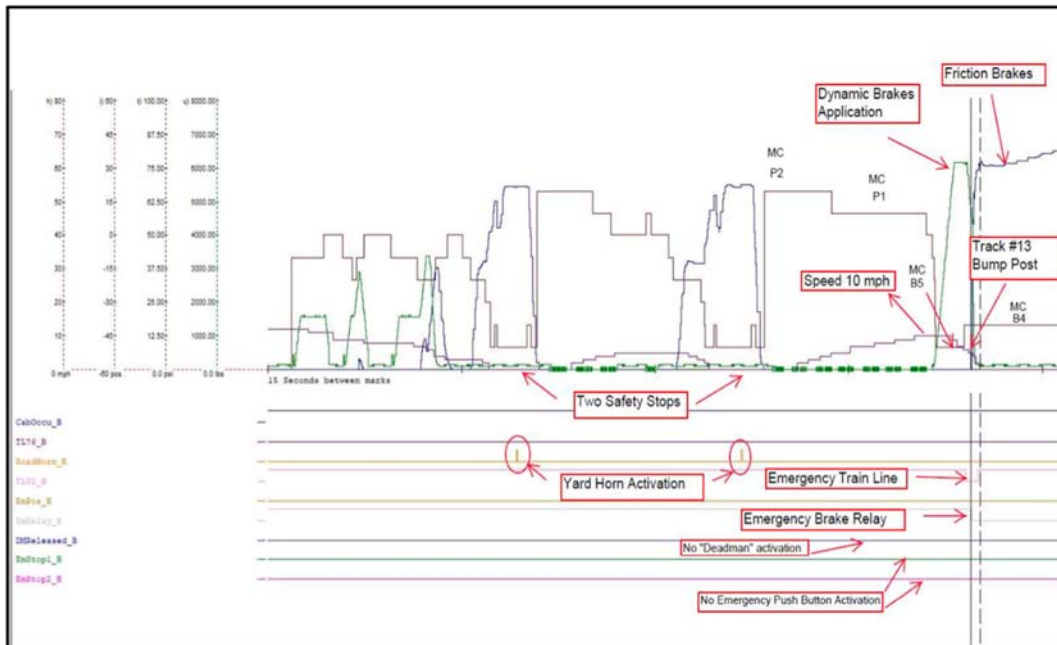
Figure 3. VMS Graph

- The train made two (2) safety stops at 232 feet and 156 feet from the bump post respectively. The road horn was activated during both safety stops.
- Approximately 63 feet from the bump post, the train speed was recorded as 10 mph at P1 Power rate
- Approximately 36 feet from the bump post, the master controller was placed in B5 brake rate
- The train speed decreased to 6 mph, the emergency brake relays, and emergency stop train lines (A car and B car) were deenergized to activate maximum friction brake rate
- The train came to rest after contacting the bump post
- There is no indication of Car Wash Train Line activation during this incident
- There is no indication of Push Button Emergency Valve activation during this incident
