WMSC Commissioner Brief: W-0154 – Evacuation for Life-Safety Reasons – Dunn Loring Station – November 25, 2021

Washington Metro Area Transit Authority Department of Safety and Environmental Management (SAFE) FINAL REPORT OF INVESTIGATION A&I E21602

Date of Event:	11/25/2021
Type of Event:	Evacuation for Life Safety Reasons
Incident Time:	18:55 hours
Location:	Dunn Loring, Track 2
Time and How received by SAFE:	19:00 hours. SAFE/IMO On-call Phone
WMSC Notification Time:	20:17 hours
Responding Safety Officers:	WMATA SAFE: No
	WMSC: No
	Other: N/A
Rail Vehicle:	Train ID 901, [L3164-3165.3035-3034.3246-3247T]
Injuries:	None
Damage:	Left side Operator Cab Heater/floor heater element
	burnt on Lead Car 3164.
SMS I/A Incident Number:	20211125#97041MX

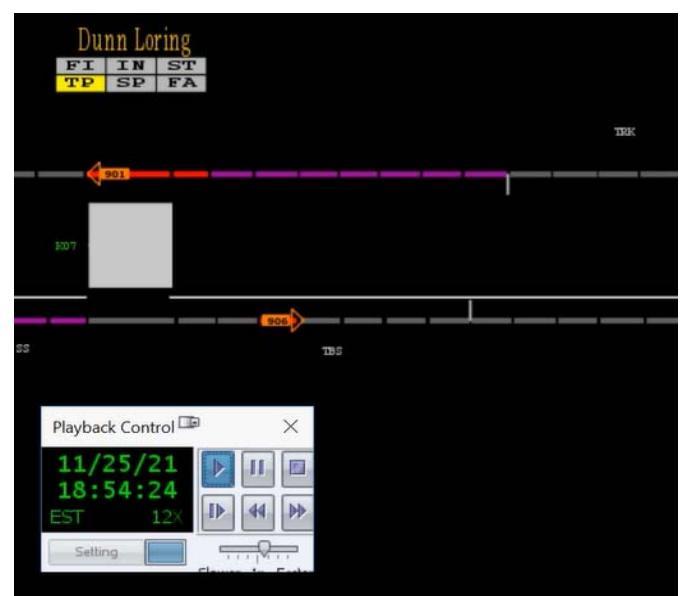
Diagram 1 - Based on the AIMS playback, Train ID 901 berthed at Dunn Loring Station, Track 2, at 18:54:24 hours.

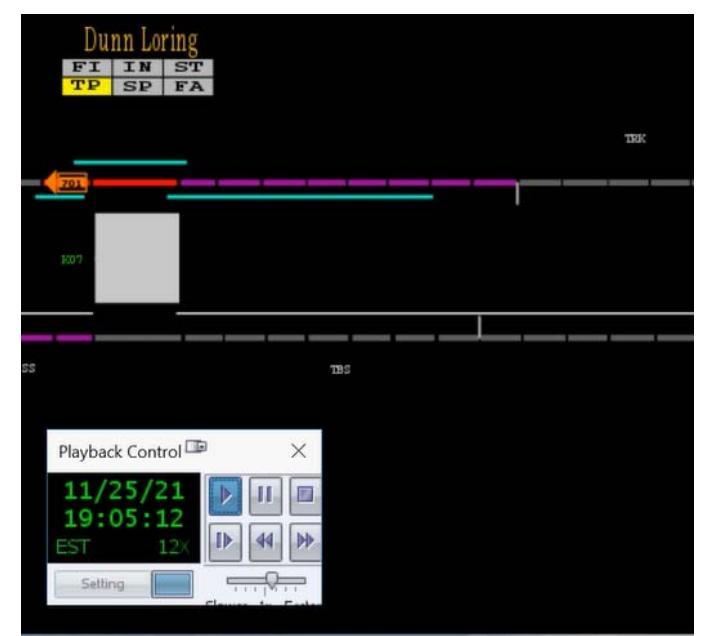
Diagram 3 - Based on the AIMS playback, Dunn Loring Station, Track 2, third rail power was de-energized at 19:05:12 hours.
