WMSC Commissioner Brief: W-0156 – Serious Injury – Navy Yard Station – December 4, 2021

FINAL REPORT OF INVESTIGATION A&I E21631

Date of Event:	12/04/2021
Type of Event:	Serious Injury
Incident Time:	05:51 hours
Location:	Navy Yard Station, Escalator W02
Time and How received by SAFE:	06:00 hours via IMO Notification
WMSC Notification Time:	06:48 hours
Responding Safety Officers:	WMATA: No WMSC: No Other: N/A
Rail Vehicle:	N/A
Injuries:	Two contractors: one major injury, one minor injury
Damage:	None
Emergency Responders:	DCFEMS

Navy Yard Station – Serious Injury

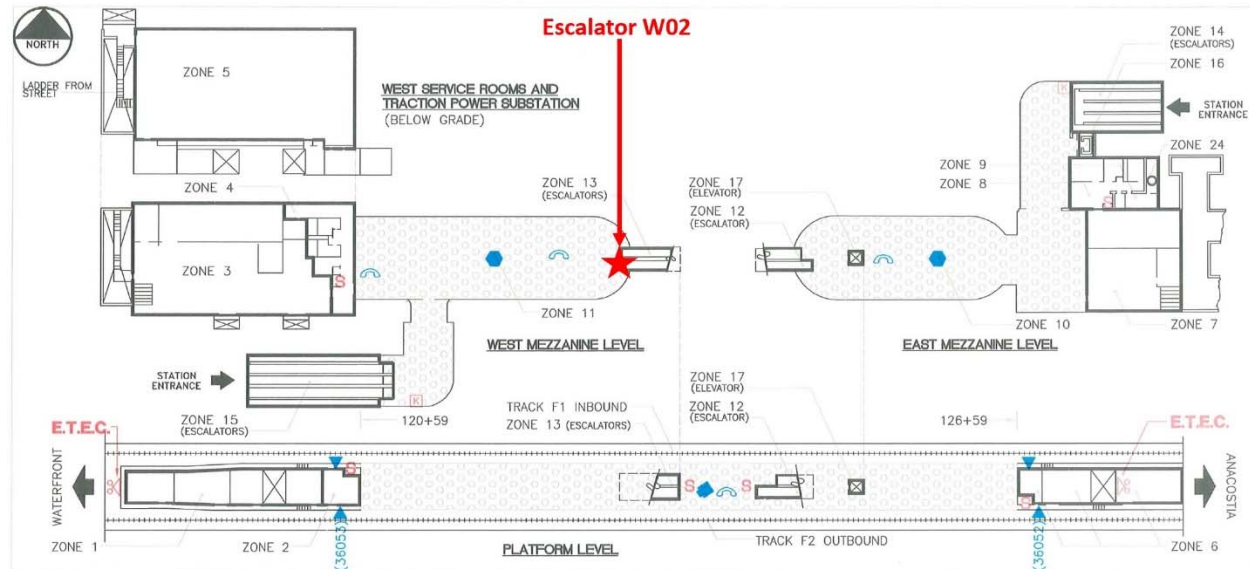
Field Sketch/Schematics

On Saturday, December 4, 2021, at approximately 05:51 hours, the crew of four Mid-American Elevator Contractors were completing work activities on Escalator W02 at the Navy Yard Station. As the work crew was in the process of completing the welding tasks for the evening, they organized their work tools to be removed. The work crew utilized a work sled throughout the shift to move welding equipment up and down the escalator truss where pan replacement operations were being conducted. As the crew cleaned up the work site for the day, the work sled was hoisted up. One helper was assigned to operate the winch during the hoisting operation. A second helper observed the hoisting line and periodically lifted it to prevent the line from becoming caught on the crossmembers/frame. During the hoisting operation, two contractors were located within the truss below the work sled. While in operation, the sling connecting the work sled to the winch became disconnected, causing it to descend the escalator truss and make contact with the two contractors working below. The work sled went past the first contractor who received minor injuries to their arm. The work sled continued to descend and made direct contact with the second contractor. This contact resulted in the second contractor receiving serious injuries to their head, leg and back. The other contractors came to the aid of the injured contractor and emergency services were requested. The work sled came to rest at the bottom of the escalator. The injured contractor was transported to George Washington University Hospital for their injuries. The work sled and escalator were not damaged in this incident.
