#### WMSC Commissioner Brief: W-0158 – Fatality – Franconia-Springfield – December 18, 2021

## FINAL REPORT OF INVESTIGATION A&I E21666

## Franconia-Springfield – Fatality

### December 18, 2021

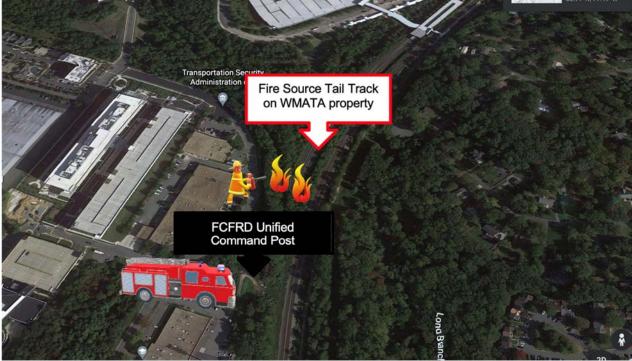
#### Field Sketch/Schematics\*

Franconia-Springfield, Track #3
