## **WMSC Commissioner Brief: W-0162 – Improper Door Operation – Fort Totten Station – January 7, 2022**

**FINAL REPORT OF INVESTIGATION A&I E22015**

# Fort Totten Station – Improper Door Operation

January 7, 2022

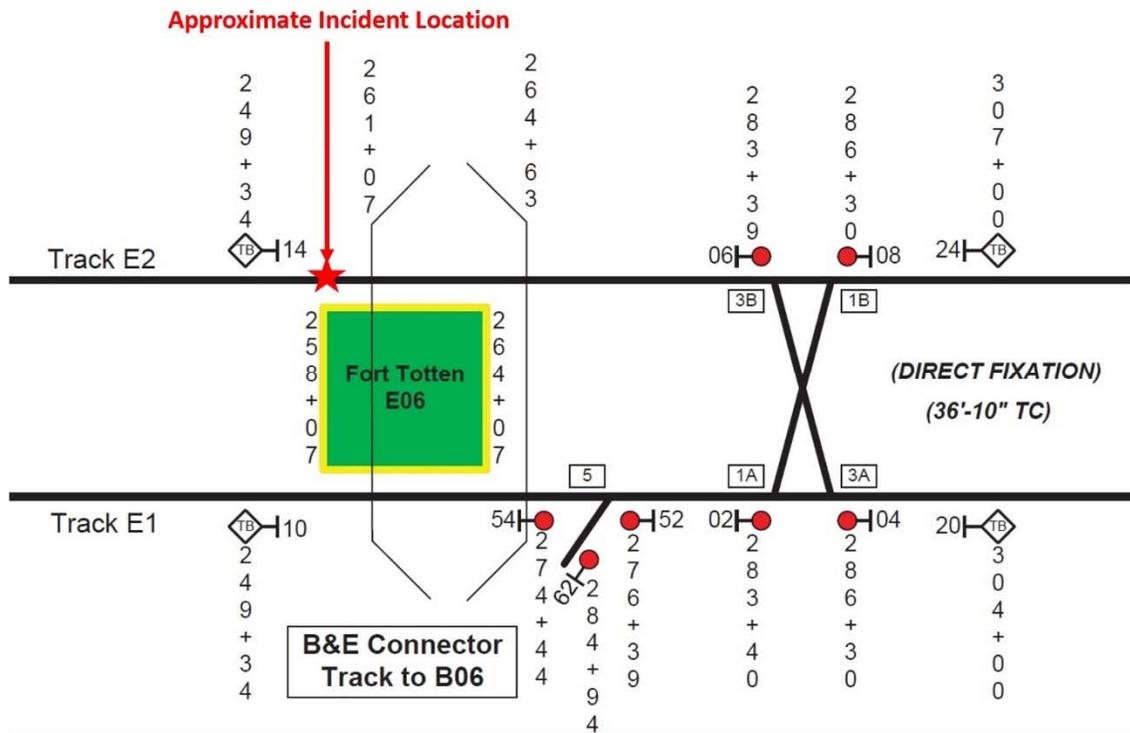
## Field Sketch/Schematics

Fort Totten Station, Track 2

IIT CMOR analysis of the VMS data found that the train entered Fort Totten Station, Track 2 in a "B1" Braking mode at a speed of 41 mph. The Master Controller (MC) was moved to the emergency position, initiating emergency braking approximately 85 feet from the 8-Car Marker. The train overran the station by passing the 8-Car marker at approximately 9 mph with the MC in the Emergency Position. The train came to a complete stop after traveling approximately 11 feet beyond the 8-Car Marker.

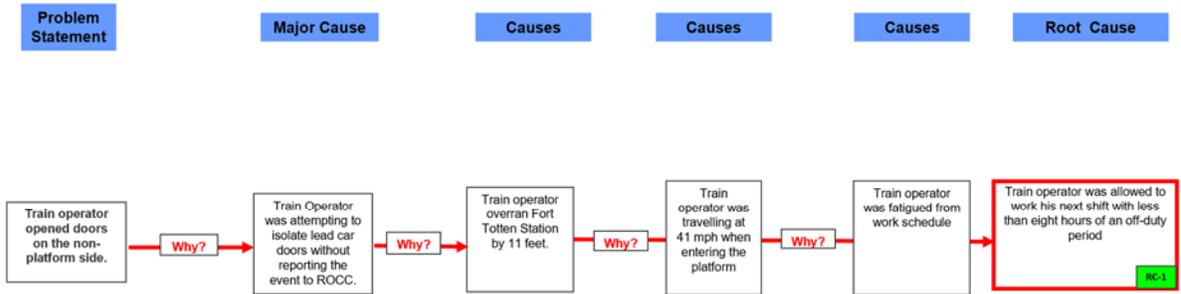
## E22015 – Improper Door Operation – Fort Totten Station

The probable cause of the station overrun event that led to the Improper Door Operation was a human factors failure to adhere to established procedures of reporting all events on the WMATA rail right-of-way, including Station Overruns. Contributing factors included multiple fatigue factors, such as a mix of night- and day-work and an inadequate release period on the day preceding the incident. Fatigue possibly contributed to the errors in judgement and decision-making that resulted in the Train Operator failing to report the events and ultimately depressing the Right-Side Open Doors button.
