WMSC Commissioner Brief: W-0165 – Collision at Potomac Avenue Station – January 9, 2022

FINAL REPORT OF INVESTIGATION A&I E22019

Date of Event:	01/09/2022
Type of Event:	Person Struck by Train
Incident Time:	19:51 hours
Location:	Potomac Avenue Station, Track 2
Time and how received by SAFE:	19:57 hours, SAFE MAC
WMSC Notification Time:	19:57 hours
Event Scene Release	21:52 hours, WMSC
Responding Safety Officers:	WMATA SAFE: No WMSC: No Other: N/A
Rail Vehicle:	Train ID 903 L3213-3212 x 2003-2002 x 3245-3244T
Injuries:	One transport for medical attention. Non-life-threatening injury. Right Leg Lacerations
Damage:	Train-to-Wayside Communication Antenna
Emergency Responders:	Office of Rail Transportation (RTRA), Metro Transit Police Department (MTPD), District of Columbia Fire and Emergency Services (DCFEMS), Office of Car Maintenance (CMNT), Emergency Response Team (ERT), and Office of Plant Maintenance (PLNT).
SMS I/A Incident Number:	20220109#97784MX

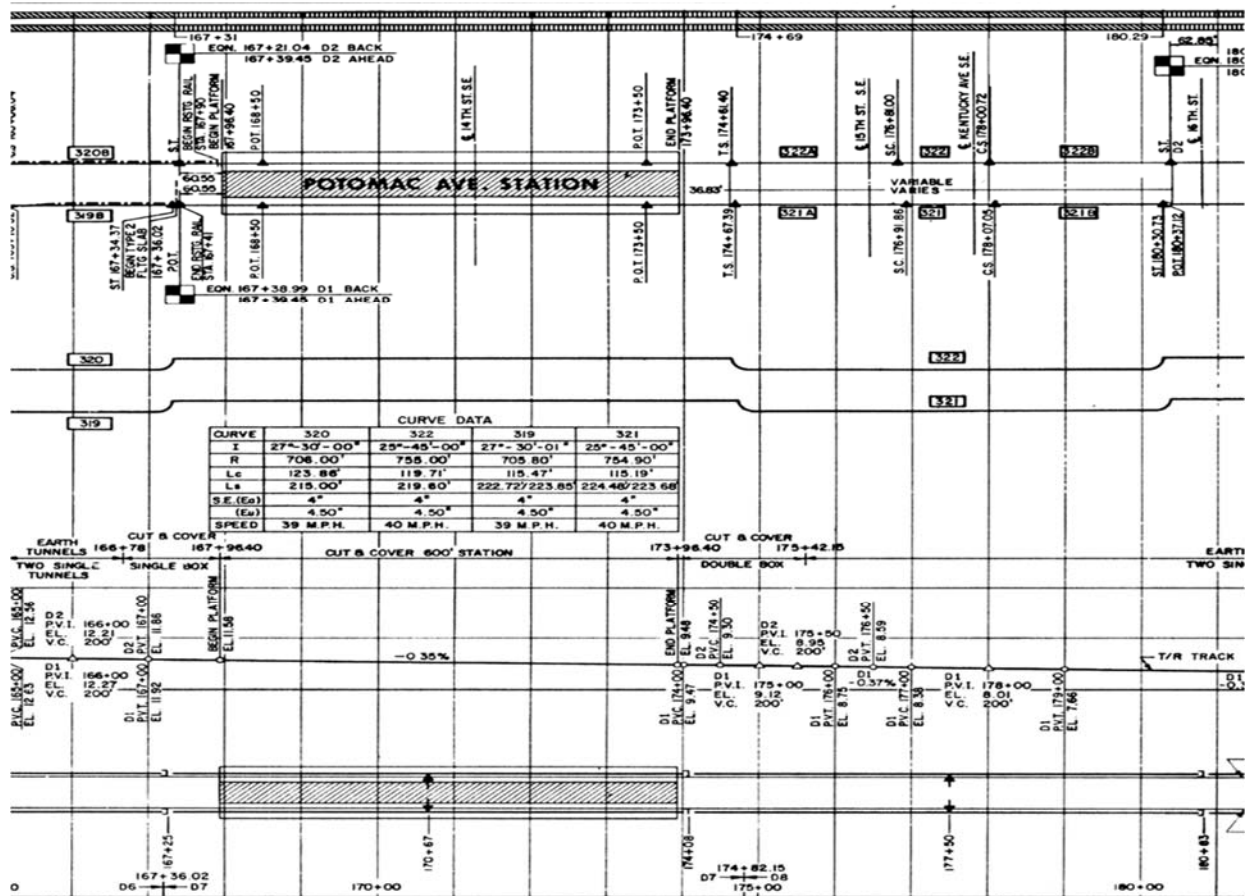
Field Sketch/Schematics

The Vertical Curve ends 36.83 feet before the Station platform entrance. WMATA's Quick Access Guide shows a restricted view curve on approach to the Potomac Avenue station end at the platform limits near D2-174+00, meaning that the Train Operator had a limited view of Potomac Avenue Station on approach.
