The Washington Metrorail Safety Commission

Safety Audit of the Washington Metropolitan Area Transit Authority

Audit of Communications Systems

Final Report:
September 29, 2022

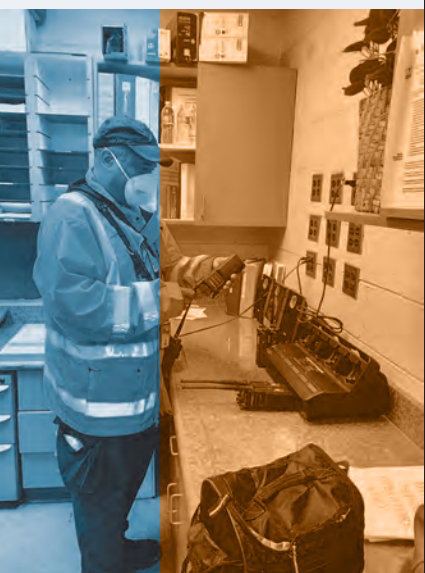
During a field visit to the Greenbelt Yard Tower, the WMSC audit team found three handheld radios that were out of calibration. In addition, an analog radio was observed in use at the tower operator's console. Through our direct access to WMATA's network, the WMSC found an undated notice during a search of WMATA's intranet site that stated on December 31, 2014, the VHF Analog radio system would be deactivated. During its 2015 Triennial Review of Radio and Communications Systems, the TOC identified among its findings that Maximo records showed numerous radios had outdated calibration dates.

This demonstrates that while WMATA has developed a program to ensure portable radios are not used beyond calibration dates as required by the TOC (TOC-OTR-15-012A), there is still a long-standing issue with Metrorail not ensuring that each radio in use is current and calibrated in accordance with policies. Metrorail has not ensured that all personnel are aware of and follow these requirements.

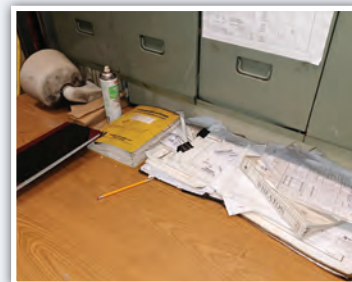
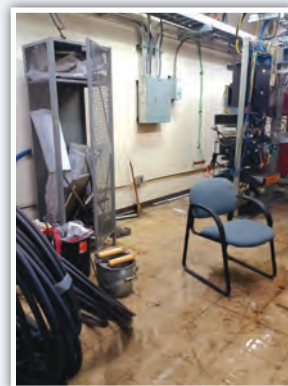
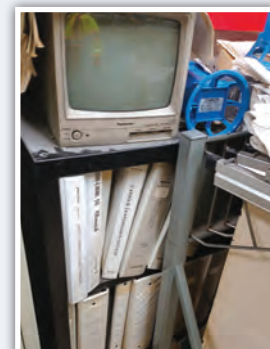
During a site visit for this audit, evidence of ongoing water intrusion was observed in the communications rooms at Fort Totten and Wheaton stations. Communications equipment was not properly protected from accumulated dirt and debris and possible water damage.

Despite these requirements, the WMSC observed a panel cover on the floor, a locker ajar with outdated equipment and various documents covered in dirt, and wires on the ground, with some near water that had accumulated at Fort Totten Station. Similar conditions with

In Communications Room 124 at Fort Totten Station, the WMSC encountered standing water, used rags, a bucket, and a squeegee tool used to redirect water. These tools along with an associated entry found in the communications room logbook, dated February 5, 2022—40 days prior to the WMSC's visit on March 17, 2022—are evidence of a recurring problem that had not been properly remediated. MOC was contacted by WMATA personnel during the site visit to report the issues and discovered that Work Order 16865775 had already been created regarding this issue on the date the issue was entered into the communications room logbook. The WMSC later reviewed this work order and found a discrepancy in location: The work description was listed as E06 (Fort Totten Station), but the asset and location were listed as E05 (Georgia Ave-Petworth Station). This may have been why the issue was not being properly addressed.

The WMSC audit team observed dirt accumulation in the communications rooms at Fort Totten, Greenbelt and Wheaton stations. Dirt, dust, debris, moisture and water pose risks to the proper function of the components housed in the rooms. For example, corroded electrical contacts can short causing circuit failures and intermittent anomalies that cannot easily be detected.

Minimum Corrective Action: WMATA must conduct a special inspection of all communications rooms to check for water intrusion or signs of water intrusion. Metrorail must prioritize and address all identified hazards and safety deficiencies in a timely fashion. Metrorail must provide the records of these inspections and this prioritization and schedule for addressing each issue on at least a quarterly basis along with documentation of all implemented mitigations. Metrorail must then institute a process that ensures water intrusion is identified and addressed on an ongoing basis going forward. WMATA must develop processes to ensure all equipment and documents in communications rooms are kept clean, organized and protected, including routine verification inspections conducted and documented by supervisors.
