WMSC Commissioner Brief: W-0179 - Collision - Forest Glen Station - May 7, 2022

Prepared for Washington Metrorail Safety Commission meeting on September 20, 2022

Washington Metro Area Transit Authority Department of Safety and Environmental Management (SAFE) FINAL REPORT OF INVESTIGATION A&I E22283

Forest Glen Station – Collision

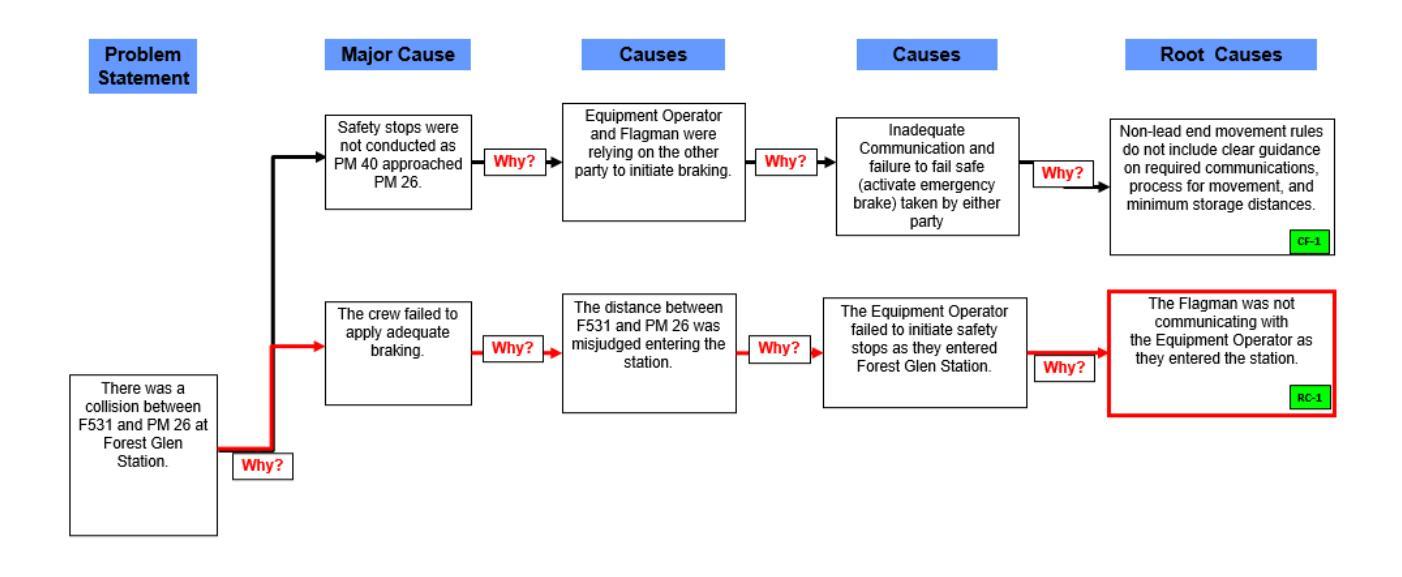
Appendix F – Root Cause Analysis

The probable cause of this event was Metrorail's inadequate procedures for non-lead-end operations and work vehicle storage. Contributing to this event was insufficient communication, and Metrorail's culture that accepts noncompliance with written operational rules, procedures and manuals.

The root cause of this event were multiple human factors errors, including a lack of communication between the Equipment Operator and Flagman and a failure to act by the Flagman and Equipment Operator when safety stops did not occur. Inadequate procedures relating to non-lead-end operations were identified as contributing factors. While there are established procedures for when to conduct safety stops, non-lead-end operations and minimum storage distances for Class II vehicles are not clearly described and understood. Fatigue risk for this event was determined to be moderate due to the time of day and work schedules; however, parties involved reported sufficient sleep and had enough time off preceding the event to achieve adequate rest.
