**WMSC Commissioner Brief: W-0184 – Improper Roadway Worker Protection – King Street Station – June 15, 2022**

Washington Metropolitan Area Transit Authority  
Department of Safety (SAFE)  
Office of Safety Investigations  
**FINAL REPORT OF INVESTIGATION A&I E22365**

# King Street Station - Improper RWP

June 15, 2022

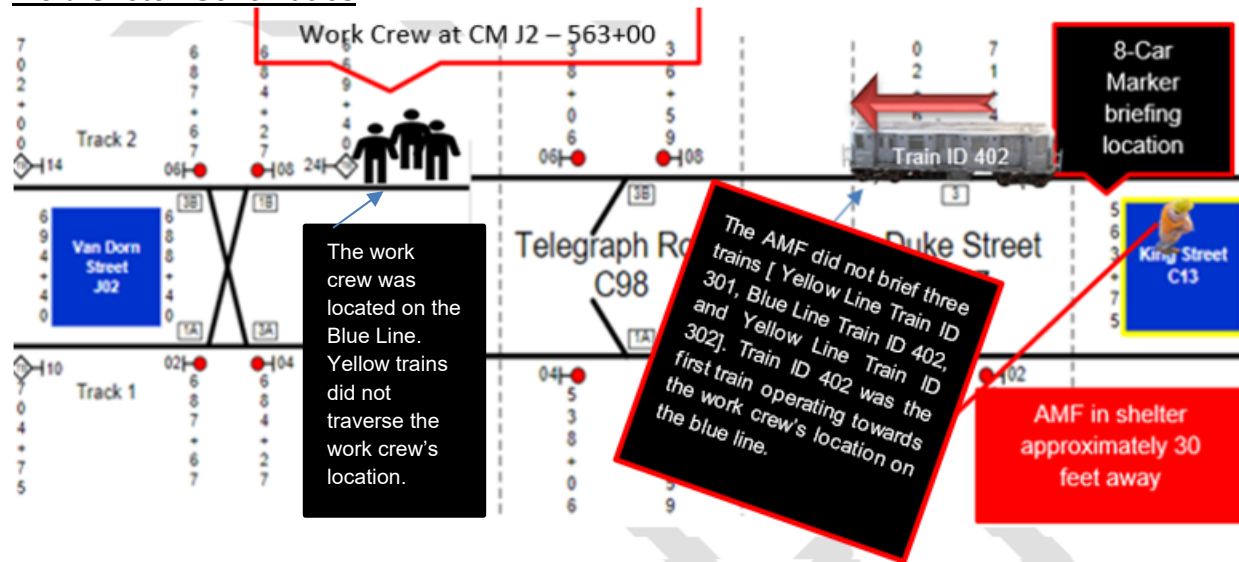
Between King Street and Van Dorn Street Stations, track 2

Closed Circuit Television (CCTV) playback showed that the AMF was positioned in the station platform shelter as trains 301, 402, and 302 serviced the station and departed. At approximately 10:18 hours, Train ID 402 observed personnel on the roadway, applied brakes, and reported the observation to ROCC.

As the AMF walked away from the lantern, yellow line Train ID 301 entered the platform limits and the AMF failed to brief the Train Operator.
