WMSC Commissioner Brief: W-0186 – Improper Vehicle Movement – McPherson Square Station – June 23, 2022

Washington Metropolitan Area Transit Authority
Department of Safety (SAFE)
Office of Safety Investigations
FINAL REPORT OF INVESTIGATION A&I E22386

McPherson Square Station – Improper Rail Vehicle Movement

June 23, 2022

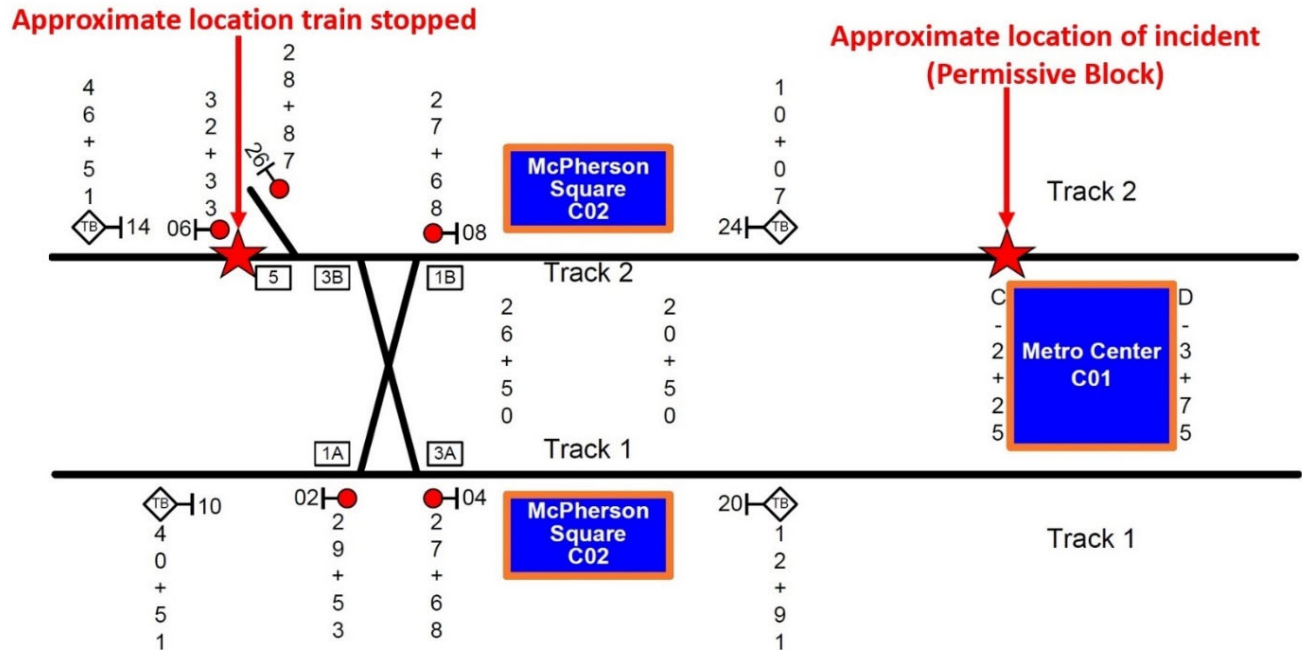
Field Sketch/Schematics

The Train Operator then continued operating past Metro Center and McPherson Square Stations without stopping. The Train Operator contacted the RTC and requested a permissive block in approach to Farragut West Station. The RTC advised the Train Operator of Train 701 of the requirement for permissive blocks for trains operating with trucks cut out. The RTC contacted an Office of Rail Transportation (RTRA) Supervisor to meet the Train Operator at Farragut West Station. The Train Operator was removed from service for the violation. There were no injuries or damages reported as a result of this incident.

McPherson Square Station, Track 2
