WMSC Commissioner Brief: W-0189 – Evacuation for Life Safety Reasons – Ballston-MU Station – August 11, 2022

FINAL REPORT OF INVESTIGATION A&I E22513

Evacuation for Life Safety Reason, Ballston-MU Station

August 11, 2022

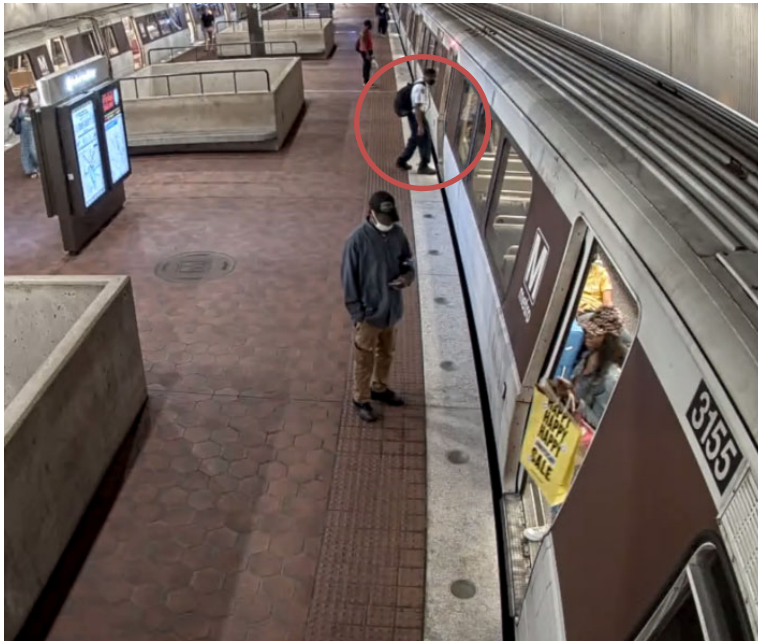
CCTV confirmed an RTRA Supervisor boarded Train ID 601 Track #1 headed inbound in Ballston Station's direction at approximately 21:32 hours.

Figure 2 - RTRA Supervisor Boarded Train ID 601 at approximately 21:32 hours.
