**WMSC Commissioner Brief: W-0190 Derailment – New Carrollton Station – August 29, 2022**

**FINAL REPORT OF INVESTIGATION A&I E22558**

<b>Date of Event:</b>	August 29, 2022
<b>Type of Event:</b>	Derailment
<b>Incident Time:</b>	12:47 Hours
<b>Location:</b>	New Carrollton Station (ACS) – D2 591+00 (1B switch)
<b>Time and How received by SAFE:</b>	13:00 Hours – SAFE/OSO
<b>WMSC Notification Time:</b>	13:50 Hours
<b>Responding Safety Officers:</b>	WMATA: OSO, OSI WMSC: None Other: None
<b>Rail Vehicle:</b>	Hi-Rail Vehicle 03-135241 Flat Car 57-189164 (CR7719)
<b>Injuries:</b>	None
<b>Damage:</b>	None
<b>SMS I/A Incident Number:</b>	20220829#102508

# **New Carrollton Station (ACS) – Derailment**

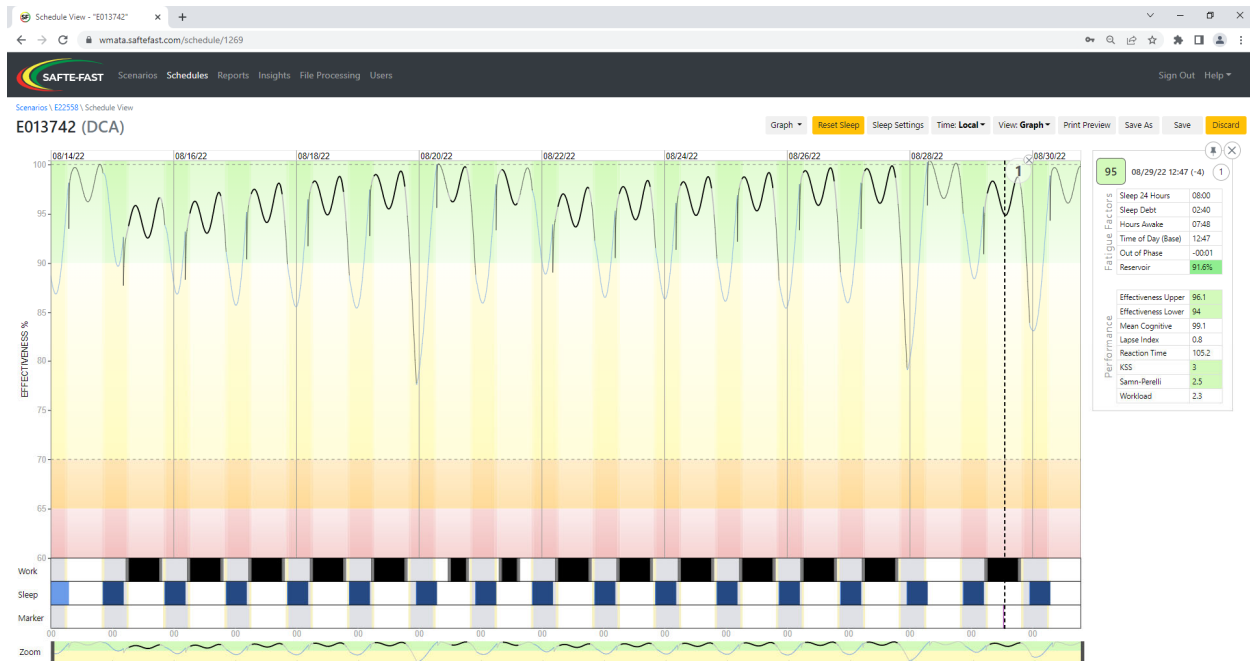
durations. Estimated performance effectiveness at the time of the incident was 95%. There were no major risk factors for fatigue identified.

Modeling analysis output shows estimated performance effectiveness during the incident work shift and for the week leading up to the work shift, based on the employee work and reported sleep schedule. Estimates were based on the ATC Mechanic's work schedule, reported sleep from the day preceding the incident, and reported habitual sleep durations (8 hours a day). Bold portions of the modeled curve show work (in black) and sleep times (in blue). Effectiveness is shown on the vertical axis, with colored fields in the chart background signifying ranges of effectiveness scores including high effectiveness (>90%) in green, and low effectiveness (<65%) in red. Time is shown on the horizontal axis. Markers for work and sleep times are shown in the lanes above the time of day on the horizontal axis.

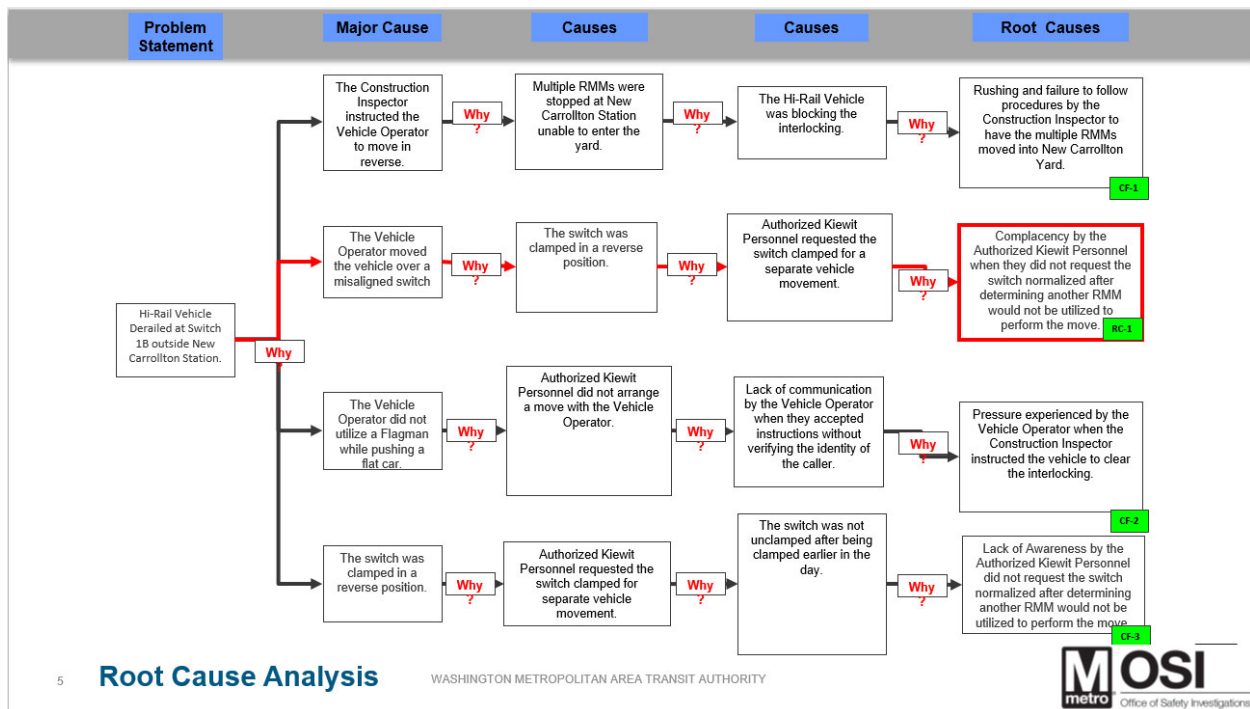
## Appendix D - Root Cause Analysis

The probable cause of the derailment event on August 29, 2022, was a failure to follow established procedures for vehicle movements within the ACS. The Construction Inspector and Hi-Rail Vehicle Operator both acknowledged that the movement was supposed to be coordinated through the Kiewit supervisor. A Contributing Factor to the event was that the Vehicle Operator moved the unit without a Flagman present, which was also required by procedure.
