WMSC Commissioner Brief: W-0191 – Serious Injury – Largo Town Center Station – July 28, 2022

Washington Metro Area Transit Authority
Department of Safety (SAFE)
Office of Safety Investigations (OSI)
FINAL REPORT OF INVESTIGATION A&I E22446

Largo Town Center Station – Serious Injury

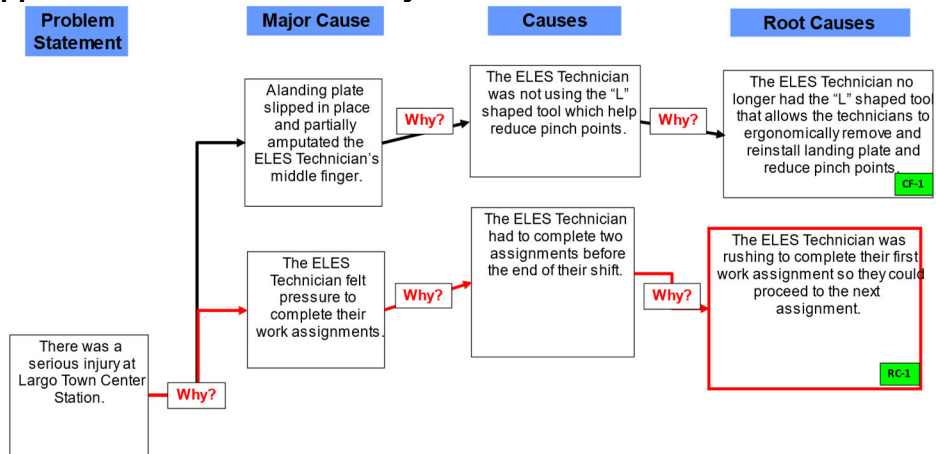
Appendix C - Root Cause Analysis

The probable cause of the Serious Injury event was a human factors error (rushing). A contributing factor to the injury was the lack of a proper tool to lower the landing plate, which would have prevented the employee's hands from being within a pinch point. The ELES Technician reported a time constraint pressure to complete the assignment so they could respond to their second assignment before their shift ended. The ELES technician also reported years ago an L-shaped tool was issued that assisted with removing and re-installing landing plates to avoid injuries like the one sustained; however, they were not issued the tool.
