WMSC Commissioner Brief: W-0201 – Evacuation for Life Safety Reasons – Court House Station – November 7, 2022

Prepared for Washington Metrorail Safety Commission meeting on March 7, 2023

Washington Metropolitan Area Transit Authority
Department of Safety (SAFE)
Office of Safety Investigations (OSI)
FINAL REPORT OF INVESTIGATION A&I E22724

Court House Station – Evacuation for Life Safety
November 7, 2022
Table of Contents

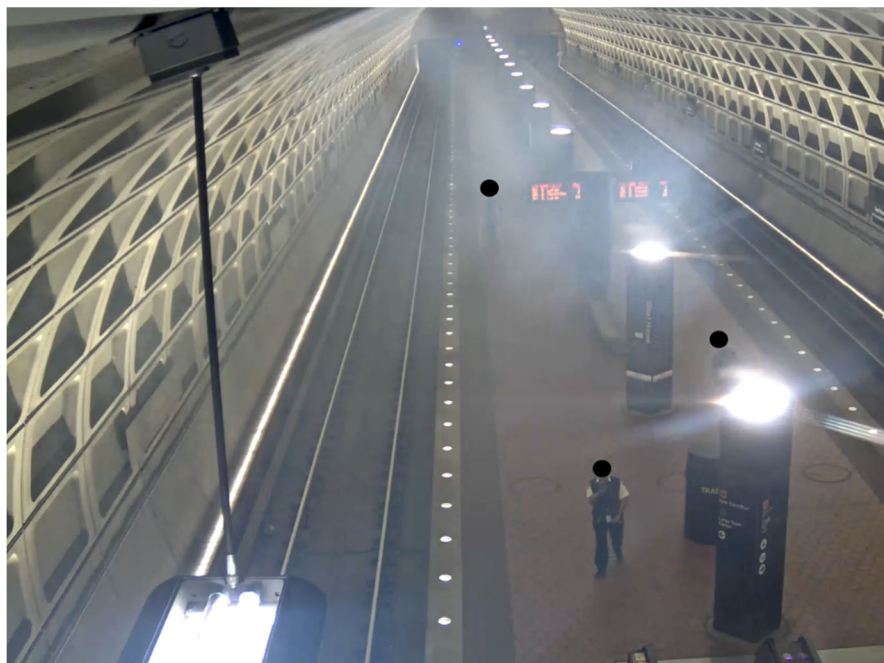
Figure 5: Station Manager on scene investigating at approximately 19:59 hours.

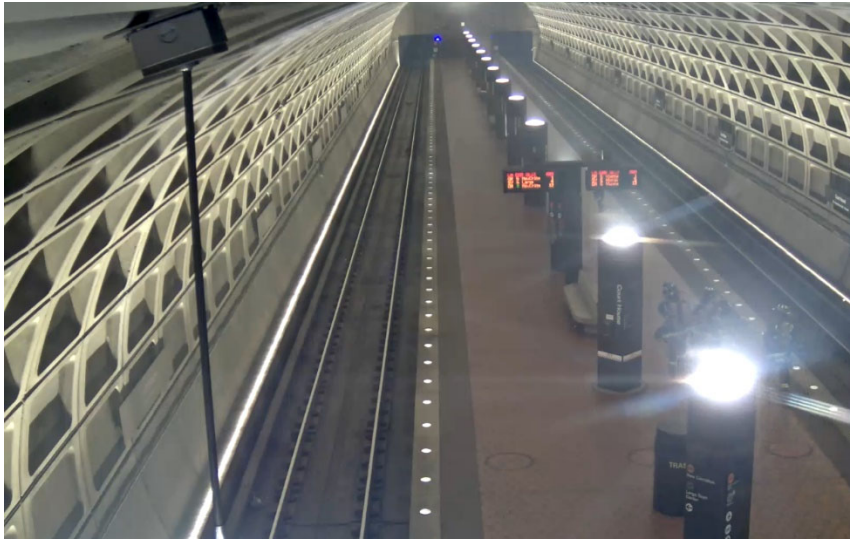
Figure 6: ACFD on scene investigating at approximately 20:10 hours.

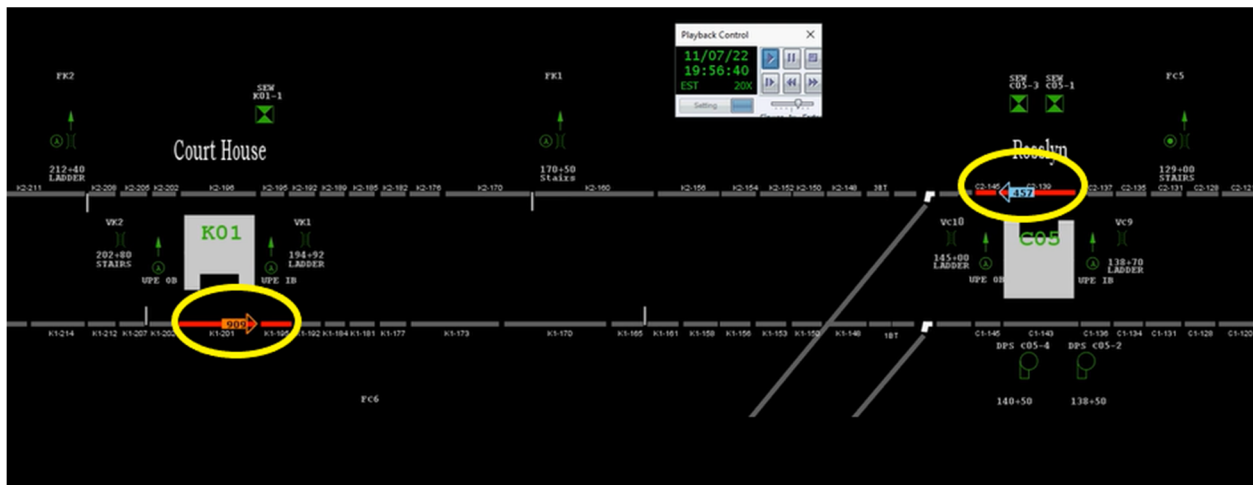
Consultation of AIMS determined at 19:56 hours, Train ID 909 serviced Court House Station and reported the smoke in the station. At the same time, Train ID 457 serviced Rosslyn Station

Figure 9: Train ID 909 and 457 servicing Court House and Rosslyn Stations, respectively.

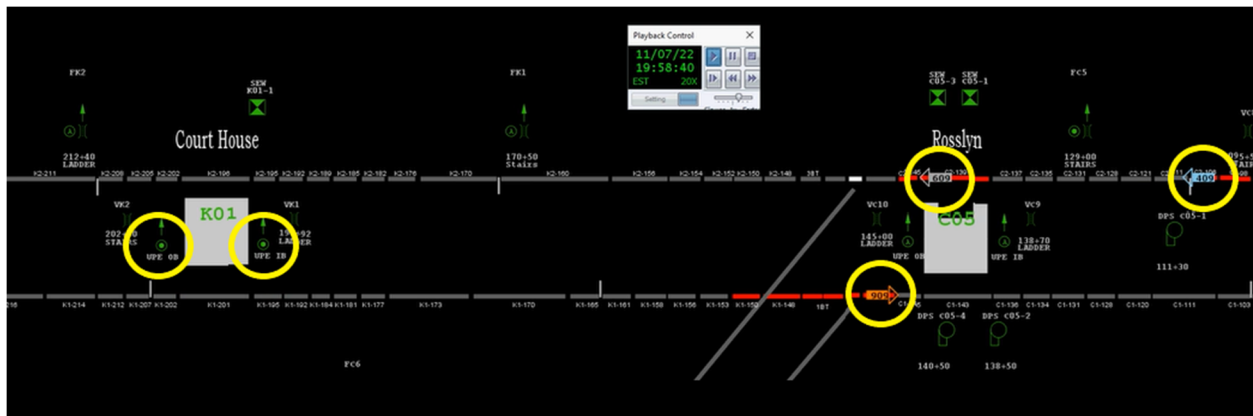
At approximately 19:58 hours, fans were activated at Court House Station while Train ID 909 approached and Train ID 609 serviced Rosslyn Station. Train ID 409 can be observed leaving Foggy Bottom Station at this time.

Figure 10: Train ID 909, 609 and 409. Fans were activated at Court House Station
