WMSC Commissioner Brief: W-0207 – Derailments – near future Potomac Yard Station – September 13, 2022

Washington Metropolitan Area Transit Authority Department of Safety (SAFE) Office of Safety Investigations FINAL REPORT OF INVESTIGATION A&I E22593/E22595

Date of Event:	September 13, 2022		
Type of Event:	Derailment		
Incident Time:	03:15 & 12:10 hours		
Location:	Potomac Yard Authorized Construction Site (ACS)		
Time and how received by SAFE:	03:59 & 12:58 hours – Mission Assurance		
	Coordinator (MAC)		
WMSC Notification Time:	04:29 & 13:02 hours		
Event Scene Release:	04:29 & 13:05 hours		
Responding Safety Officers:	WMATA: OSI/OSO		
	WMSC: None		
	Other: None		
Rail Vehicle:	Plasser Tamper Unit T006		
Injuries:	None		
Damage:	None		
Emergency Responders:	CTEM, CENV, TRST		
SMS I/A Number	20220913#102838MX

Potomac Yard ACS – Derailment

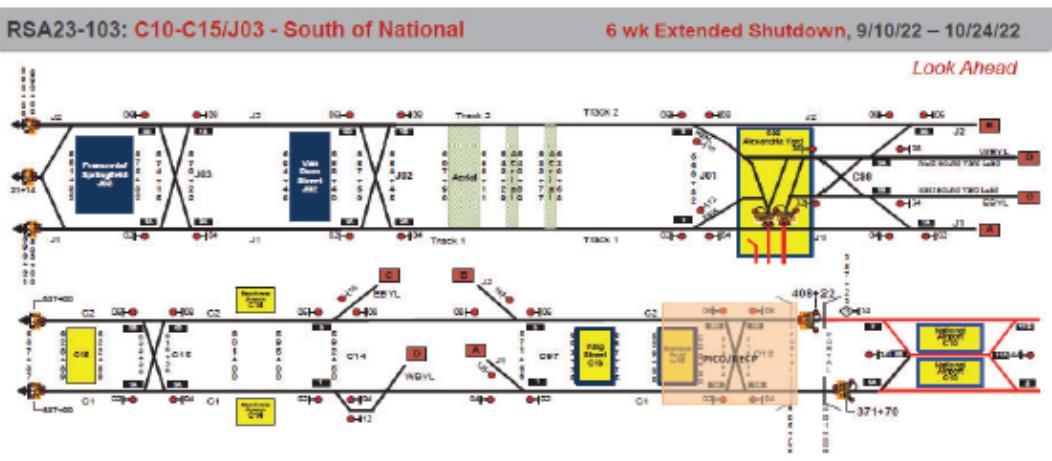
Figure 1, ACS Map 1 of 2

At approximately 3:15 hours on the morning of September 13th, 2022, within the Potomac yard station tie-in Authorized Constriction Site (ACS), Tamper T006 Derailed. (Figure 1 & 2).

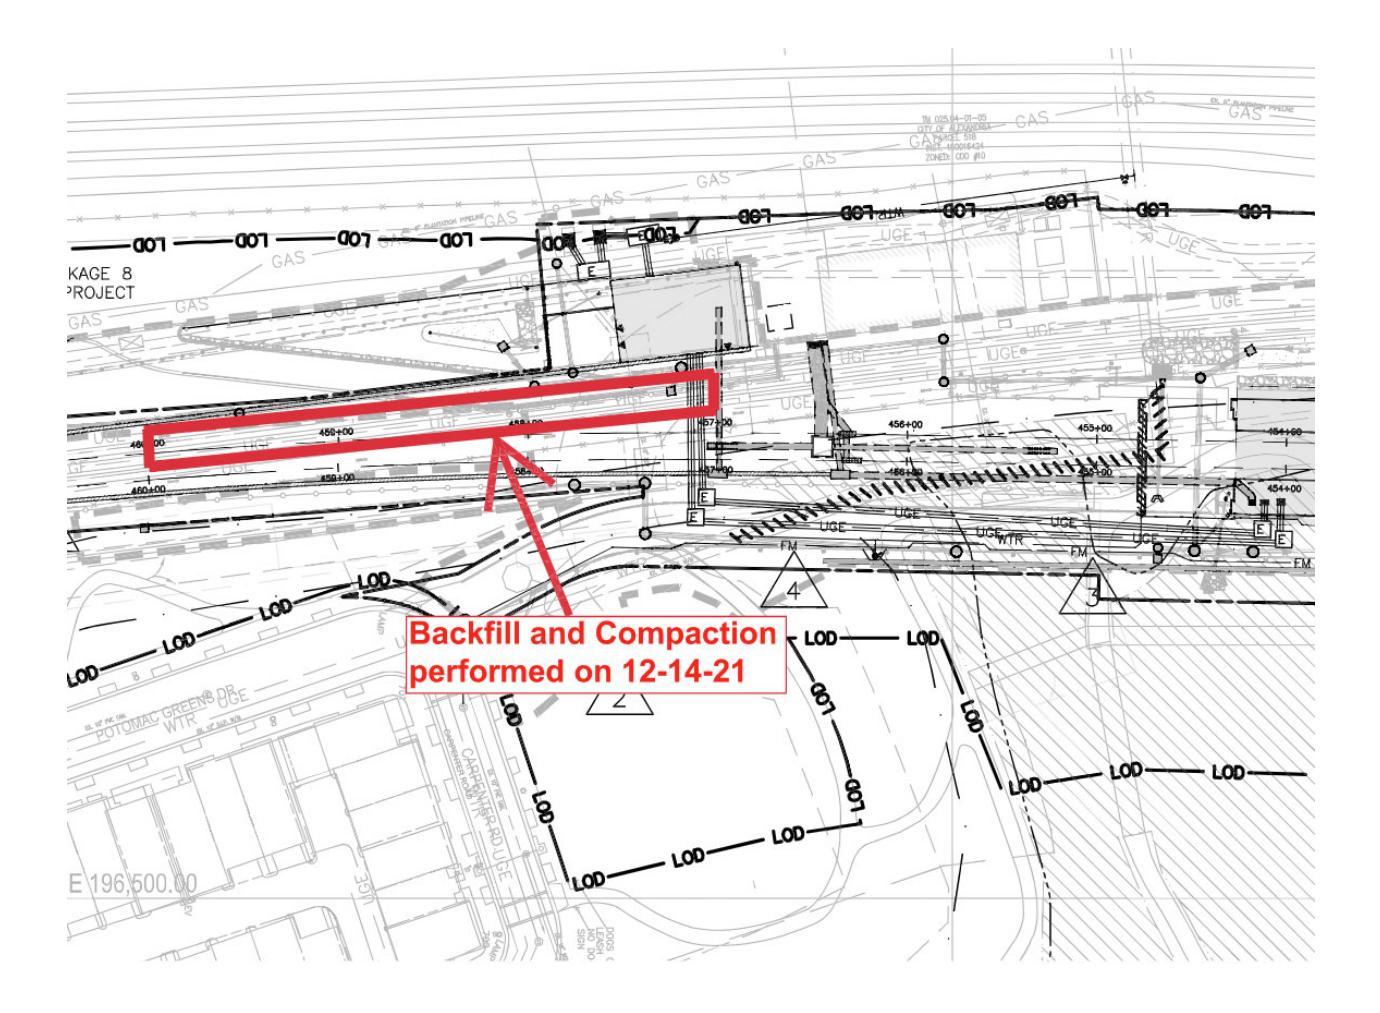
Appendix D – Root Cause Diagram

The probable cause of this event was a combination of track deficiencies, including cross level and elevation changes over a short distance, which are inherent during track construction. Insufficient joint support also likely contributed to the derailments. Post-incident field inspections by CENV and evaluation of the T006's design did not find significant evidence to show that a vehicle deficiency contributed to the derailments.
