WMSC Commissioner Brief: W-0209 – Collision – Friendship Heights Station – October 6, 2022

FINAL REPORT OF INVESTIGATION A&I E22652

Date of Event:	October 6, 2022
Type of Event:	Collision
Incident Time:	17:21 hours
Location:	Friendship Heights Station, Track 1
Time and How received by SAFE:	17:25 Hours - SAFE/MAC
WMSC Notification Time:	18:48 Hours
Responding Safety Officers:	WMATA: None WMSC: None Other: None
Rail Vehicle:	Train 111 - L7710/11x7542/43x7567/68x7655/54T
Injuries:	Serious Non-Life Threatening Injures
Damage:	TWC Antenna
Emergency Responders:	District of Columbia Fire and Emergency Medical Services (DCFEMS), Montgomery County Fire and Rescue Services (MCFRS), Metro Transit Police Department (MTPD)
SMS I/A Incident Number:	20221006#103367MX

Friendship Heights Station – Collision

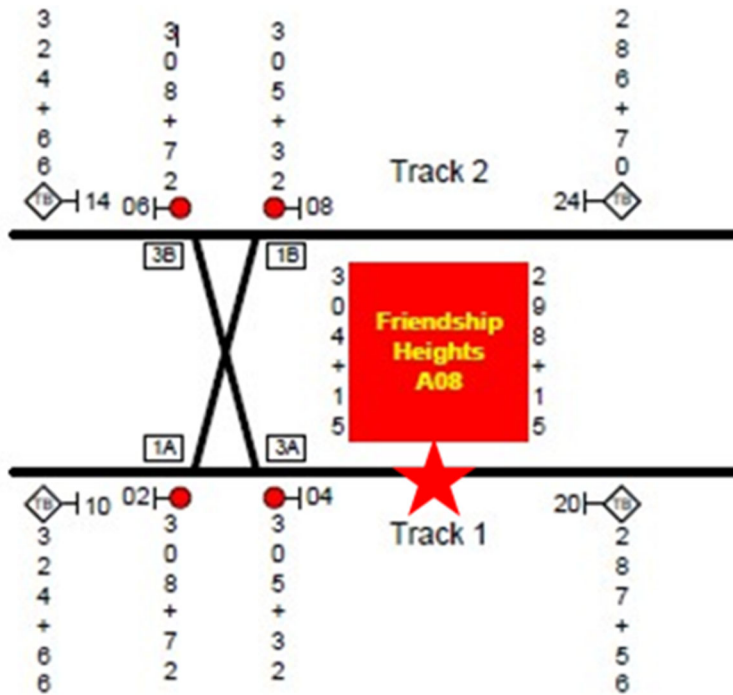
Field Sketch/Schematics

Friendship Heights Station, Track 1

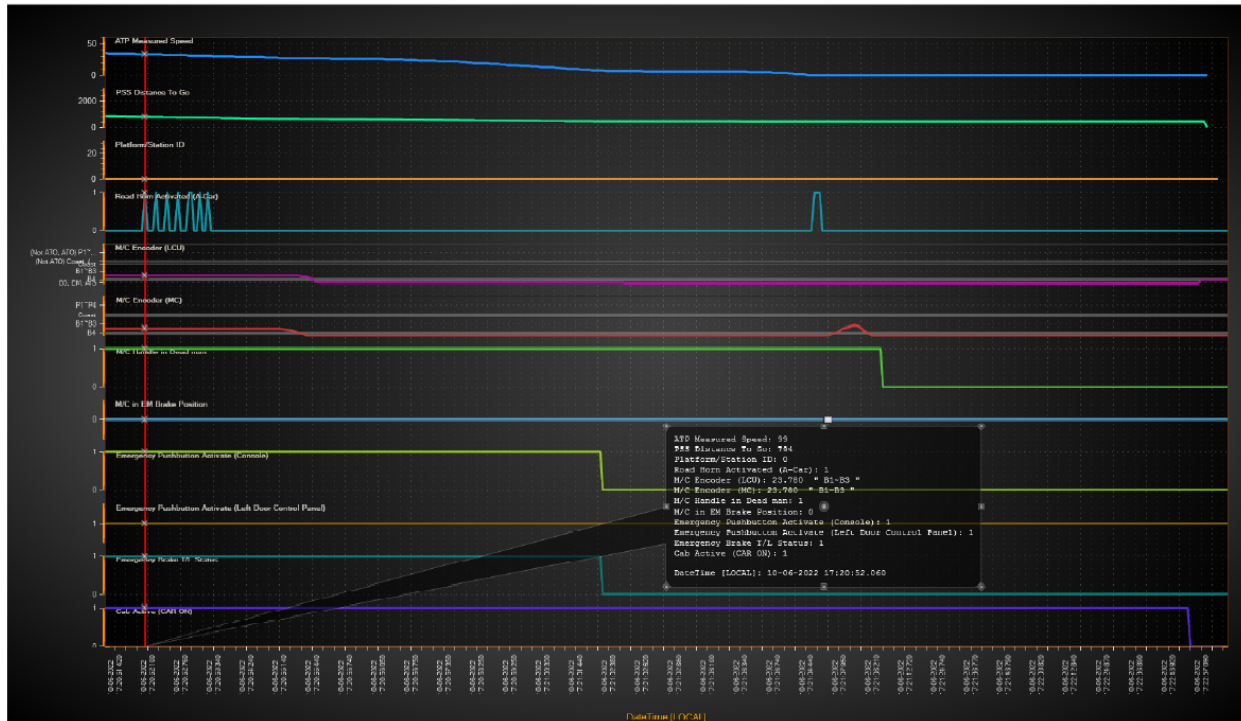
Time	Description of Events
10-06 17:20:52	Road horn activated seven (7) times over one (1) second. Speed 33 mph, 194 feet prior to entering the platform (794 ft to the 8-car marker). Master Controller at "B1 ~ B3".
10-06 17:20:55	Master Controller moved to "B5, EM, A/S" Speed 27 mph.
10-06 17:21:02	Emergency Stop on operator's console depressed. Speed 8 mph, 147 feet into the platform (453 ft to the 8-car marker)
10-06 17:21:04	Train is stopped. 160 feet into the platform (440 ft to the 8-car marker)
10-06 17:21:05	Road horn activated
10-06 17:21:08	Master Controller handle released
10-06 17:22:56	Car [7710] is keyed down
