WMSC Commissioner Brief: W-0211 – Evacuation for Life Safety Reasons – Gallery Place Station – November 23, 2022

Washington Metropolitan Area Transit Authority
Department of Safety (SAFE)
Office of Safety Investigations (OSI)
FINAL REPORT OF INVESTIGATION A&I E22768

**Gallery Place Station – Evacuation for Life Safety Event
November 23, 2022**

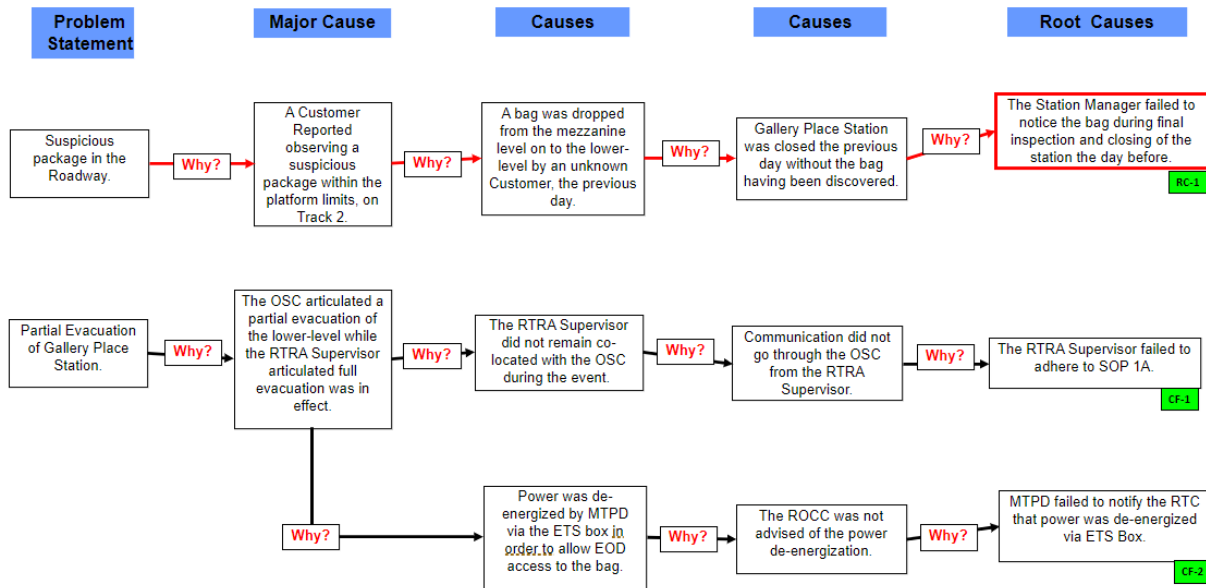
Appendix C - Root Cause Analysis

The Probable Cause for the Evacuation for Life Safety Reasons at Gallery Place Station was that an unknown customer dropped a bag from the mezzanine level on to Track 2 of the lower-level of Gallery Place Station. The platform was evacuated to allow law enforcement authorities to investigate and determine the threat level. No WMATA personnel or equipment contributed to this event.
