**WMSC Commissioner Brief: W-0227 – Evacuation for Life Safety Reasons – Rosslyn Station – February 8, 2023**

Washington Metropolitan Area Transit Authority  
Department of Safety (SAFE)  
Office of Safety Investigations (OSI)  
**FINAL REPORT OF INVESTIGATION A&I E23088**

## Rosslyn Station – Evacuation for Life Safety Reason

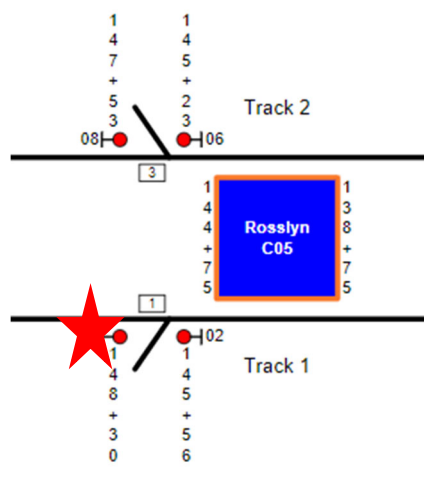
**Field Sketch/Schematics**

Inbound on Track 1 at Rosslyn Station

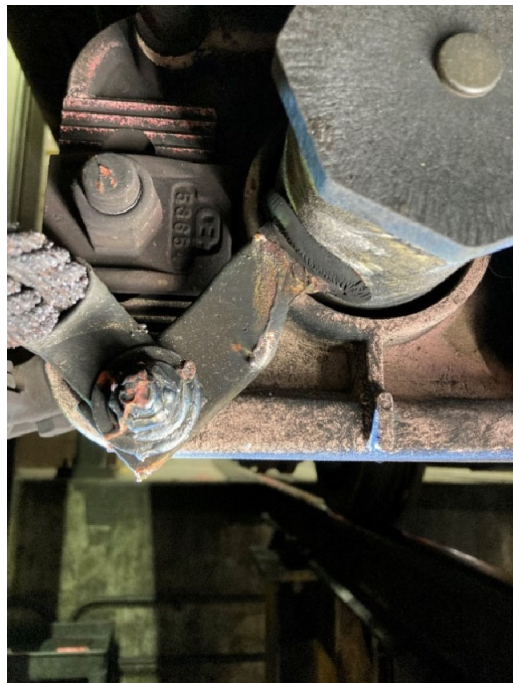
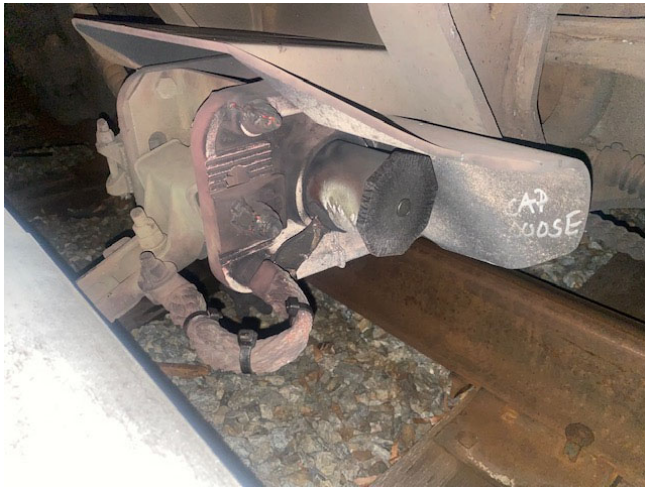
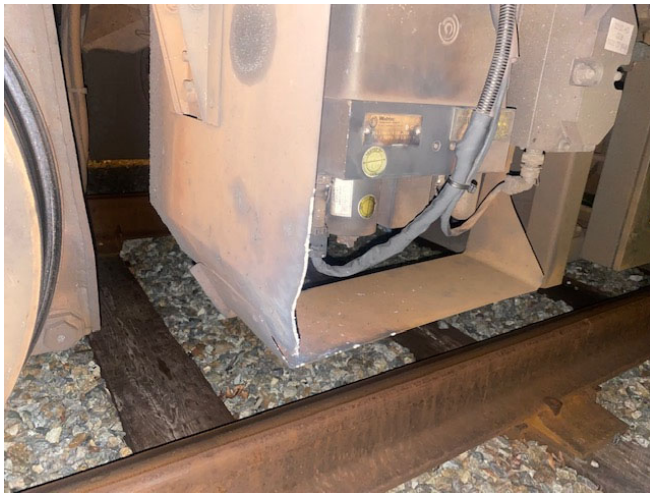
## Digital Images and Photographs

"IIT observed evidence of flashing on the #2(Front/Left) collector shoe fuse bus bar, the #2 shoe fuse shunt, the #4 Brake Disc, the HP-4 on brake disc #4, and shielding around the Front Truck Digitrol on car 3255. No other apparent damage was observed during the ground walk around.

IIT suspects this incident stemmed from foreign object damage, resulting in Flashing of 700V various points on the Collector assembly and the truck, including the #4 Brake Disk.

- Perform a complete undercar inspection on entire consist for possible foreign object damage.
- Download Propulsion fault logs from cars 3254-55
- Fully inspect Primary Cable on Car 3255.
- Replace Front Truck due to evidence of flashing on 3255.
- Perform collector shoe height checks cars 3254-55.

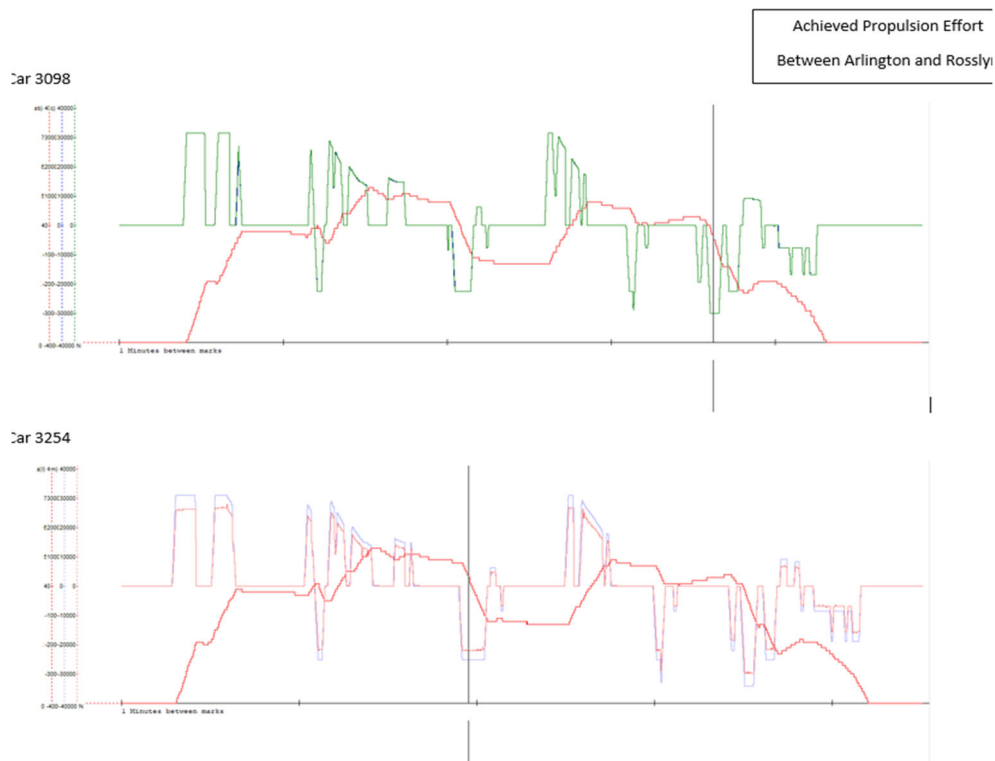
Based on the VMS data, there were no High or Low current events observed with the trains APS systems nor propulsion. All shoe fuses were inspected, and all checked good for continuity. **No fuses were blown** [emphasis added]. This explains why the data indicates no abnormalities as the train approached Rosslyn.
