#### WMSC Commissioner Brief: W-0235 – Evacuation for Life Safety Reasons at Clarendon Station – March 7, 2023

# FINAL REPORT OF INVESTIGATION A&I E23155

Date of Event:	March 7, 2023
Type of Event:	Evacuation for Life Safety Reasons – Smoke
Incident Time:	08:08 hours
Location:	Clarendon Station, track 1
Time and how received by SAFE:	09:21 hours
	Mission Assurance Coordinator (MAC)
WMSC Notification Time:	09:21 hours
Responding Safety Officers:	WMATA: None
	WMSC: None
	Other: None
Rail Vehicle:	None
Injuries:	None
Damage:	None
Emergency Responders:	Arlington County Fire Department (ACFD),
	Metro Transit Police (MTPD)
SMS I/A Incident Number:	20230308#106705

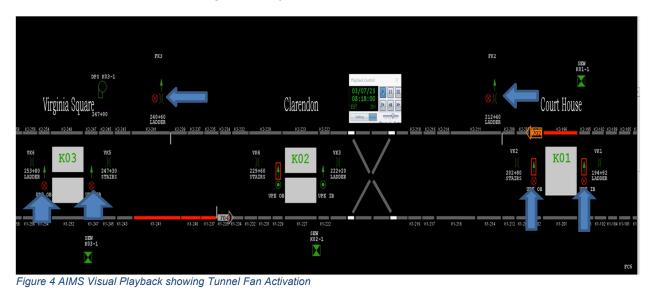
#### Advanced Information Management System (AIMS)

08:20:08.749 03/07/23	<mark>Clarendon</mark>	UPE IB Fan Exhaust COMMANDED Supply BY 015175 AT ctwkspower9pp
08:20:08.749 03/07/23	<mark>Clarendon</mark>	UPE IB Fan On COMMANDED Emergency On BY 015175 AT ctwkspower9pp

08:20:09.905 03/07/23	<mark>Clarendon</mark>	UPE IB Fan Status COMMANDED CHANGE = Emergency On
08:20:09.905 03/07/23	Clarendon	UPE IB Fan Orientation COMMANDED CHANGE = Supply
