WMSC Commissioner Brief: W-0256 Derailments – Blue Line (near Arlington Cemetery, Largo Town Center, and Rosslyn stations) – October 12, 2021

Prepared for Washington Metrorail Safety Commission meeting on January 23, 2024

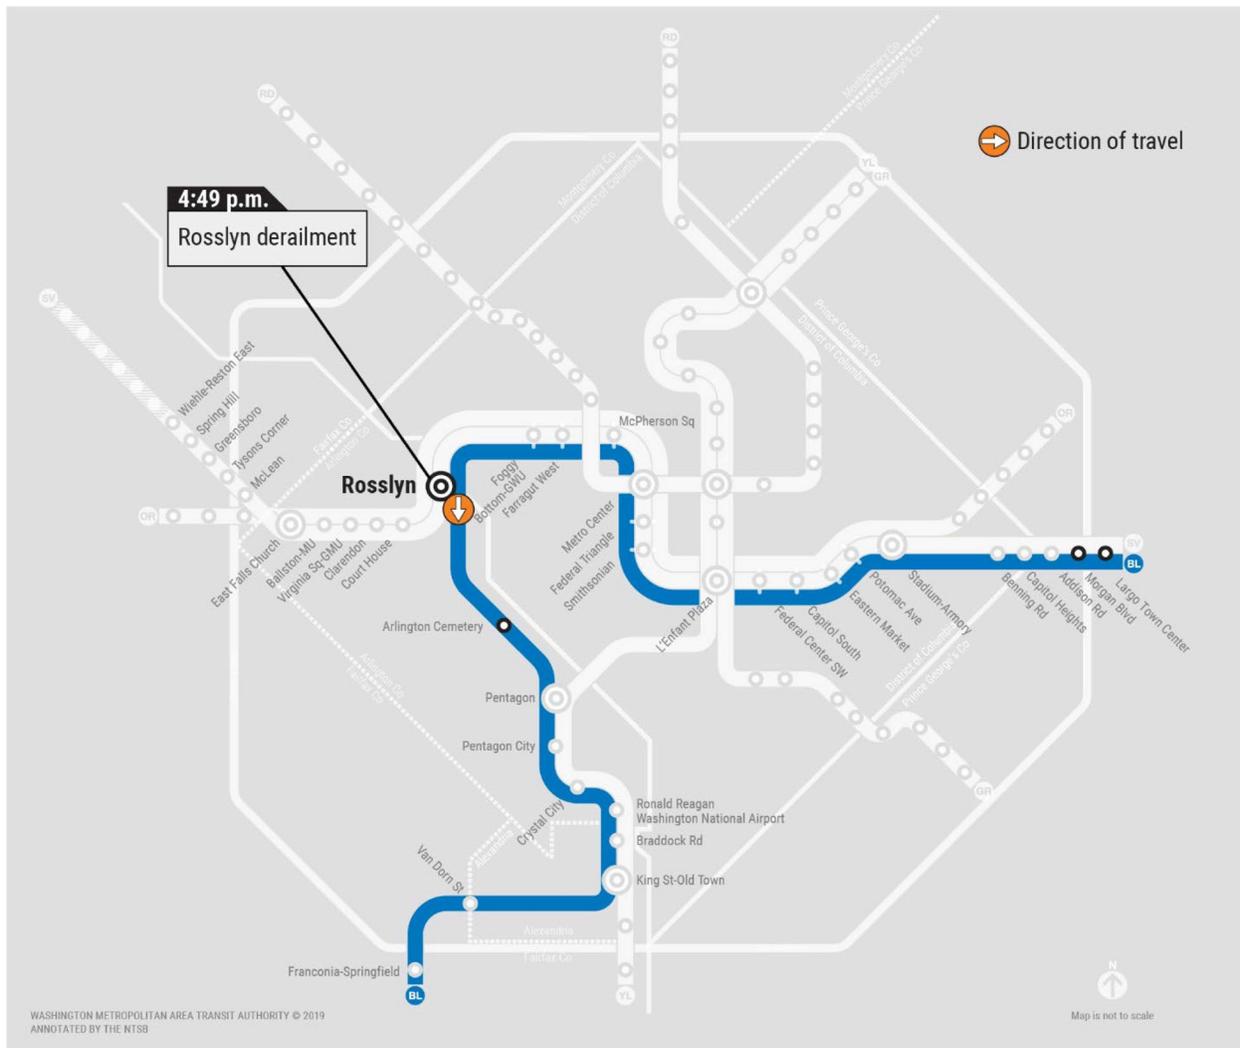
Figure 1. Map showing the Rosslyn derailment.

On October 12, 2021, about 4:49 p.m. local time, Washington Metropolitan Area Transit Authority (WMATA) train 407, consisting of eight 7000-series railcars, was traveling from Rosslyn Station toward Arlington Cemetery Station on track 2 of the Blue Line in Arlington, Virginia, when the last wheelset on the fourth railcar (wheelset #4 on railcar 7200) derailed.¹ The derailment occurred at a turnout within a tunnel south of Rosslyn Station.² (See figure 1.) The train was traveling about 37 mph before the derailment. The train decelerated after the derailment, traveling about 430 feet before the operator stopped it within the tunnel. All railcars remained upright and in-line.

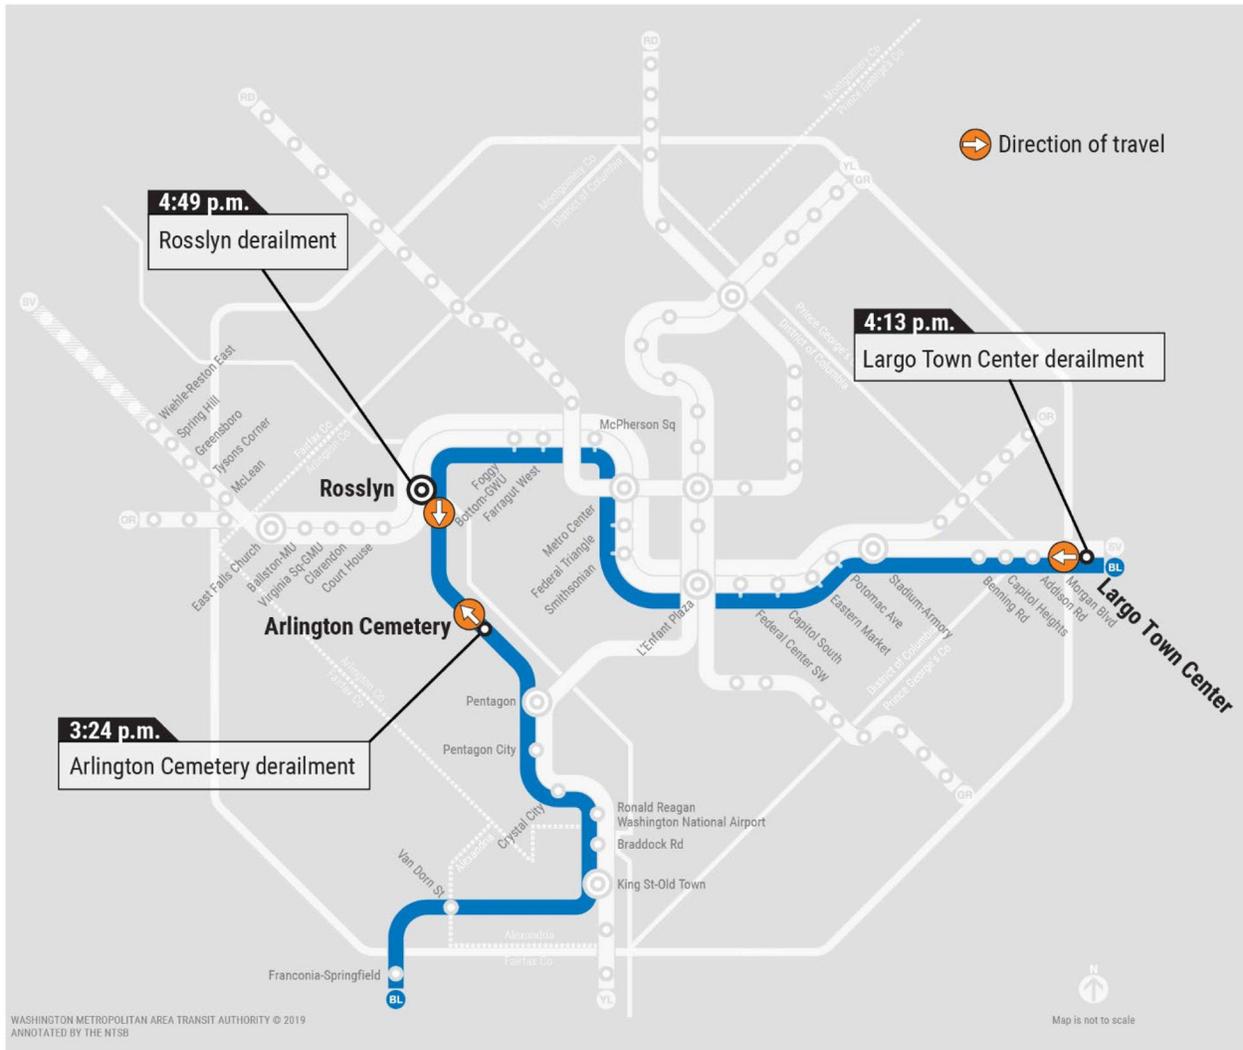
Figure 4. Map of all three derailment locations.

The NTSB also directed WMATA to examine the tracks traveled by the accident train on the day of the derailment for signs of other derailments that could have occurred before the Rosslyn derailment. During this examination, WMATA personnel identified physical evidence consistent with a train derailment—wheel flange departure marks and pieces of brake discs—at two locations on the Blue Line: north of Arlington Cemetery Station and west of Largo Town Center Station.

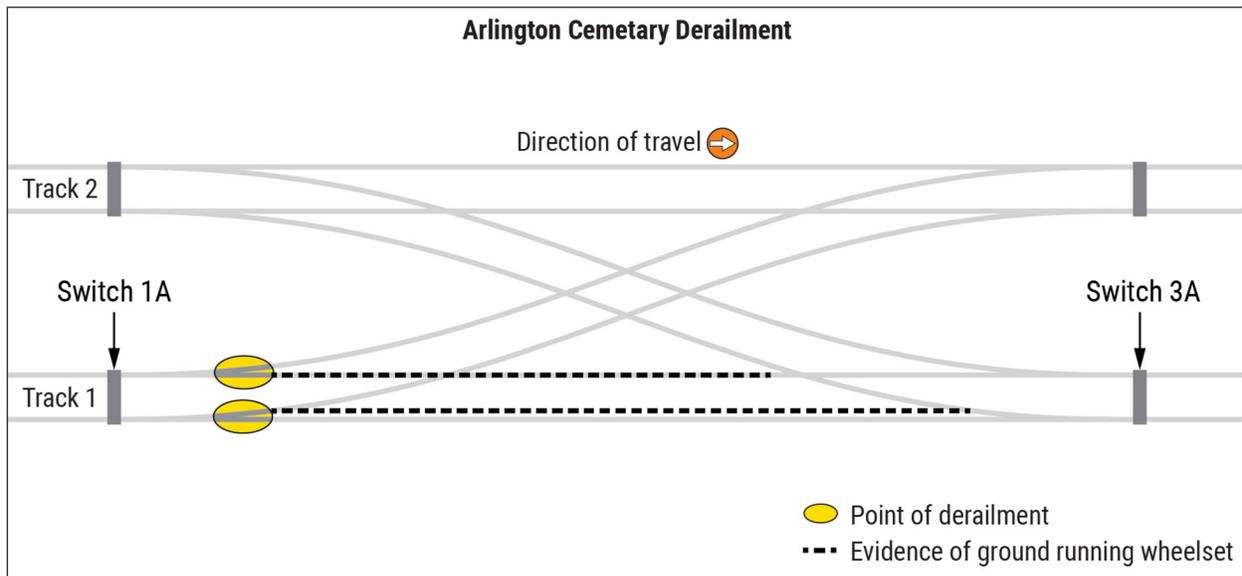
Figure 6. Diagram of Arlington Cemetery derailment site.

As a result of the investigation into the Rosslyn Station derailment, WMATA employees discovered damage to switches 1A and 3A chain marker 187+25 on main track 1 in a crossover north of Arlington Cemetery Station, including wheel flange departure marks near the switch point (across a switch point guard) of switch 1A.¹² (See Figure 5.) While examining the track between switch 1A and switch 3A, the NTSB noted damage to two switch heel blocks, bolts, ties, and automatic train control

equipment consistent with one or more derailed wheels running along the ground and re-railing as they approached switch 3A. (See figure 6.) WMATA employees also found broken sections of brake disc in this area, which the NTSB matched to the right-side brake disc on wheelset #4 of railcar 7200.¹³

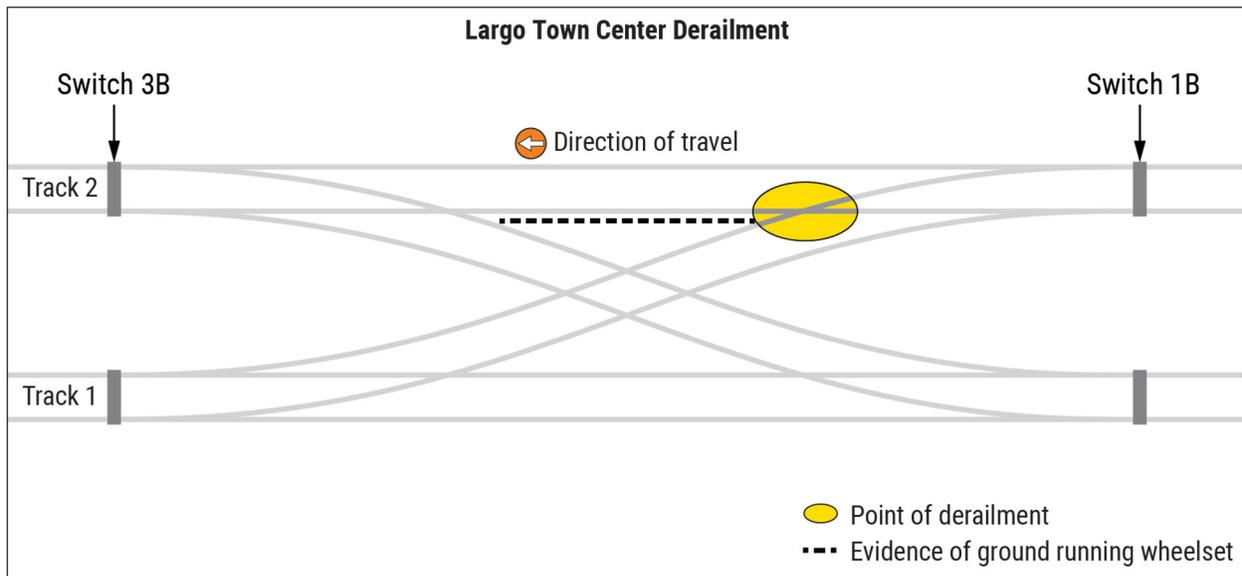
Figure 8. Diagram of Largo Town Center derailment site.

The NTSB also identified wheel flange departure marks on the tread portion of the track (the tread portion carries the wheel tread) on switches 1B and 3B at crossover G05 west of Largo Town Center Station at chain marker 621+98 on main track 2. (See figure 7.) In addition, the NTSB identified wheel marks on the ground, broken ground pads, and damaged automatic train control equipment between switch 1B and switch 3B. The damage was consistent with one or more derailed

wheels running along the ground and re-railing as it neared switch 3B. The NTSB found fragments of brake disc at the crossover.¹⁴

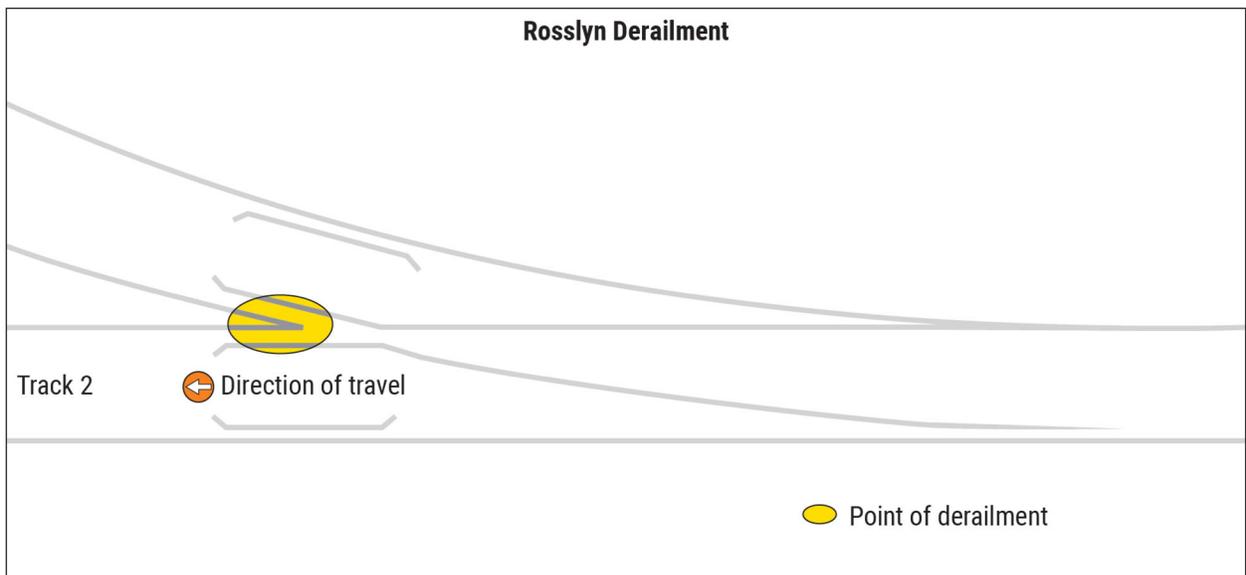
Figure 10. Diagram of Rosslyn derailment site.

The NTSB identified wheel flange departure marks in the turnout at the frog of the switch in the C05 turnout at chain marker 146+70, about 166 feet south of Rosslyn Station. (See figure 9 and figure 10.) Investigators also found wheel departure marks on other track components nearby. This turnout was the final point of derailment.

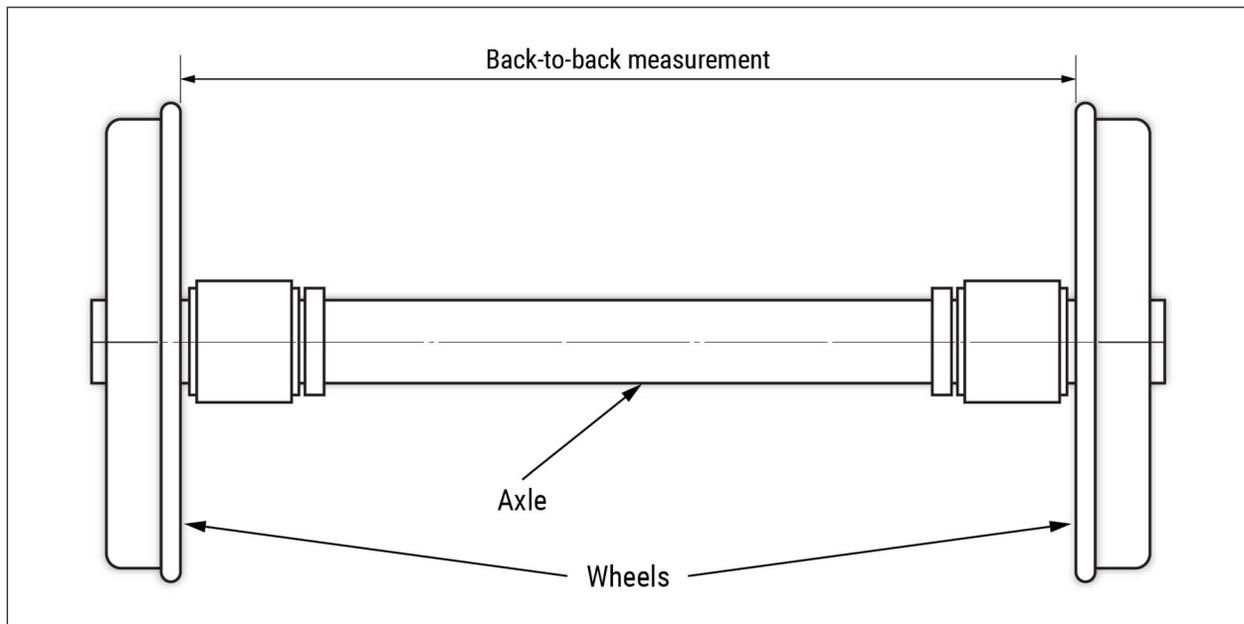
Figure 11. Diagram of a back-to-back measurement.

On October 16, 2021, the NTSB worked with WMATA technicians to inspect the lead truck (containing wheelsets #3 and #4) on railcar 7200. All inspected components were within WMATA's design specifications except for wheelset #4, which had an out-of-specification back-to-back measurement as described below. A back-to-back measurement is the distance between the inner faces of the wheels on a single axle. (See figure 11.)
