**WMSC Commissioner Brief: W-0258 Red Signal Overrun – Ballston Station – June 10, 2023**

**FINAL REPORT OF INVESTIGATION A&I E23394**

# Ballston Station – Red Signal Overrun

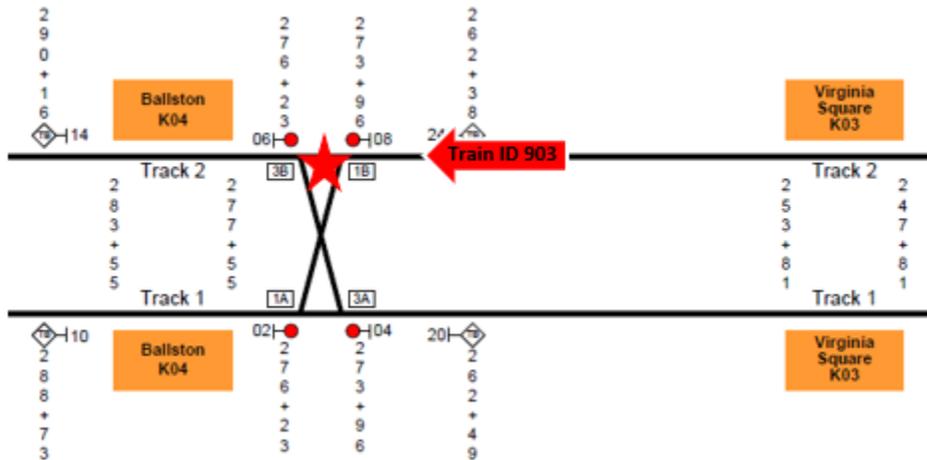
## Field Sketch/Schematics

Switch 1B, the switch on Track 2 closest to where the train had stopped prior to the red signal, was aligned in the normal position, for a straight-through move on Track 2. Switch 3B, the switch on Track 2 closest to the station platform, was aligned in reverse position for Train 607 that was departing Ballston Station toward Downtown Largo. The signal was red due to this switch alignment that did not provide a clear route through the interlocking and due to Train 607 departing the platform and moving through the interlocking.

The train movement damaged the switch point of Switch 3B.
