**WMSC Commissioner Brief: W-0259 – Collision – near East Falls Church Station – June 5, 2023**

Prepared for Washington Metrorail Safety Commission meeting on March 5, 2024

Safety event summary:

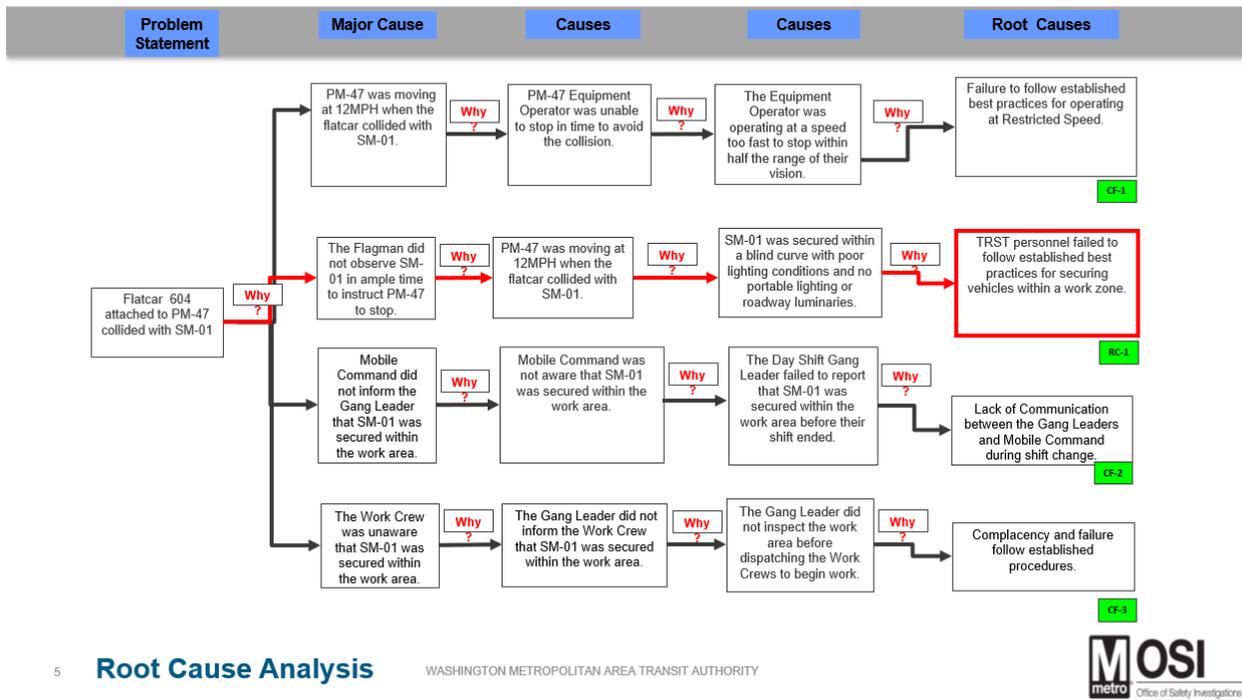
Appendix I – Why-Tree Analysis

At 9:49 p.m., the operator of PM-41, which was also carrying a crew (including a supervisor and flagman) and was pushing Flatcar 607, requested that PM-47 move up further to Chain Marker 370+00. Metrorail rules require any movement in a work zone to be coordinated with the RWIC (or piggyback crew leader if that crew has established its work area). At 9:59 p.m., as PM-47 was moving up, the Flagman, positioned on the front of Flatcar 604, being pushed by PM-47, yelled on their handheld radio, "Stop, PM-47 stop" just before Flatcar 604 struck Swing Master 01 (SM-01) and derailed. During the collision the Flagman fell to the floor of Flatcar 604. There was no evidence of the emergency brake being activated by the Flagman.

Both the PM-47 Equipment Operator and the Flagman stated that the Flagman told the Equipment Operator to slow down prior to the collision. The Equipment Operator stated they applied braking, but not in time to avoid the collision.

There was no clear communication regarding where equipment was left by departing crews.
