WMSM Commissioner Brief: W-0260 Derailment – Near Potomac Yard Station – April 11, 2023

Washington Metropolitan Area Transit Authority
Department of Safety (SAFE)
Office of Safety Investigations (OSI)
FINAL REPORT OF INVESTIGATION A&I E23242

Outside Potomac Yard Station – CM C2 408+00 – Derailment

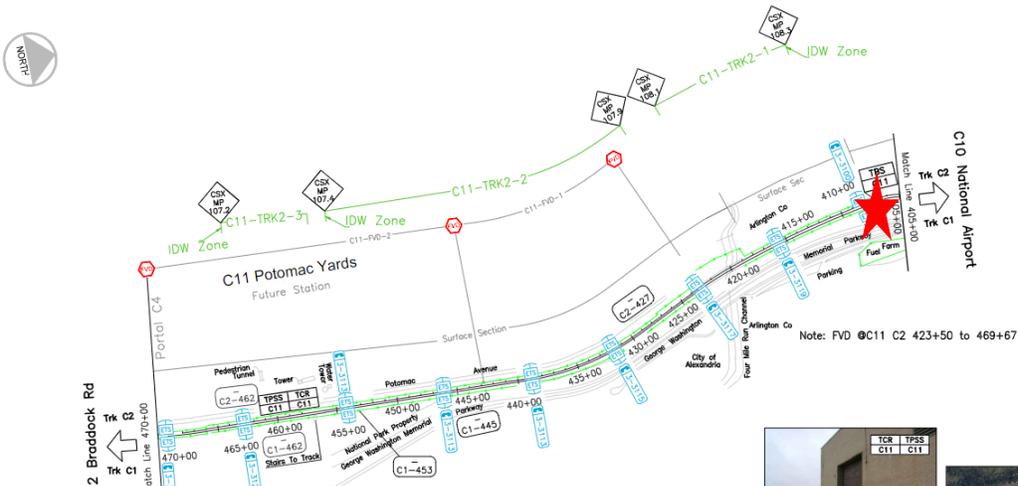
Field Sketch/Schematics

Outdoor section of track that transitioned from an aerial structure to a curved section of ballasted track.

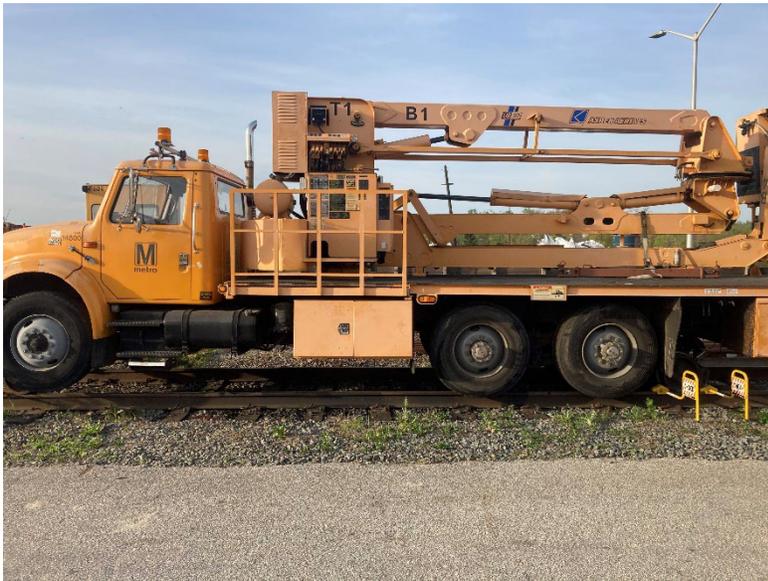
Field investigation by responding Operations and SAFE personnel identified two bolts missing from the rear right wheel chassis. These bolts can be adjusted, but they were designed to stay in place once tightened. The chassis is essential for both rail and over the road operations. Field inspection of the area also identified a change in the wheel-rail interface approximately twenty feet from the point of derailment. This was evidenced by noticeable swirl marks on the top of the running rail leading to the point of derailment. There was no damage to the tracks, ATC equipment, or third rail.

Photographs from the scene revealed that the left side rear gear was not fully deployed whereas the right side gear was deployed correctly. As noted in the CENV report, this resulted in a weight imbalance that likely contributed to the derailment. [\(See Appendix B, pg.4\) The attaching hardware is secured with locking nuts which could loosen but not fall off. The mounting locations show no signs of rattling of loose hardware. This would support the conclusion that hardware sheared at the time of derailment.](#)

Figure 8: This is a picture of Hi-Rail vehicle, 14800.
