**WMSC Commissioner Brief: W-0267 – Derailment – Greenbelt Station – August 11, 2023**

FINAL REPORT OF INVESTIGATION A&I E23556

Greenbelt Station – Derailment

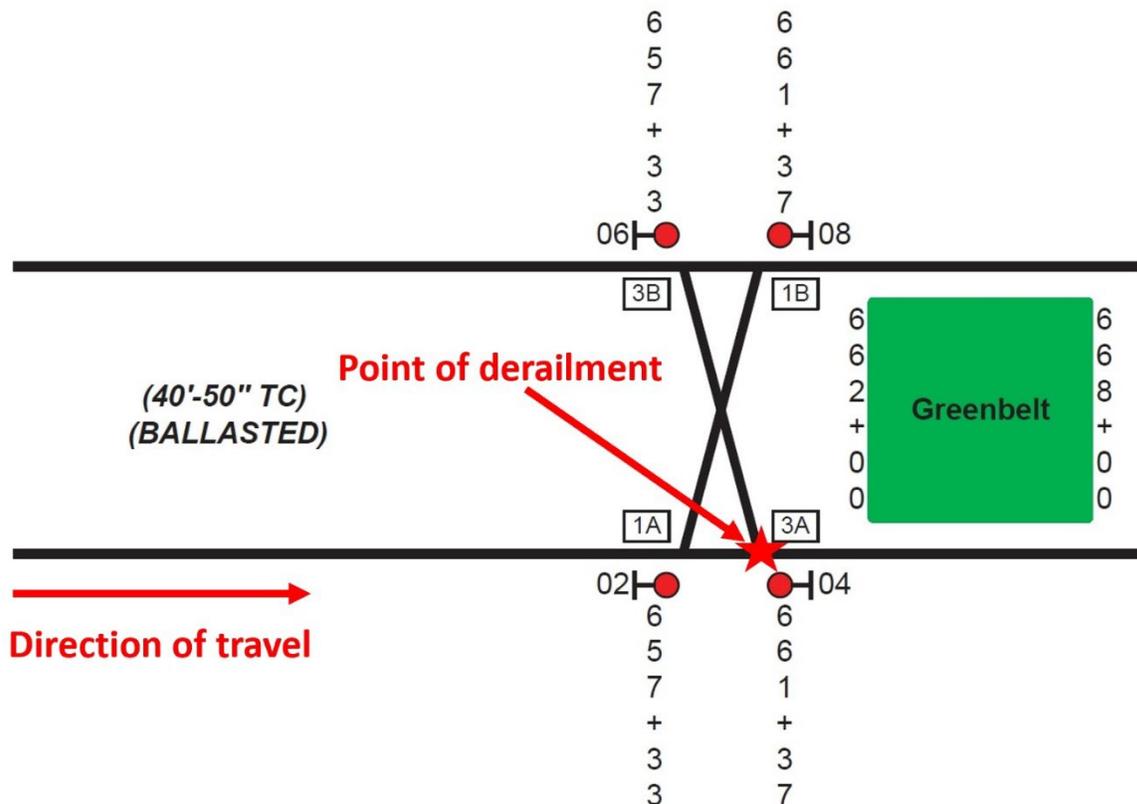
Field Sketch/Schematics

This is an above-ground station with split platforms. Greenbelt Station is a Direct Fixation Track governed by signals E10-06, 08 signals, and E10-02,04 signals. There is an interlocking at CM E1 & E2 657+33 – 661+37. This area is located within the construction zone, starting from Fort Totten Station and ending at the Greenbelt Yard.

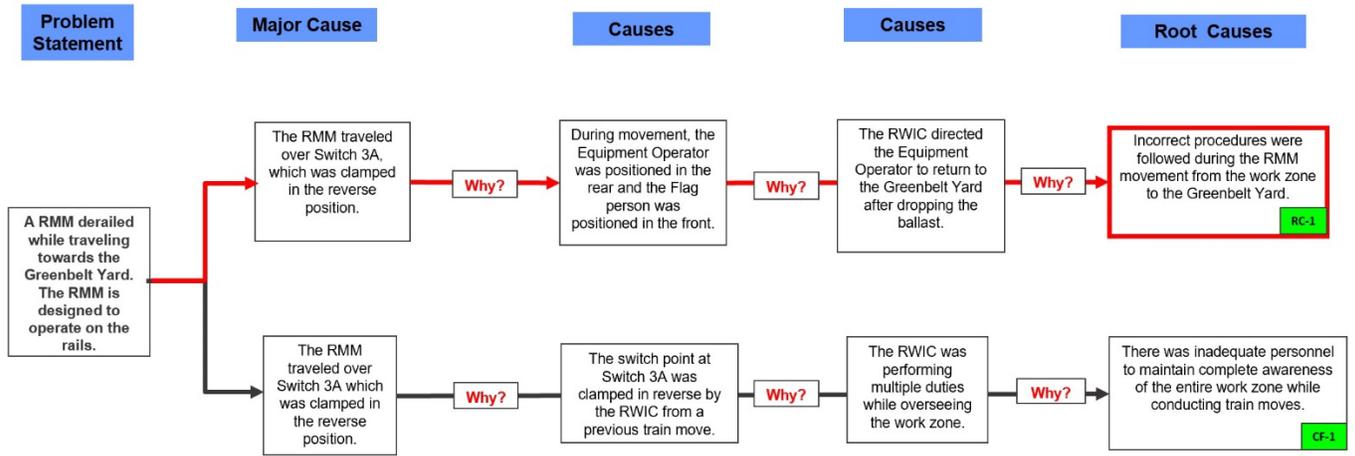
E23556 – Derailment – Greenbelt Station

The probable cause of the derailment was a failure to follow established procedures while operating an RMM. The Flag Person on the leading end of the movement is required to direct movement by radio and inform the equipment operator of the position of the switches, signal indications, and other conditions that may affect the movement prior to any movements. Contributing to the incident was inadequate personnel. The RWIC was performing work-related tasks (clamping switches) while simultaneously providing oversight for the work zone due to inadequate personnel for the work assignment.
