## **WMSC Commissioner Brief: W-0269 – Red Signal Overrun – Mount Vernon Sq. Station – July 11, 2023**

**FINAL REPORT OF INVESTIGATION A&I E23474**

<b>Date of Event:</b>	July 11, 2023
<b>Type of Event:</b>	O-8: Red Signal Overrun
<b>Incident Time:</b>	06:51 hours
<b>Location:</b>	Mount Vernon Square Station, Track 1
<b>Time and How received by SAFE:</b>	06:56 hours MAC Desk
<b>WMSC Notification Time:</b>	07:26 hours
<b>Responding Safety Officers:</b>	SAFE OSI
<b>Rail Vehicle:</b>	Train ID 307 (L 3052-3053X3046-3047X3094-3095 T)
<b>Injuries:</b>	None
<b>Damage:</b>	None
<b>Emergency Responders:</b>	ATCM, RTRA, ERT
<b>SMS I/A Number</b>	20230711#109841

# Mount Vernon Square Station – Red Signal Overrun

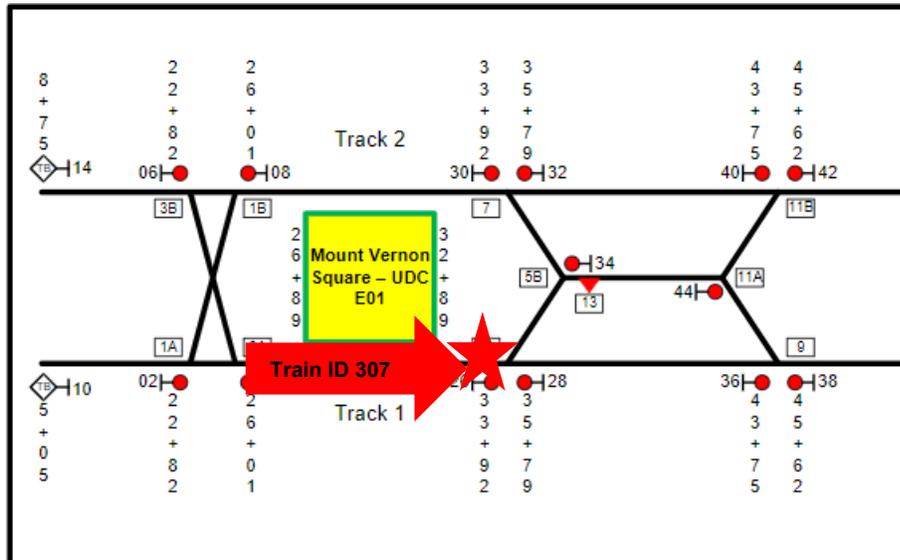
## Field Sketch/Schematics

Indoor station with a center platform and direct fixation tracks. There is a pocket track on the northbound end of the station and interlockings at both ends of the station.

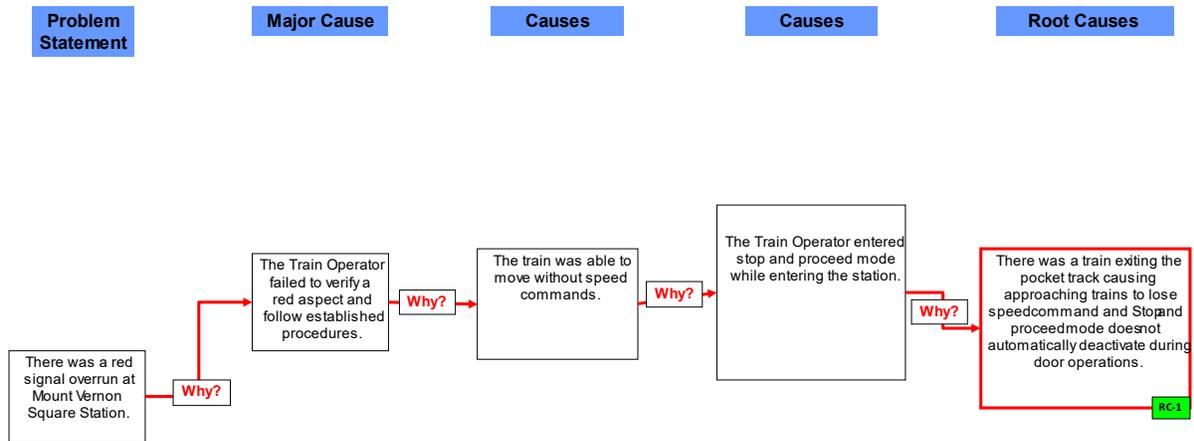
## Appendix E – Why-Tree Analysis

The probable cause for this Red Signal Overrun was that the Train Operator failed to follow established procedures for servicing a station and moving without speed commands. The ineffective functionality of stop and proceed mode was a contributing factor to the event.
