WMSC Commissioner Brief: W-0277 – Red Signal Overrun – West Falls Church Rail Yard – July 21, 2023

FINAL REPORT OF INVESTIGATION A&I E23504

West Falls Church Yard – Red Signal Overrun

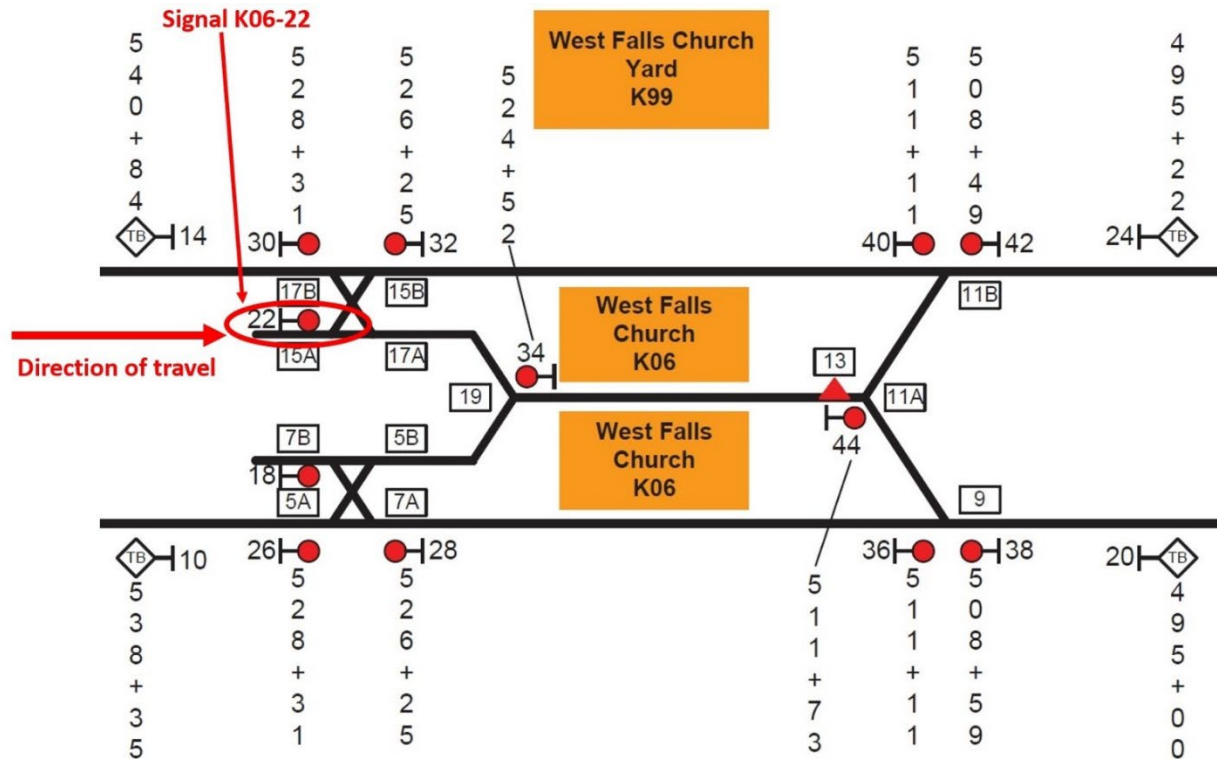
Field Sketch/Schematics

This is an above-ground station with split platforms. West Falls Church is a Direct Fixation Track governed by Yard Lead 1 Signal K06-18 and Yard Lead 2 Signal K06-22 ; Mainline Signals K06-30, K06-32, K06-26, and K06-28; Track 3 Signal K06-34 and K06-44. Two interlockings connect the yard leads to the mainline tracks.

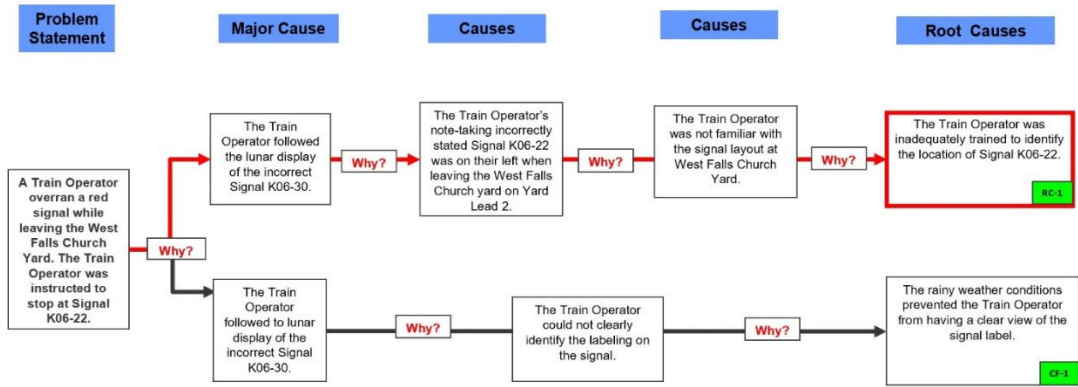
Appendix F – Why-Tree Analysis

E23504 – Red Signal Overrun – West Falls Church
