## **WMSC Commissioner Brief: W-0282 – W-0287 Improper Roadway Worker Protection Events – March-April 2023**

*Prepared for Washington Metrorail Safety Commission meeting on May 14, 2024*

# McPherson Square Station –Improper RWP

**CM N2 924+00 – Improper RWP**

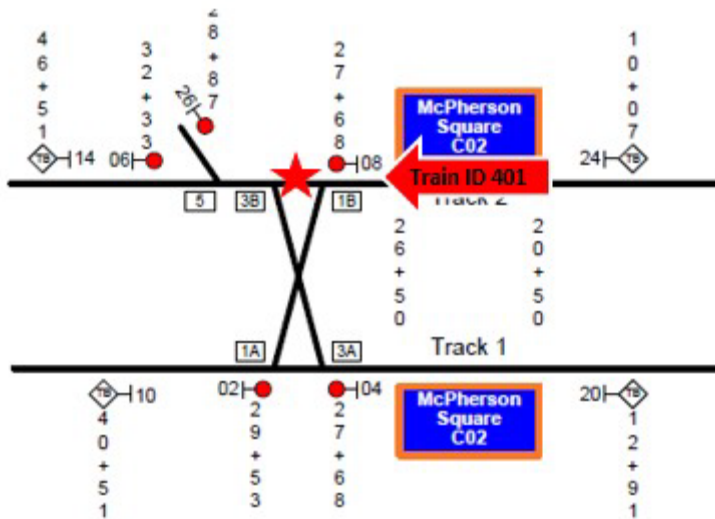
## Field Sketch/Schematics

McPherson Square Station Interlocking, track 2. Chain Markers (CM) C2 27+68 to 32+33  
Approximately 118 feet from the end of the platform

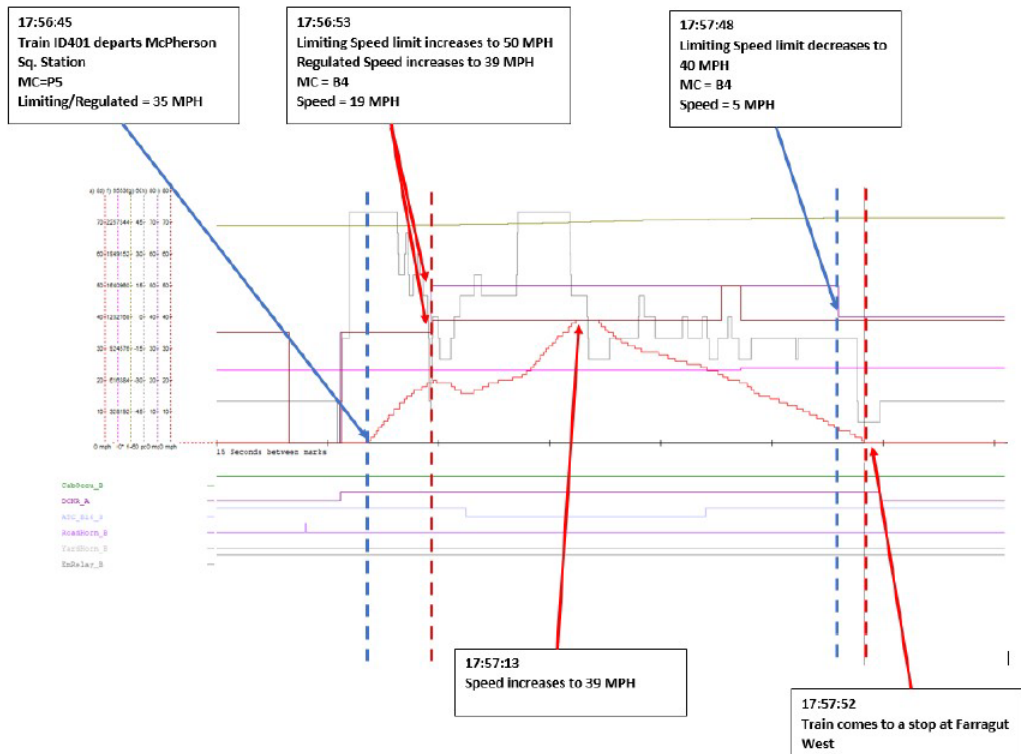
17:57:48.528	Limiting Speed limit decreases to 40 MPH, Train speed was 5 MPH and Master Controller moved to B4 Braking position, 11 ft. from the 8-Car Marker.	5 MPH	B4	40 MPH	39 MPH

17:57:51.180	Master Controller placed in B5 Braking position, train speed was 2 MPH.	2 MPH	B5	40 MPH	39 MPH
17:57:52.075	Train comes to a complete stop at the 8-car Marker at Farragut West Station and Doors open to service the station.	0 MPH	B5	40 MPH	39 MPH

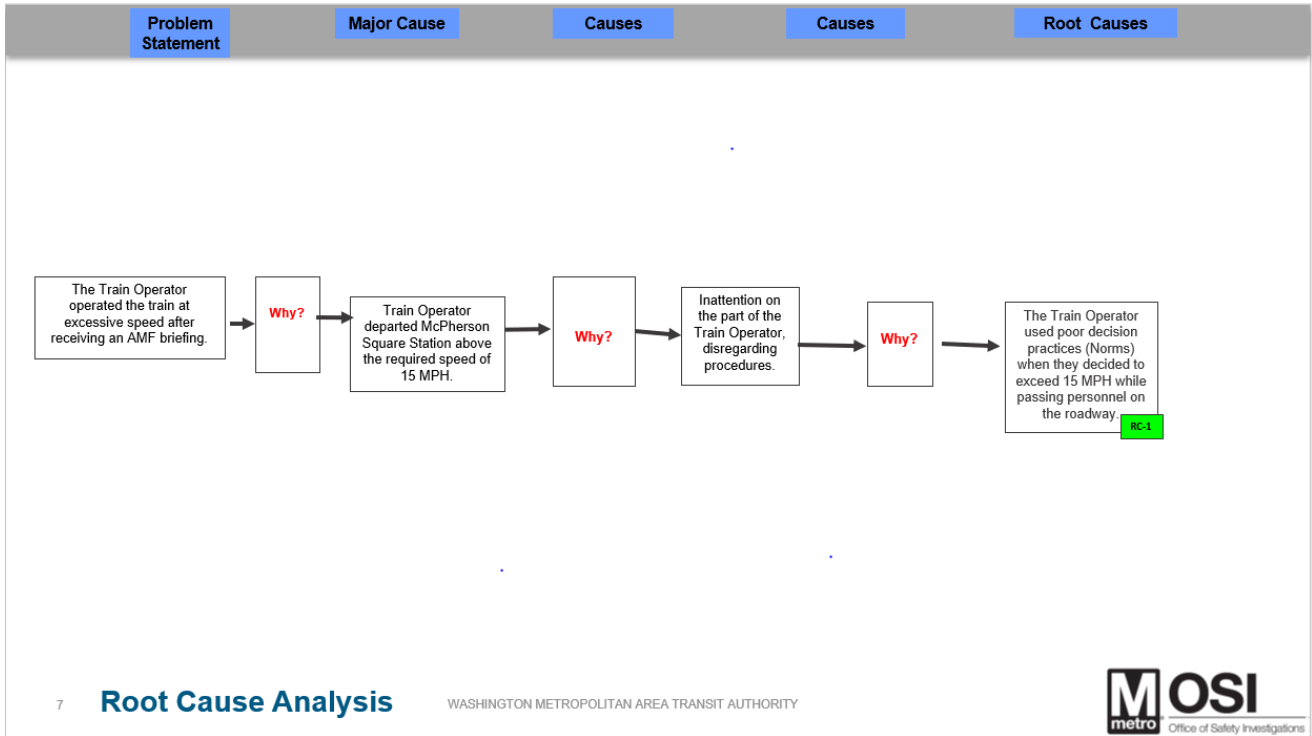
## Appendix E – Why-Tree Analysis

The probable cause of the Improper RWP event on March 10, 2023, was a failure to adhere to established procedures for passing a work crew. Train Operators are instructed to count eight chain markers (800 feet) at the required passing speed of 15 MPH to ensure they are completely clear of the mobile work crew before accelerating.

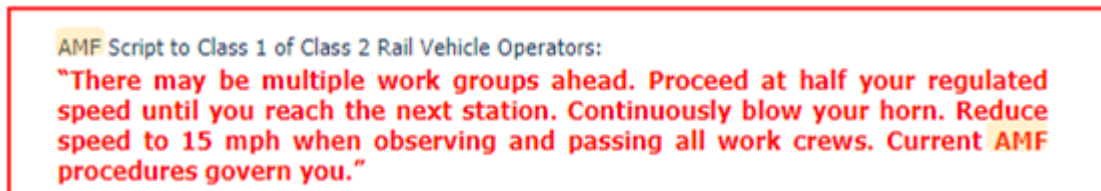
Figure 2 - AMF Script to Operators from MSRPH

MSRPH AMF Script to Operators: *"There may be multiple work groups ahead. Proceed at half your regulated speed until you reach the next station. Continuously blow your horn. Reduce speed to 15 mph when observing and passing all work crews. Current AMF procedures govern you."*

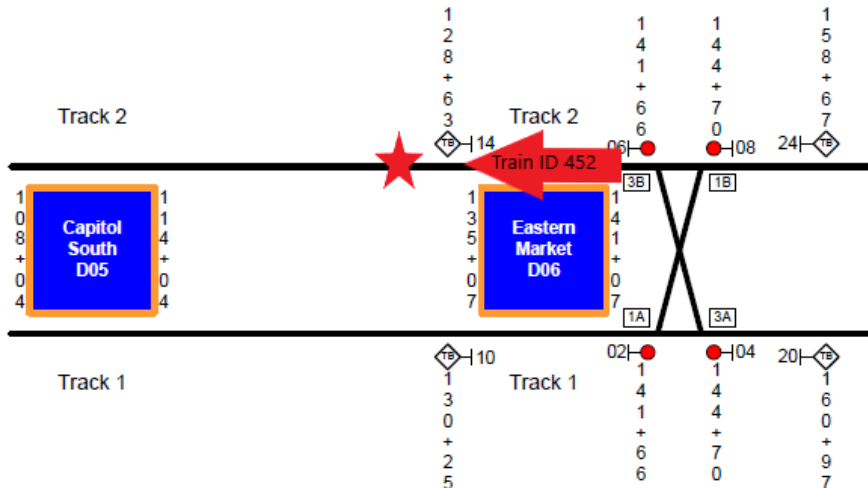
## Field Sketch/Schematics

Between Capitol South Station and Eastern Market Station, Track 2  
CM D2 127+00

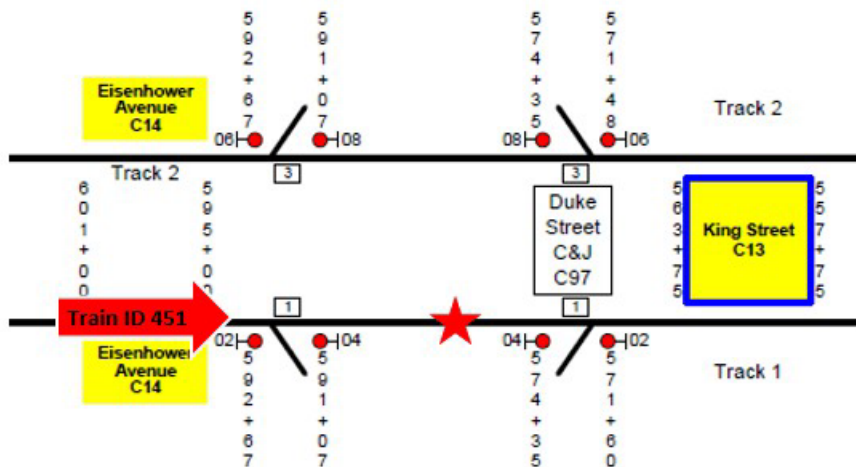
## Field Sketch/Schematics

Between Eisenhower Avenue and King Street Stations, track 1 – CM C1 582+00
