WMSC Commissioner Brief: W-0288 – W-0291 Improper Roadway Worker Protection Events – May 2023

Prepared for Washington Metrorail Safety Commission meeting on May 14, 2024

Medical Center Station, CM A2 484+00 – Improper RWP

Braddock Road Station – Improper RWP Event

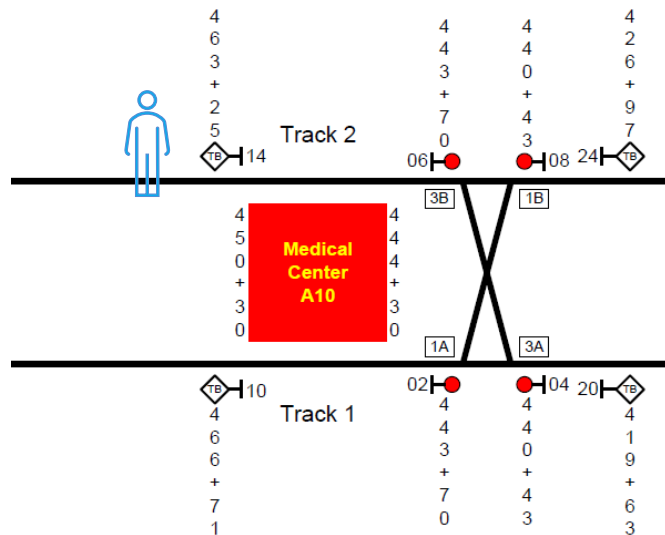
Medical Center Station, CM A2 484+00

Time	Description
03:10 hours	Contractor arrived on site via the vent shaft.
03:15 hours	Contractor fouled tracks 2 and 1 to reach work crew on track 1.
03:18 hours	Contractor advised personnel that they were on-site.
03:25 hours	Violation was identified and Contractor advised.
03:31 hours	Contractor's supervision notified.

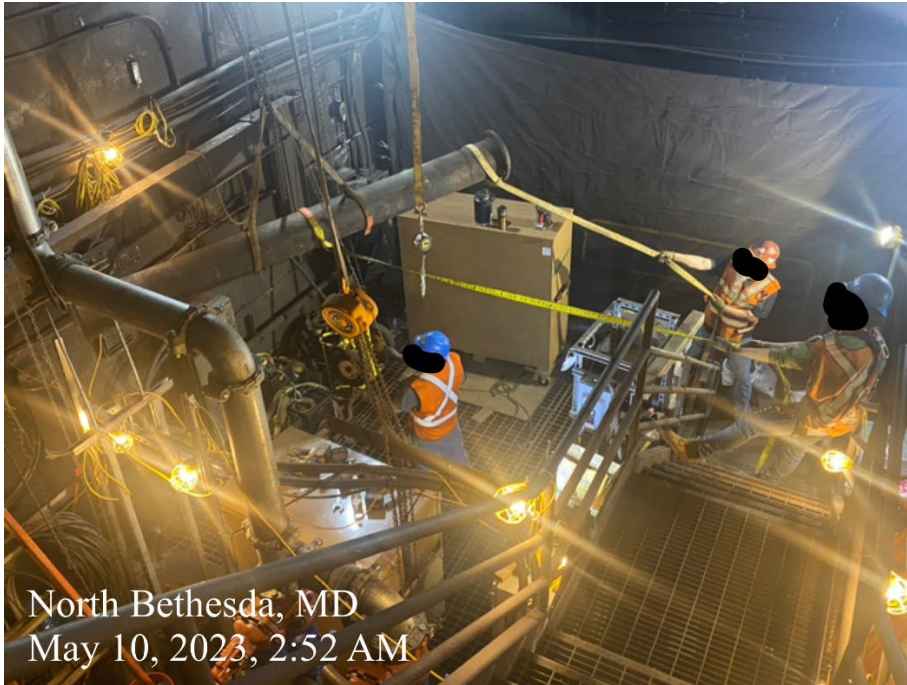
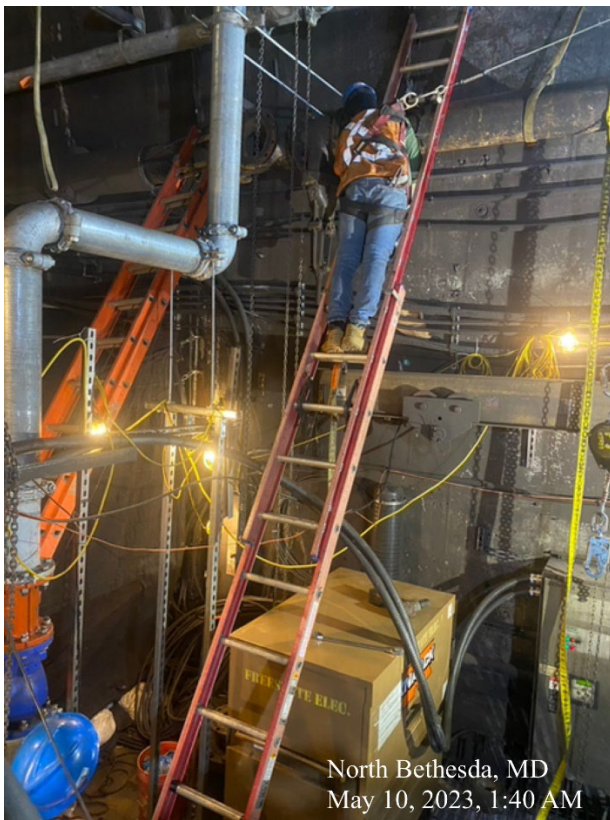
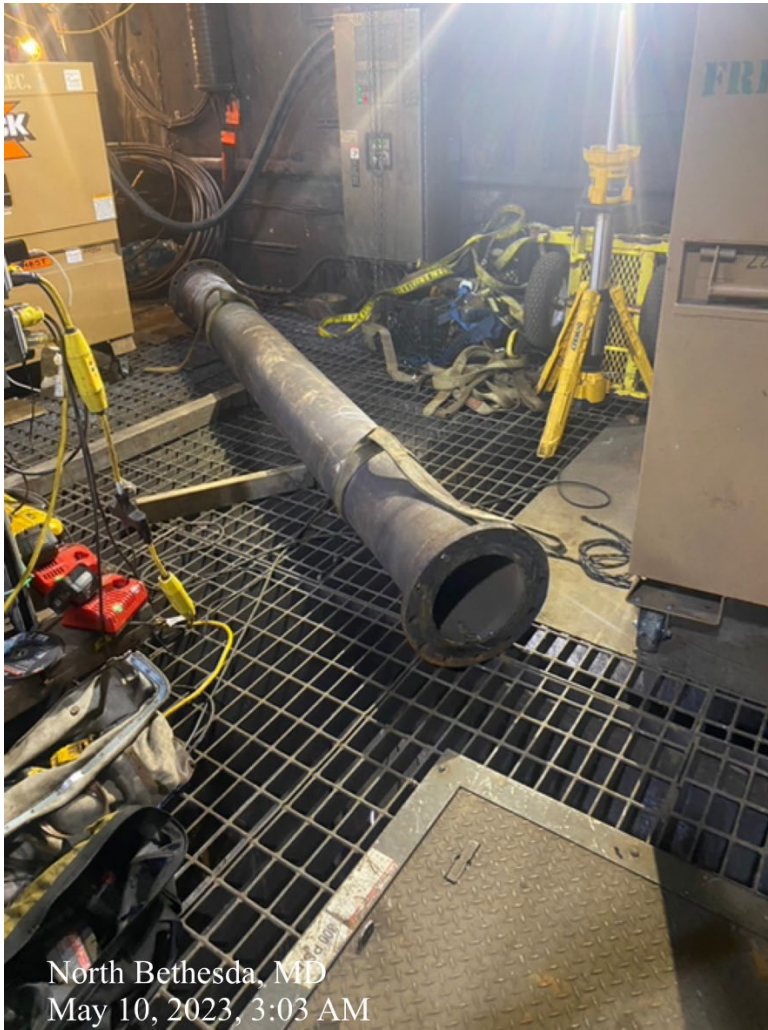
Appendix D – Scene Photographs

North Bethesda, MD
May 10, 2023, 3:03 AM

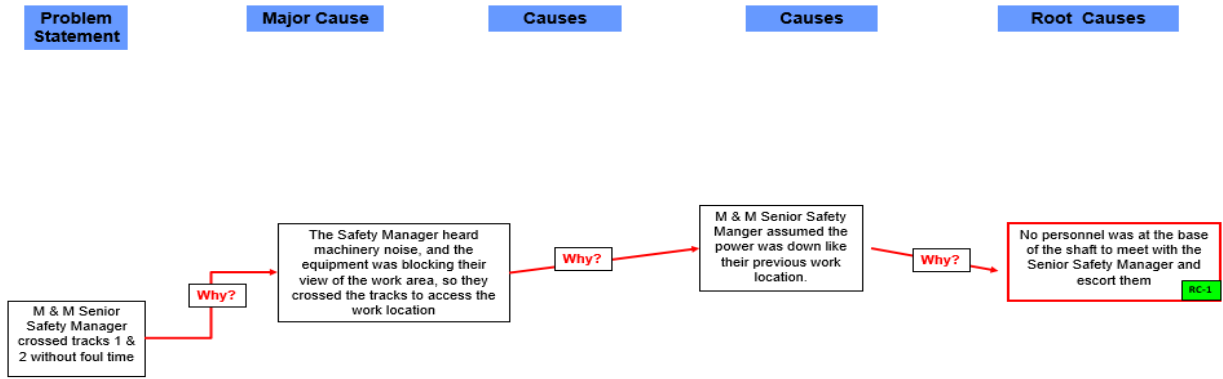
Appendix E – Why-Tree Analysis

The probable cause of the Improper Roadway Worker Protection (RWP) event was a Human Factor error in adhering to established procedures for roadway access by contractors. Contributing Factors to the Improper Roadway Worker Protection event were complacency based on experience on previous job sites, such as Authorized Construction Sites (ACS); and the failure to review the non-roadway escort checklist, requiring an escort to meet with them before entering the DPS.

Corrective Action Code	Description	Responsible Party	Estimated Completion Date
108368_SAFE CAPS_RBIR_ 001	Work crews will be reformed of the importance of reviewing the site conditions during the Job Safety Briefing to include track access rights.	RBIR	Completed
108368_SAFE CAPS_RBIR_ 002	The contractor will retake RWP Level 1 training before being reinstated with WMATA.	RBIR	Completed

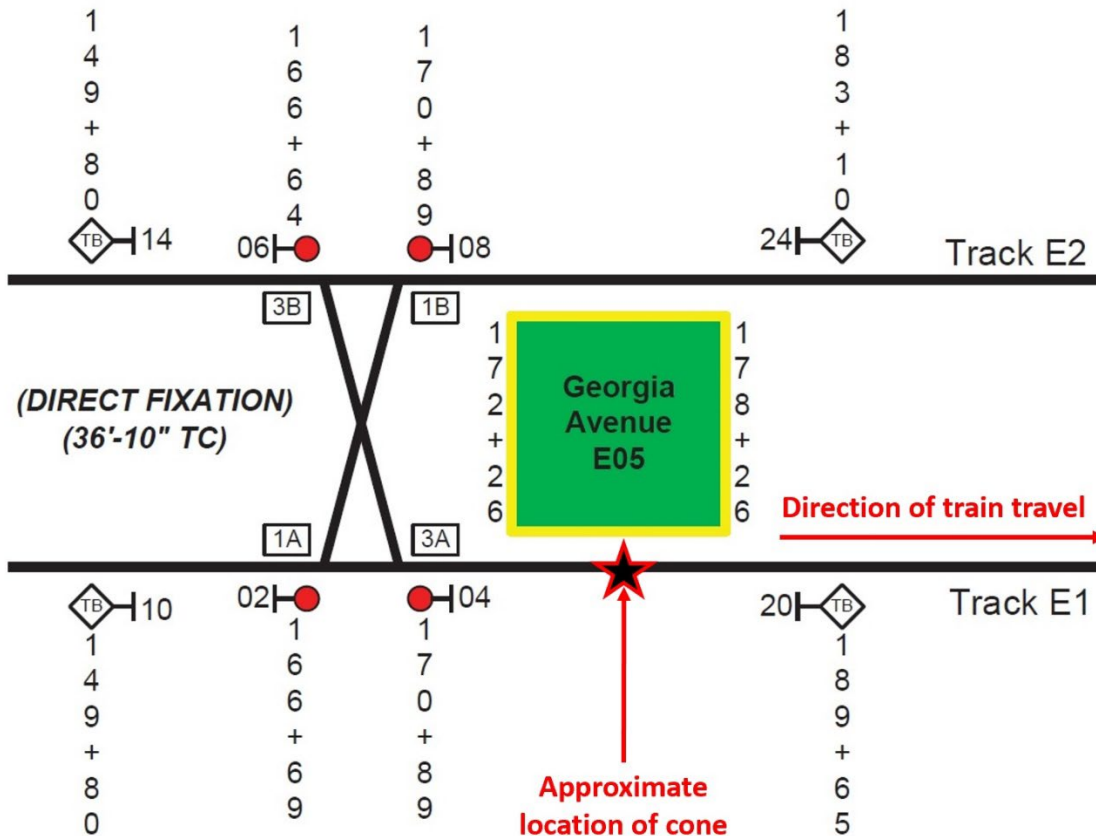
Field Sketch/Schematics

This is a below-ground station with a center platform. Georgia Avenue – Petworth is a Direct Fixation Track governed by signals E05-06, 08 signals, and E05-02,04 signals. There is an interlocking at CM E2 & E1 166+64 – 170+89.

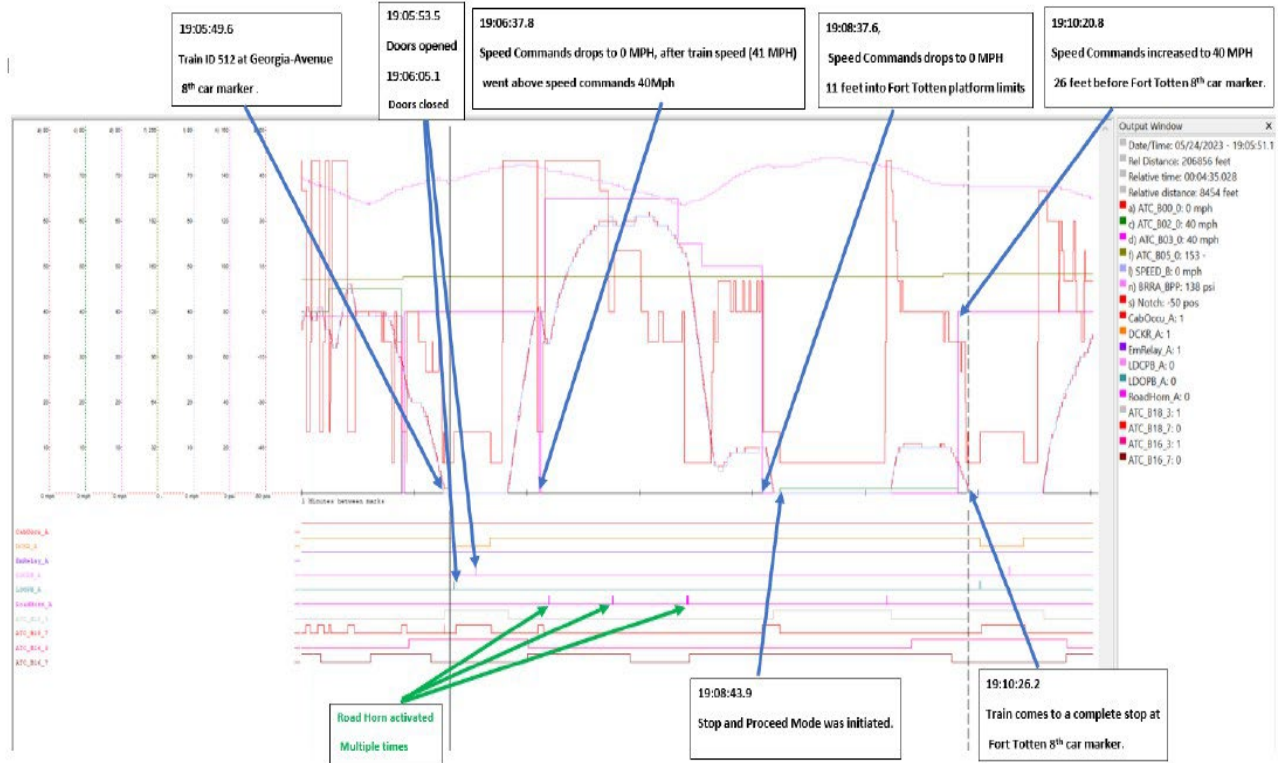
Table 3 – VMS Graph Train ID 512

Car 3180 VMS Graph:
