WMSC Commissioner Brief: W-0293 – Improper Door Operation – Archives Station – May 26, 2023

FINAL REPORT OF INVESTIGATION A&I E23358

Archives Station – Improper Door Operations

May 26, 2023

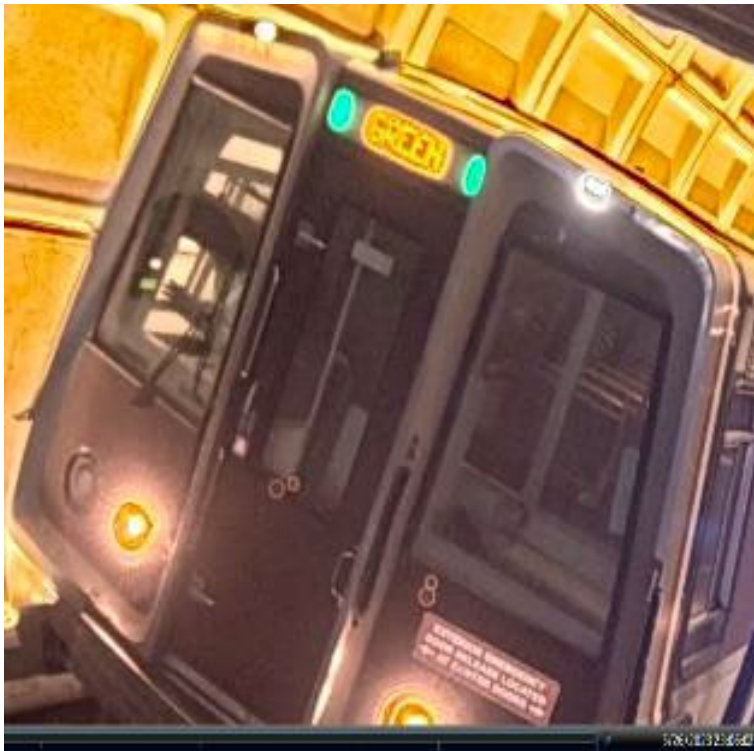
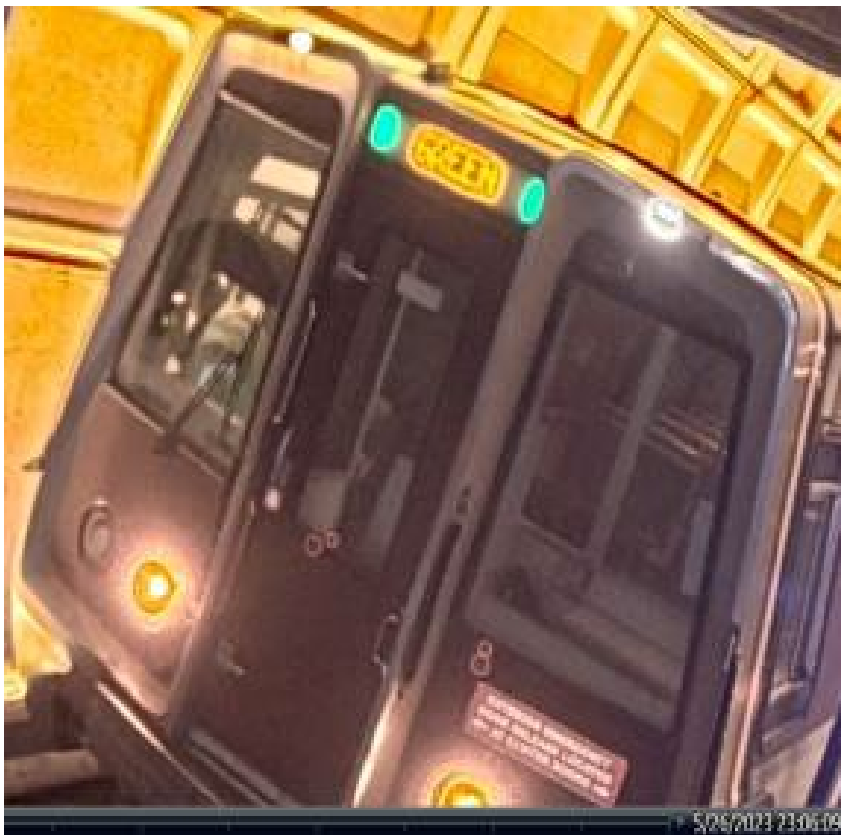
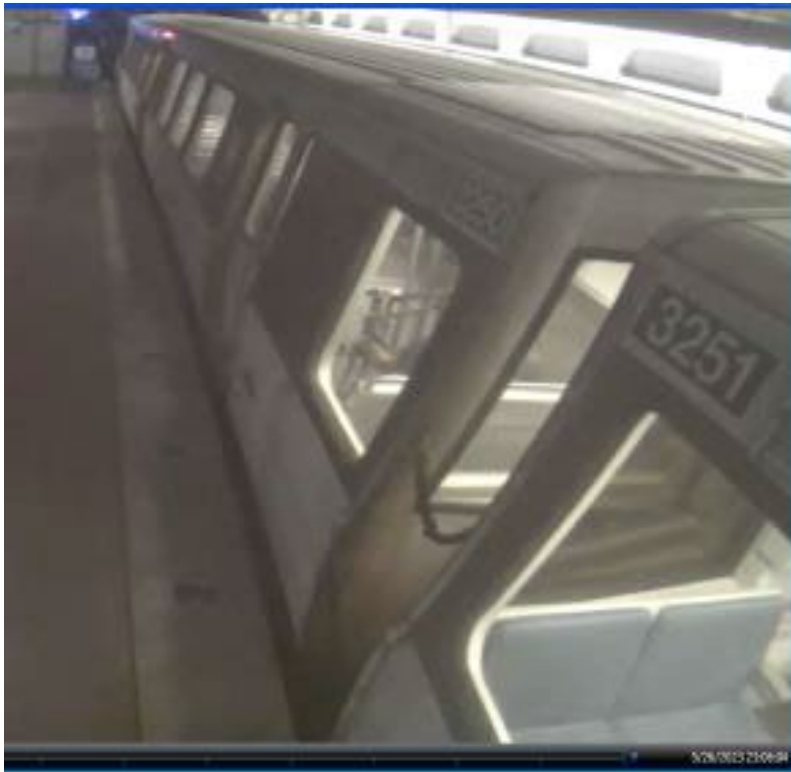
Appendix C – Scene Photographs

After stopping Train 514 at Archives Station on track 1 in preparation to service the station, data analysis shows the Train Operator incorrectly opened the train's doors on the side of the train that was not facing the station's platform. Six seconds later, the Train Operator closed the doors on the incorrect side and opened the doors on the correct side to service the station. The Train Operator continued on, operating the train toward the next station stop. Metrorail procedures require that a train operator report this type of improper door operation to the Rail Operations Control Center (ROCC) and perform a ground walkaround inspection to ensure that no passenger or personnel had fallen to the roadway. The Train Operator did not perform these tasks.
