The Washington Metrorail Safety Commission

Safety Audit

of the Washington Metropolitan Area Transit Authority
Audit of Revenue Vehicles (Railcar) Program

Final Report:
May 21, 2024

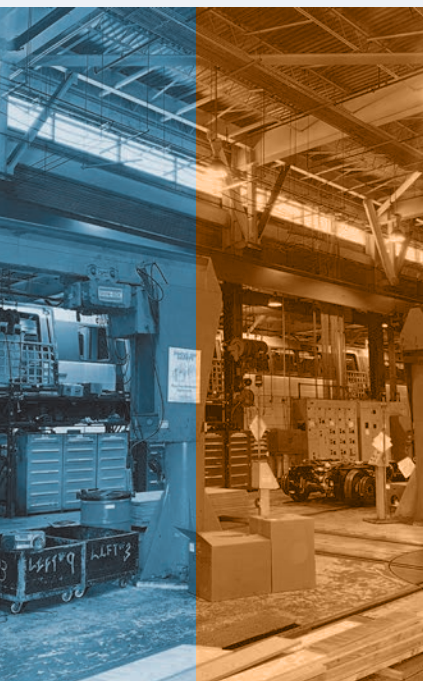
Shop cranes were used to move equipment overhead with no warning, and without personnel donning the personal protective equipment (hard hats) that supervisors acknowledged is required.

During the WMSC's field observations, shop cranes were used to move equipment overhead with no warning, and without personnel donning the personal protective equipment (hard hats) that supervisors acknowledged is required when under an active crane to provide protection against falling objects. Other work in a Metrorail railcar shop requires a bump cap when working under vehicles. The WMSC also observed personnel utilizing a crane to load traction motors into a pickup truck for delivery to another shop without any head protection.

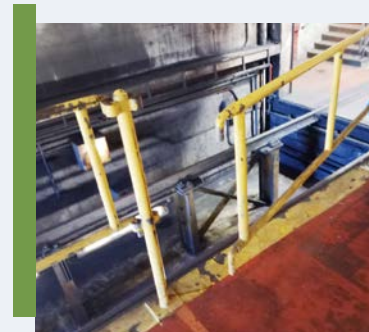
Metrorail is not complying with its hot works program related to metal grinding, has improper NFPA signage, and does not have or keep required fall protection in place around repair pits. In addition, despite the rules in the Metrorail Operating Rulebook, personnel have differing understandings of the personal protective equipment and safety practices required during lifting operations, such as whether a hard hat is required if materials are being lifted overhead by a crane.

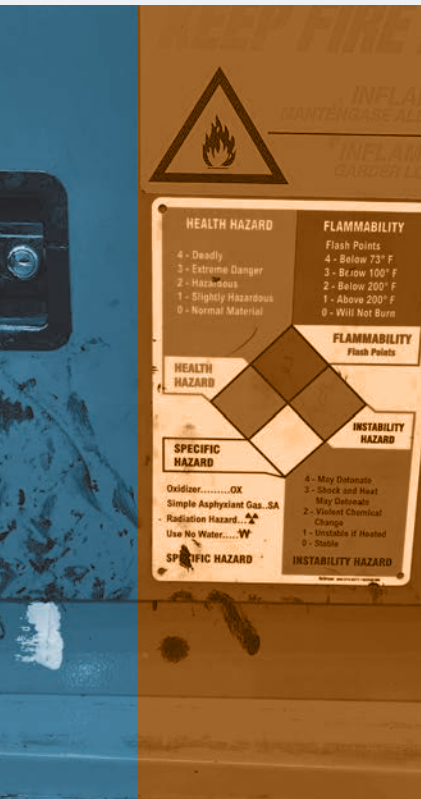
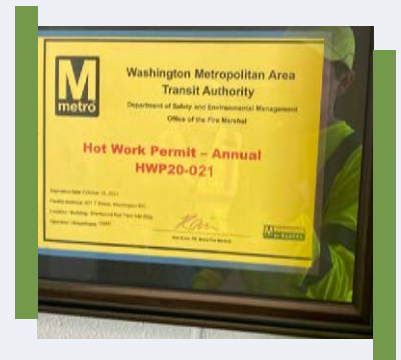
WMSC site visits during this audit identified multiple grinders in shops without protections required by Metrorail’s Hot Work Program, and in areas where personnel stated they do not have or follow hot work protections if they were to use the grinders and do not conduct hot work shop self-inspections described in the Hot Work Program Manual. Metrorail’s Hot Work Program Manual specifies that these grinders do not require individual hot work permits if compliant with OSHA 29 CFR 1910.215, and that such work may be performed “in any non-hazardous location...but are still subject to compliance with all other requirements established in this document.” Metrorail’s Hot Work Program requires appropriate personal protective equipment as determined by a job hazard analysis (JHA), consideration of respiratory protection for all hot work (with associated respiratory protection training, medical monitoring, and respirator fit testing), ventilation fans where possible, clean protective clothing that meets ANSI Z49.1 and AWS standards, safety footwear conforming to ASTM standard F2413-11 that is high top and provides protection against sparks and spatter, long pants and long sleeve shirts made of a non-synthetic or flame-retardant/proof material, the shirt top button closed and secured at all times, and other protective equipment.

The WMSC observed materials such as cardboard and other items in the immediate area of these grinders, within the rooms where these grinders are placed in areas including the Greenbelt and Brentwood facilities.

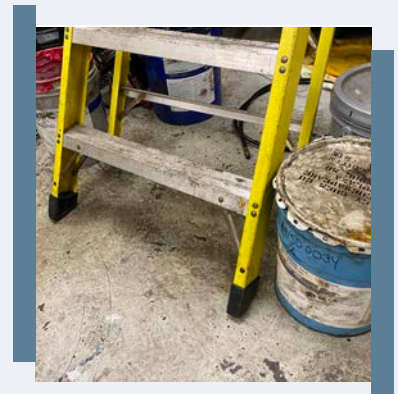
During on-site visits for this audit, the WMSC observed grease spread and lumped on the floor in facilities such as Room 025 in the Greenbelt S&I Shop and rusting drums at the Brentwood S&I Shop building.

Uncontrolled contaminants such as grease pose a risk of environmental or personal harm. This is among the items the WMSC highlighted to personnel responsible for the facility during the on-site visit.

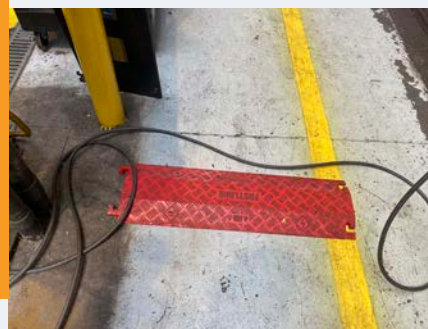
In multiple shops visited for this audit, including the Greenbelt Service and Inspection Shop, Metrorail personnel had placed high voltage power cables used to provide power to railcars while in a shop in a way that posed a trip hazard to personnel, and that risked the power cord being unintentionally dislodged, creating additional hazards.

Metrorail had identified this hazard and an associated mitigation, and communicated it to personnel in late 2022 through a Car Maintenance Special Alert (SA 22-12-L), that stated covers had been provided and were to be used as a safety mitigation when the cables were attached to a railcar or otherwise unspooled in order to protect personnel from injury and to prevent damage to or damage caused by electrical systems. The safety alert was a positive attempt, but Metrorail had not conducted supervisory oversight or otherwise followed through to ensure that the mitigation was implemented, let alone to evaluate under its safety assurance and safety risk management process whether the planned mitigation was effective as required by Metrorail's Public Transportation Agency Safety Plan. The mitigation was not implemented even in shops where the special alert remained posted on bulletin boards on the shop floor.

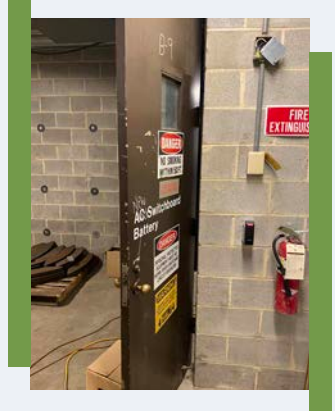
One method of providing a layer of safety related to power equipment is to secure power rooms. During site observations at the Alexandria Service and Inspection building, the WMSC observed an AC Switchboard room with the door propped open and fans in the room. Metrorail personnel, including railcar and power personnel, provided conflicting explanations for the door being open contrary to Metrorail safety requirements. One explanation related to an effort to prevent fire alarms from triggering due to heat in the room. Another explanation related to water intrusion that Metrorail personnel were attempting to dry out. Railcar personnel stated they placed fans in the power room. Whatever the true underlying hazard, Metrorail had not identified and effectively and safely mitigated it, and in the meantime introduced a hazard of allowing access to such a power room in a railcar facility by unauthorized personnel, exposing those personnel to electrical hazards and creating related risks to Metrorail assets.

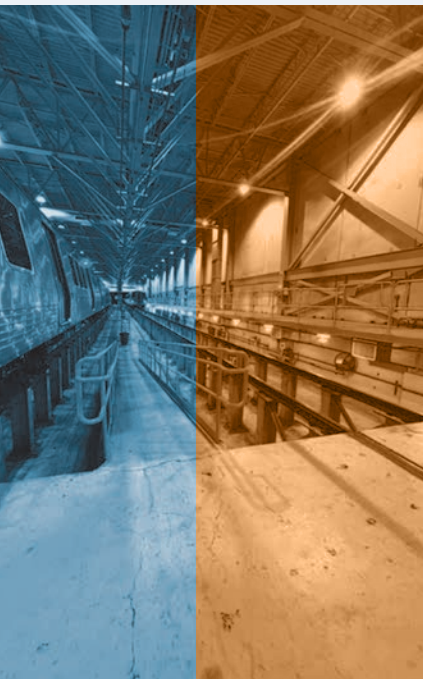
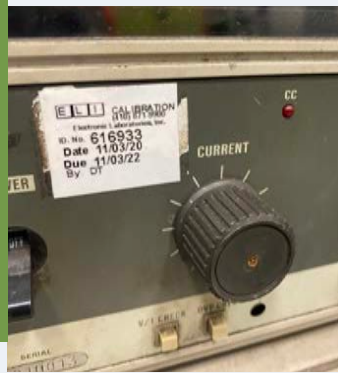
▶ **Finding 7: Metrorail is using equipment that is not calibrated in accordance with its policies and procedures, including for inspection and maintenance of components with a direct impact on safety.**

The WMSC audit team observed a power supply in use in the small motor shop at the Greenbelt Rail Yard that was out of calibration but that was being used to test contactors.

Database for this audit that showed some items past due for calibration, and many other items within calibration requirements. The past-due items included power supplies, multimeters, torque wrenches, calipers, load cells, gauges, and bench test equipment ranging in calibration due dates from 2018 to 2023.

Metrorail must ensure all calibrated equipment is included in its calibration database, that personnel are trained on requirements to ensure use of only properly calibrated equipment, and that supervisors conduct regular oversight of work areas to ensure that equipment that is out of calibration is removed from service and only properly calibrated equipment is in use.

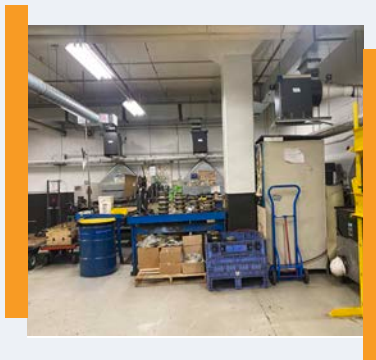
Recommendation 1: Metrorail is not tracking the shelf life of railcar parts that decay over time and therefore have a limited shelf life.

Metrorail acknowledged that shelf life is not tracked for railcar-related parts, and expressed challenges in tracking such items via Maximo, despite the implications for the proper maintenance and safe functionality of railcar systems.

Metrorail may develop and implement a process to ensure railcar-related items that decay over time are identified and that expired items are discarded.
