Improper Train Movement

At or Near Federal Center SW Station, McPherson Square Station, Federal Center SW Station, and Huntington Station

April 26, 2023 – June 14, 2023 – September 23, 2023 – November 20, 2023

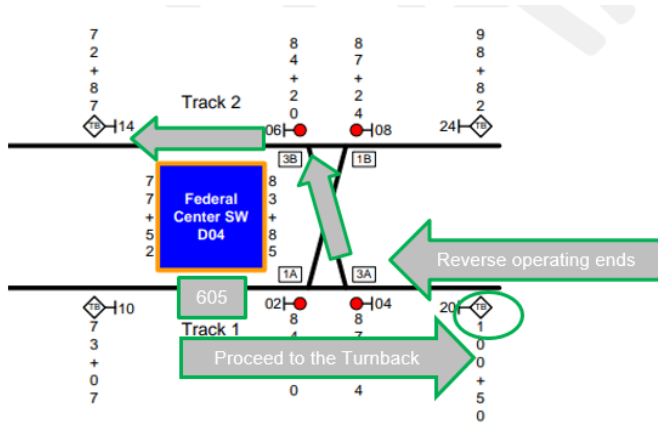
Intended move with proper tumbback operations. Not to Scale

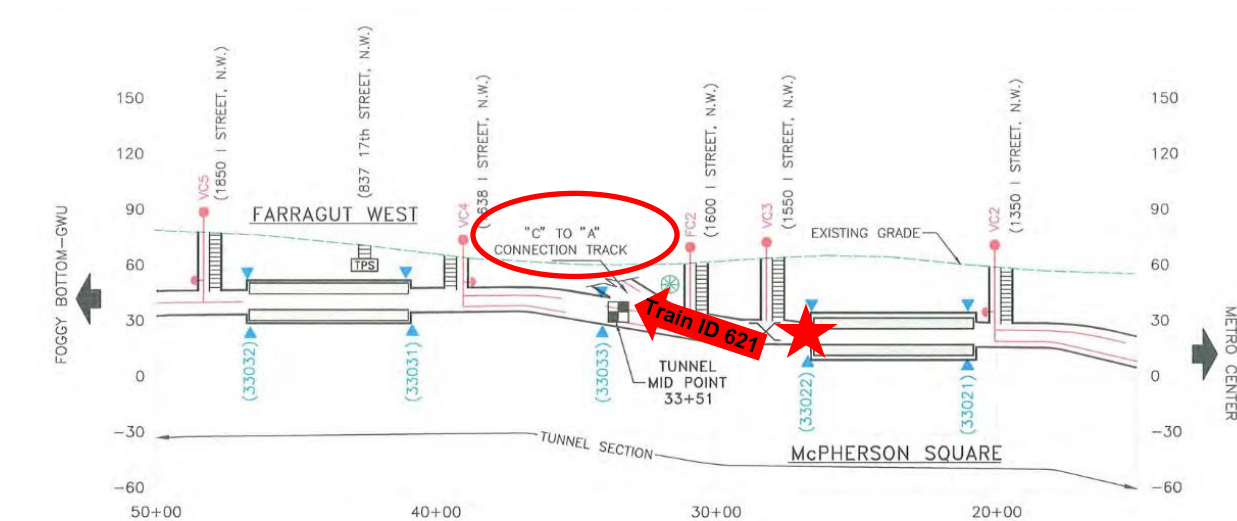
C&A Connector outside of McPherson Square Station on Track two. Track two is outbound, and McPherson Square is an indoor, center-platform station with an interlocking outside the station in the outbound direction.

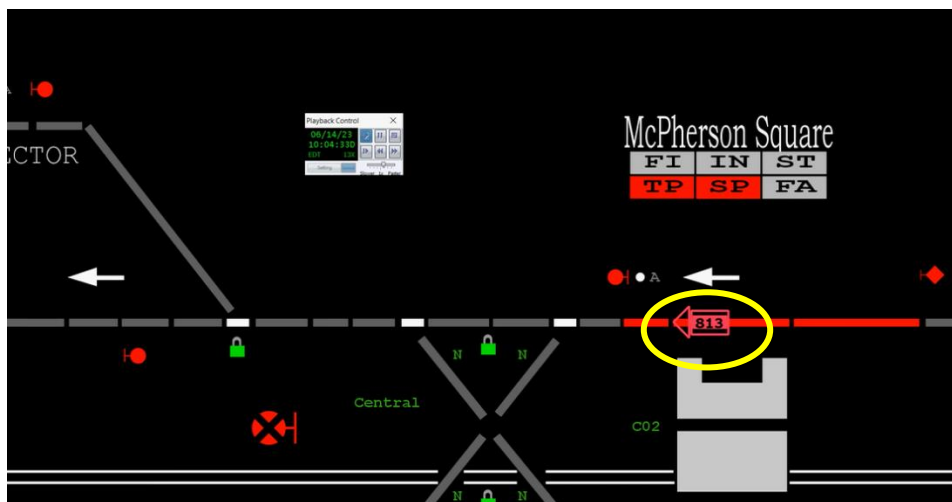
Figure 1: This image shows the incident train appeared as ID 813 after the Train Operator reportedly changed the train ID at Metro Center.

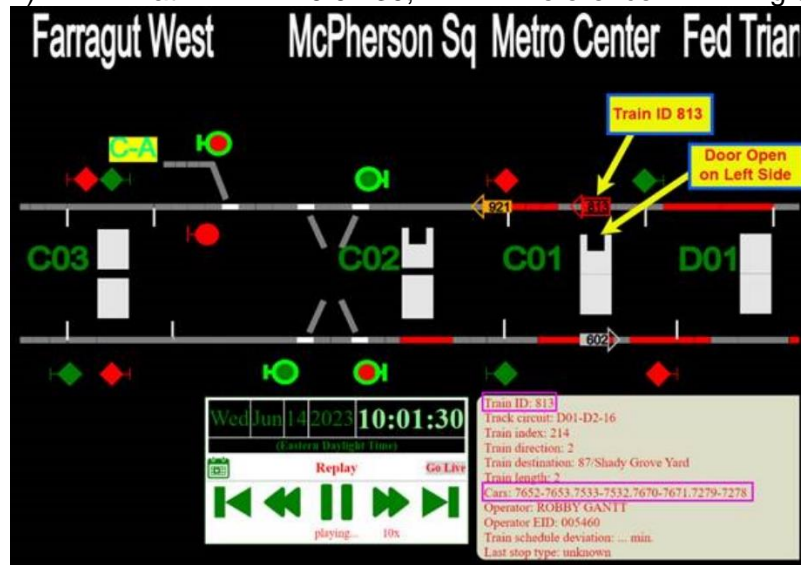
- c. Train ID changed to “621” at 10:01:27.
- d. Reference AIMS TPS Executive Traffic Graphic of Train 813 at Metro Center (C01-2) at 10:01:30; reference graphic below.

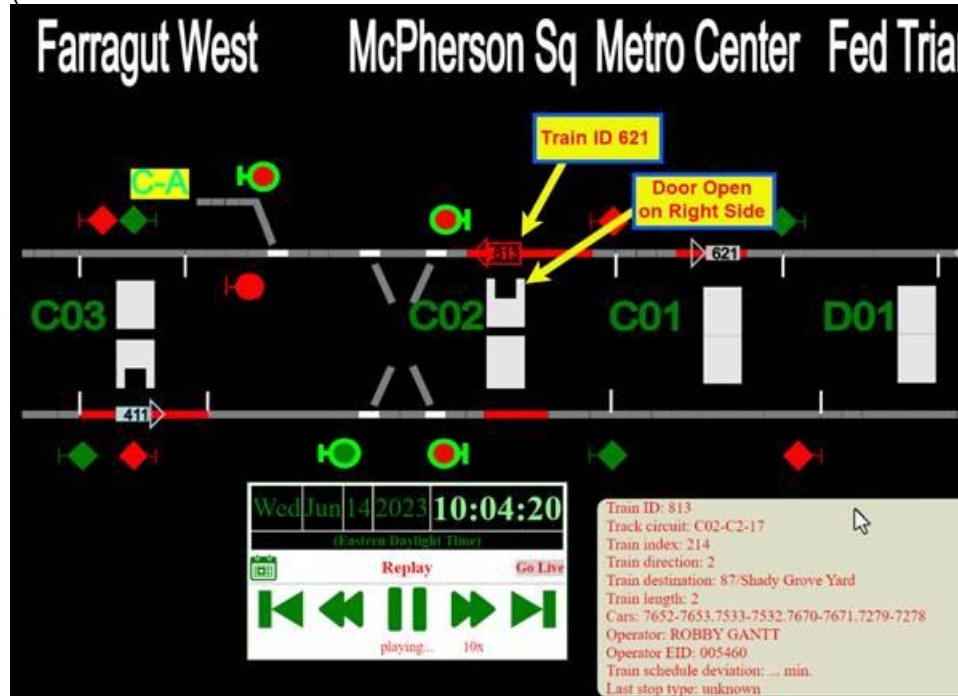
- a. Reference AIMS TPS Executive Traffic Graphic of Train 813 at McPherson Sq (C02-2) at 10:04:20; reference graphic below. Per Car EMM Data, the Train ID is 813, and the Destination Code is set to 62

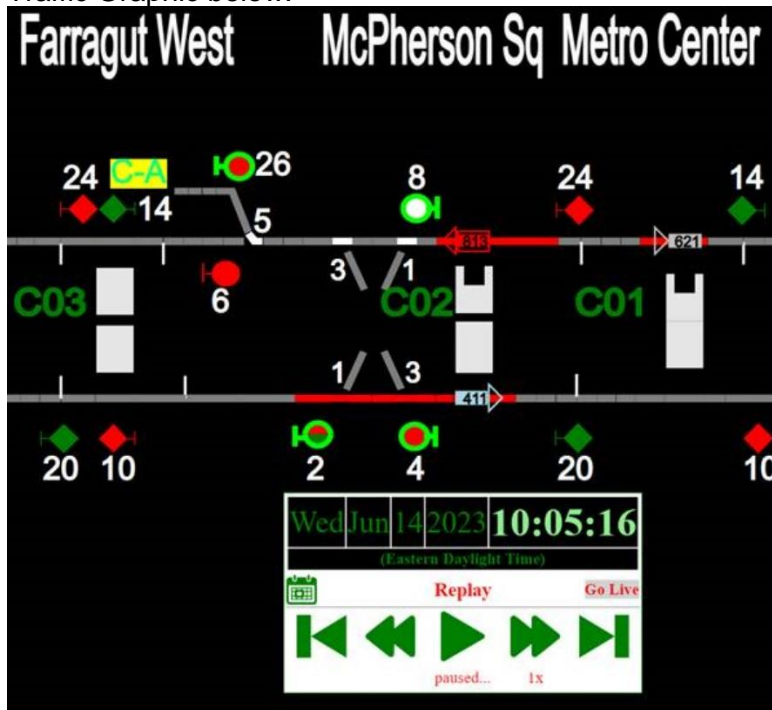
- 6. The Train begins to move at 10:05:09 and travels 533 feet, stopping at 10:05:40 for Red Signal 8.
- 7. At 10:05:16, Signal 8 changes to Lunar. Switches 1 and 3 are set for Straight Move, and Switch 5 is set for a divergent move to the “C-A” junction; reference AIMS TPS Executive Traffic Graphic below.

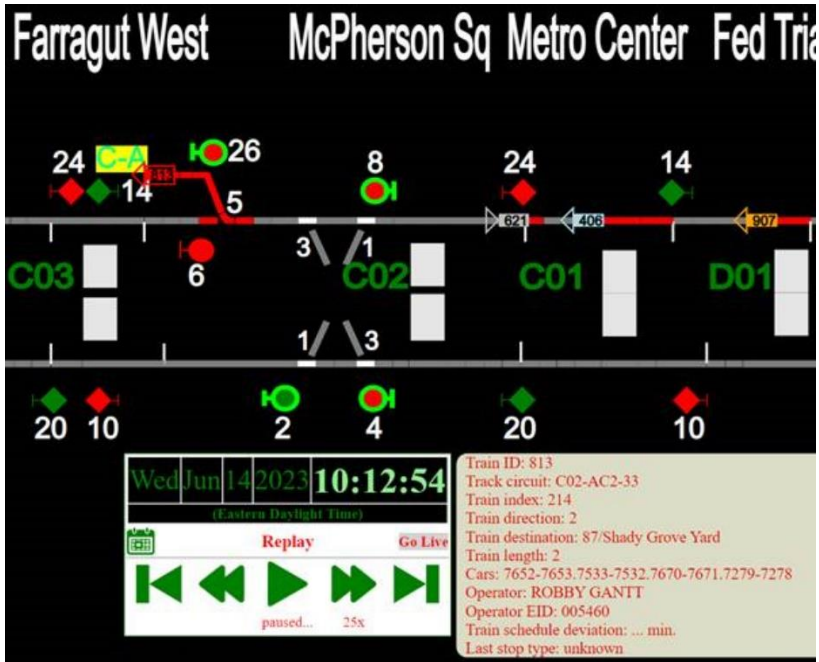
- 8. The Train begins to move at 10:11:35 and travels 698 feet, stopping at 10:13:27.
- 9. The Train Keys Down at 10:12:29, reference AIMS TPS Executive Traffic Graphic below.

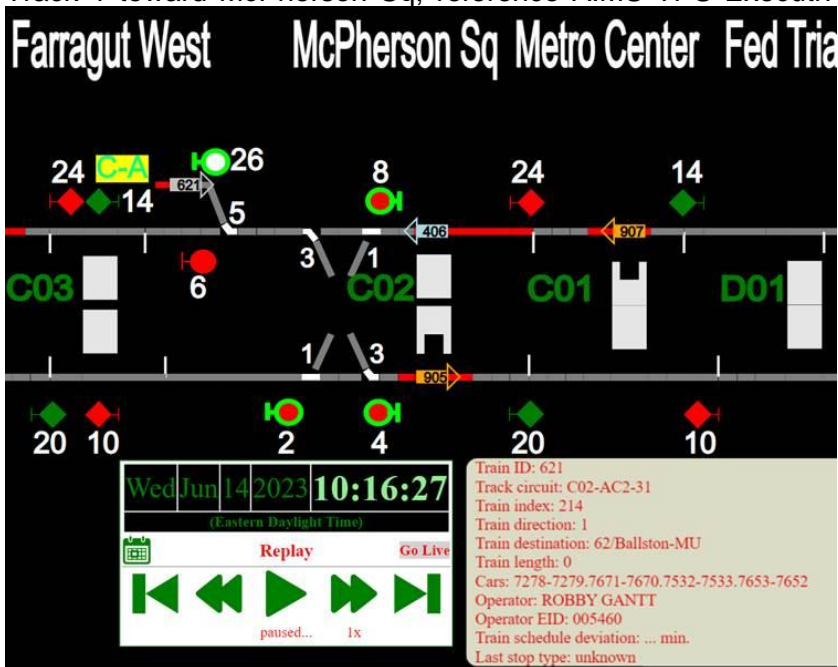
11. At 10:16:27, Signal 26 goes Lunar, and Switches 5, 3, and 1 are set for a Crossover to Track 1 toward McPherson Sq; reference AIMS TPS Executive Traffic Graphic below.

12. At 10:17:15, the Train began moving in reverse toward McPherson Sq (C02) and crossed over to Track 1; reference AIMS TPS Executive Traffic Graphic above, and per Car 7652 EMM Data Graphic.

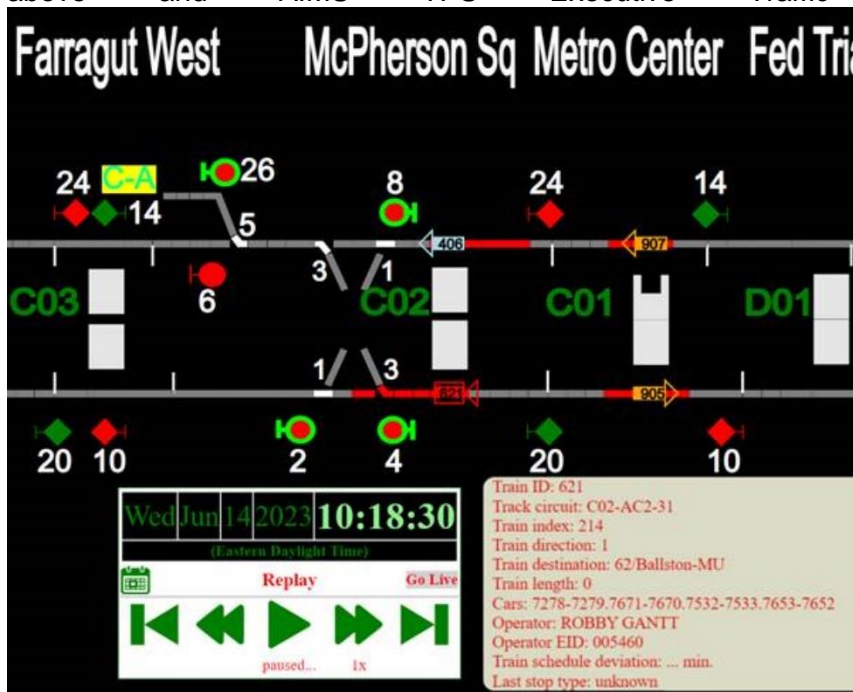
13. At 10:18:30, the Train stops at McPherson Sq (C02-1); reference Car 7658 EMM Data above and AIMS TPS Executive Traffic Graphic below.

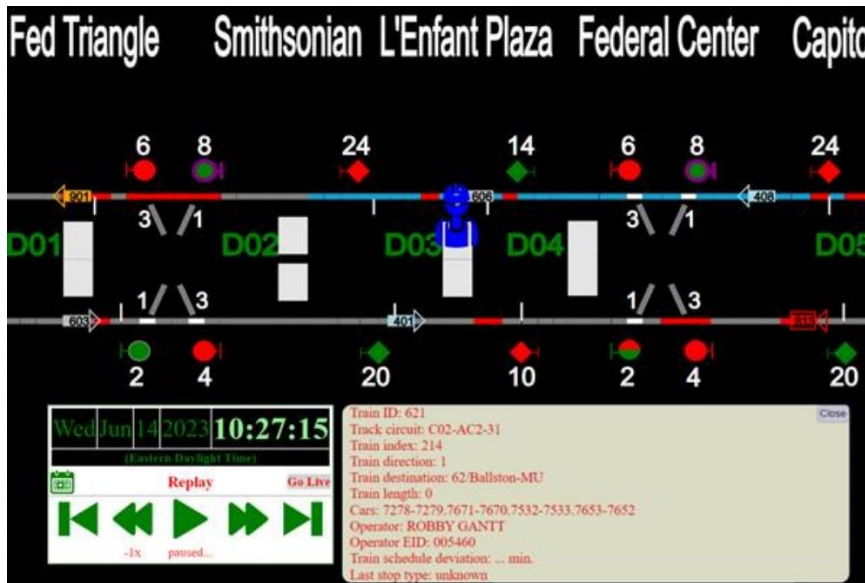
14. At 10:21:49, the Train stops at Metro Center (C01-1), per Car 7652 EMM Data Graphic.
 15. At 10:25:22, the Train stops at L'Enfant Plz (D03-1); per Car 7652 EMM Data Graphic.
 16. At 10:27:15, the Train passes through Federal Center (D04-1) at 21 MPH and travels 1,186 Ft before stopping at the TurnBack, per Car 7652 EMM Data Graphic, reference AIMS TPS Executive Traffic Graphic below.

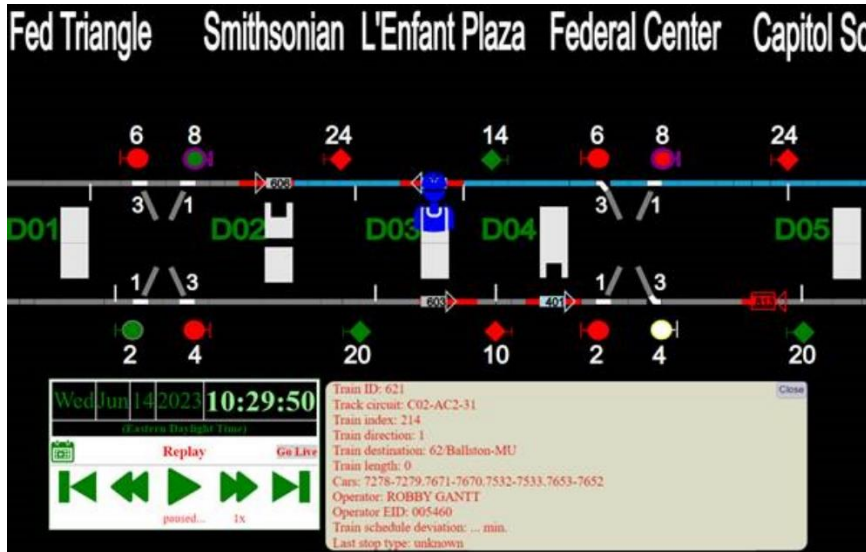
17. At 10:27:31, Car 7652 Keys Down.
 18. At 10:29:50, Interlock Switch 3 and 6 move to a divergent position for Train 813 to cross over to Track 2, and Signal 4 go Lunar.

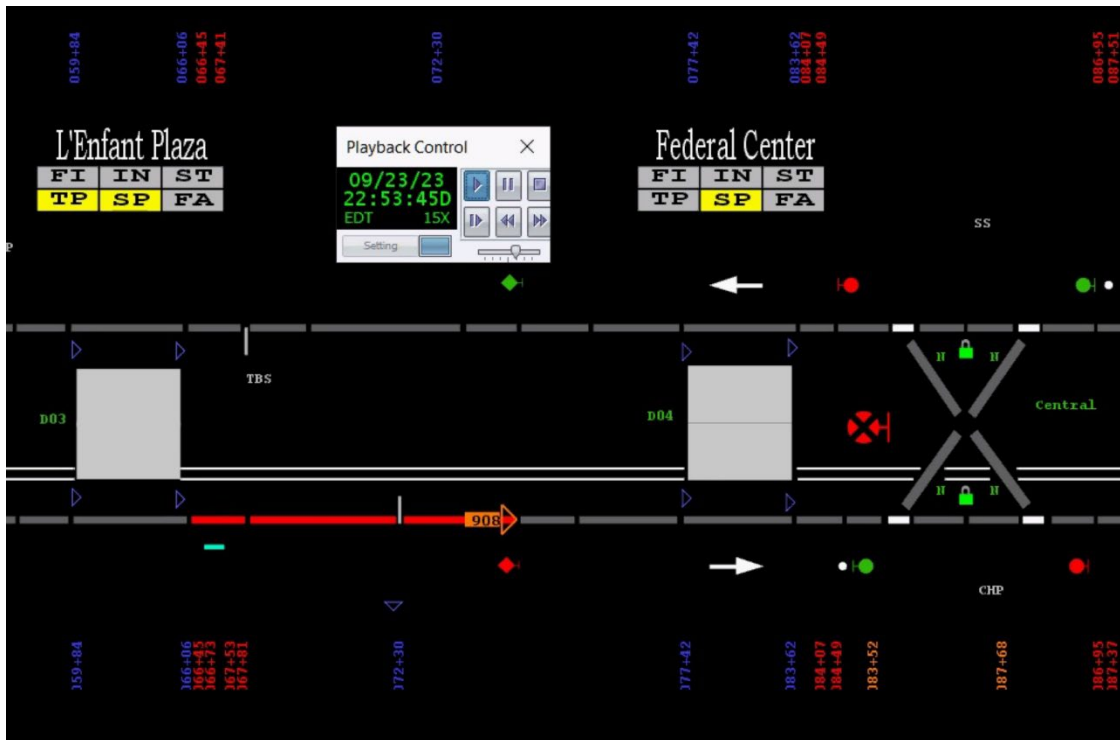
Figure 1 - Train ID 908 approaching Federal Center SW Station, Track 1 at 23:53 hours.

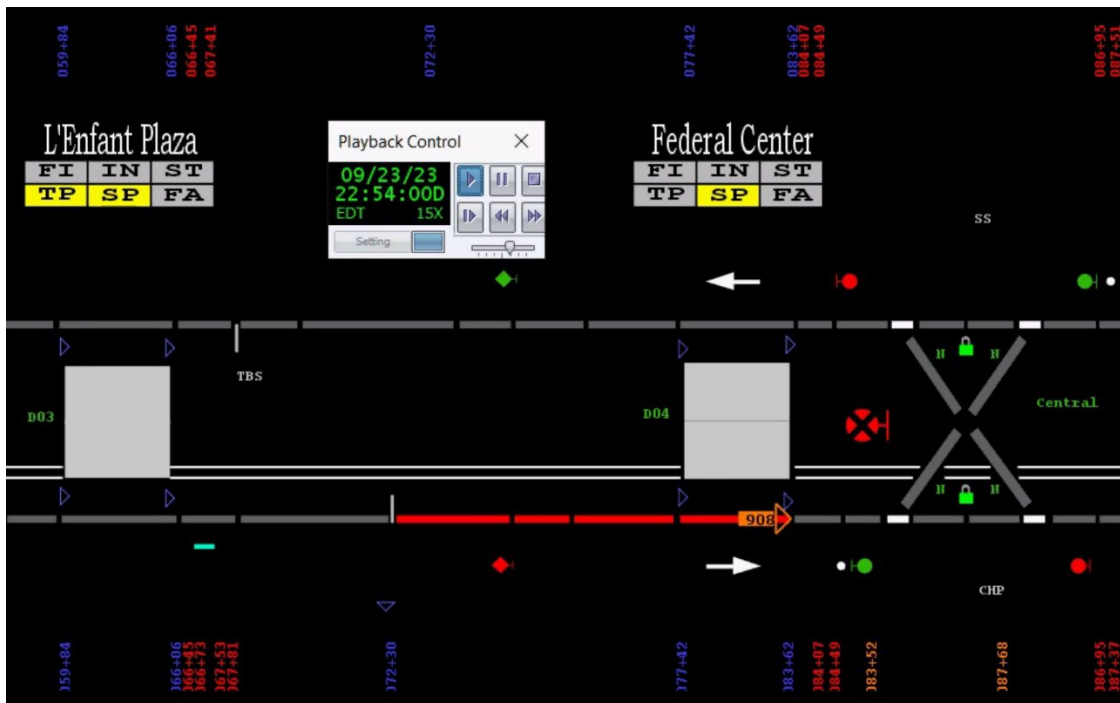
Figure 2 - Train ID 908 arrived at Federal Center SW Station, Track 1, at 22:54 hours.

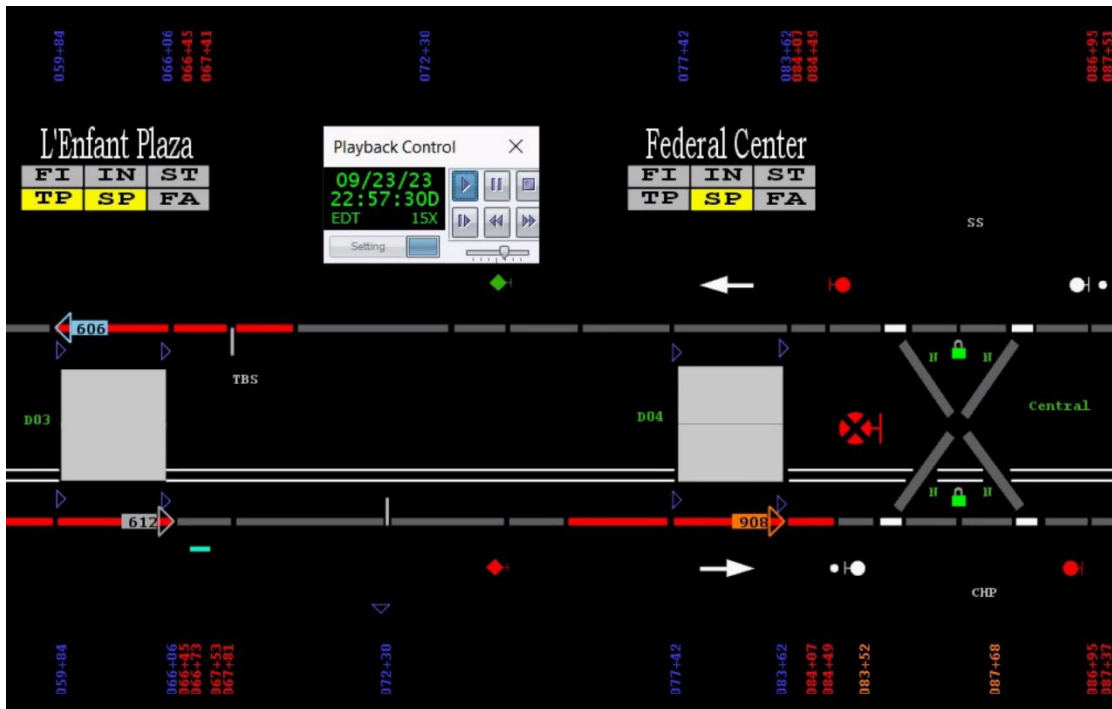
Figure 3 - Train ID 612 arrived at L'Enfant Plaza Station on Track 1 as Train ID 908 was berthed at Federal Center SW Station, Track 1, at 22:57 hours.

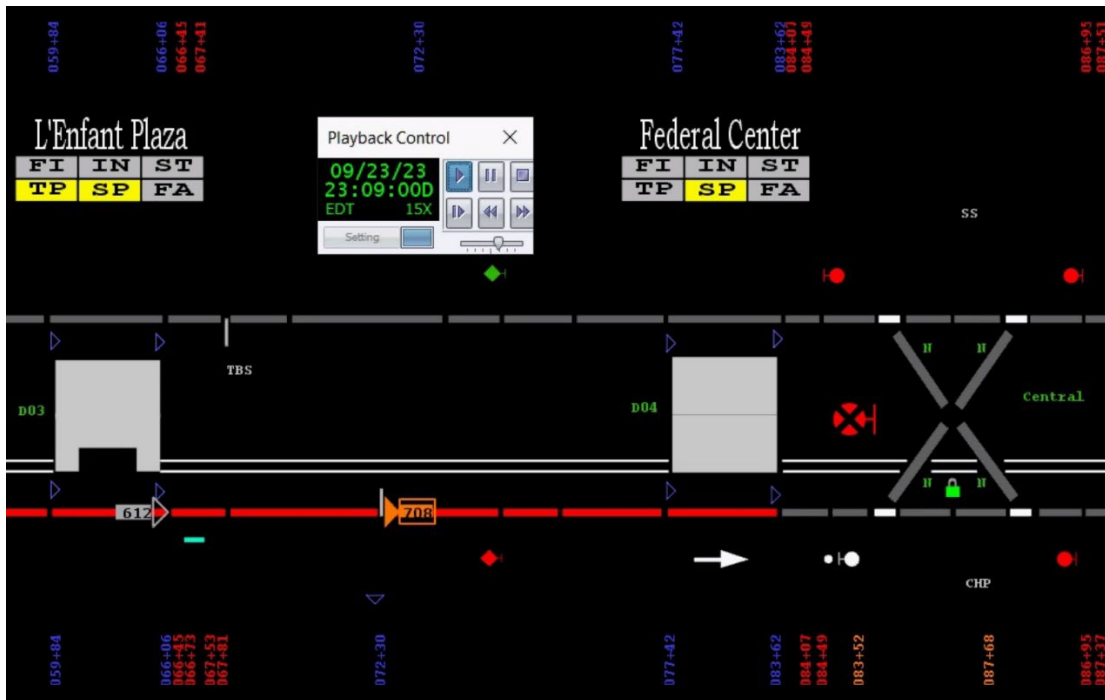
Figure 5 - Train ID 608 changed its identification marker to Train ID 708 in non-revenue service at 23:09 hours.

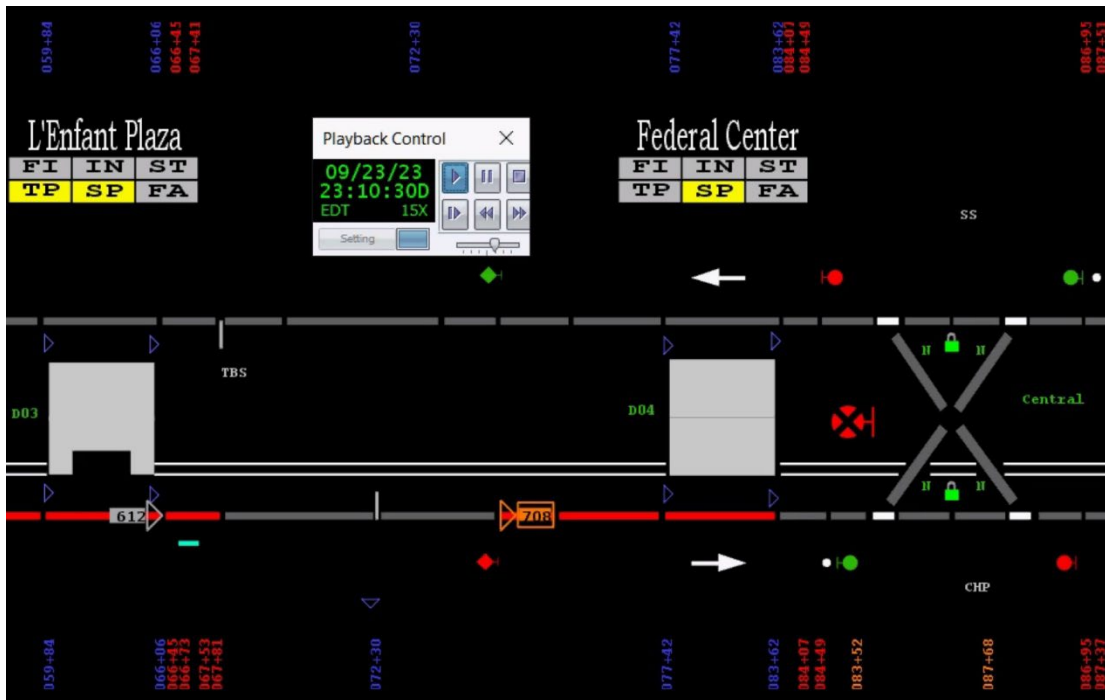
Figure 6 - Train ID 708 began to travel toward New Carrollton Station in non-revenue service at 23:10 hours.

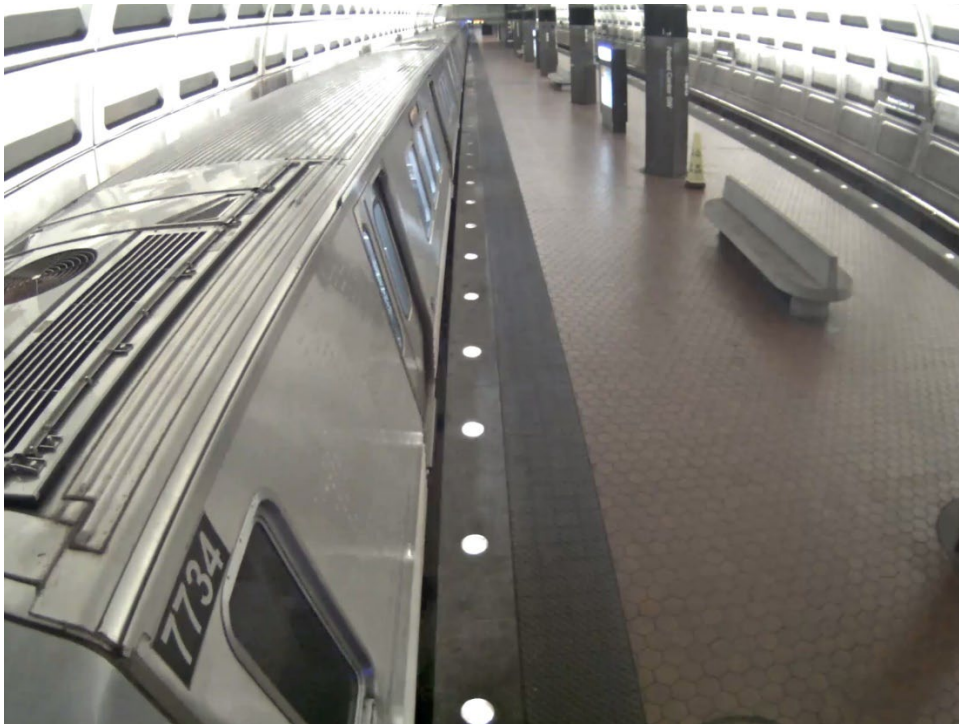
Figure 7 - Train ID 908 arrived at the 8-car Marker at Federal Center SW Station, Track 1, at 22:54 hours.

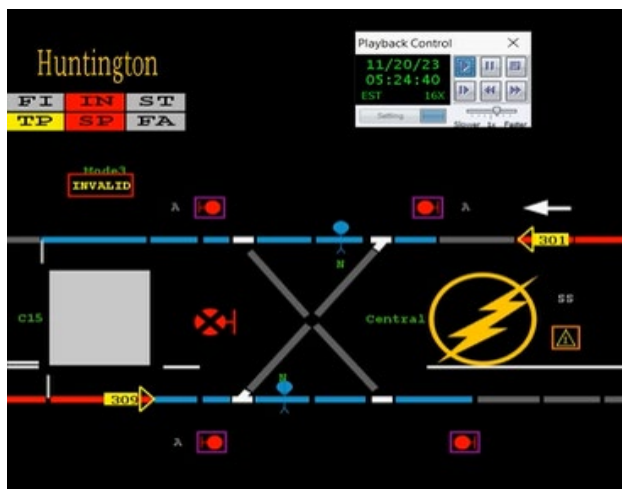
Figure 1 - AIMS depicts blue blocking, prohibited exits, and personnel at switches 1A & 3A for clamping at 05:24 hours.

Train ID 309 was dispatched from Huntington Station on track 1, then began to crossover from track 1 toward track 2. The Train Operator of Train ID 309 stopped the train and reported to the MICC that the train was taking a diverging route. Rail Supervisor #1 had clamped switch 1A in a reverse position, leading the train to make a crossover move.

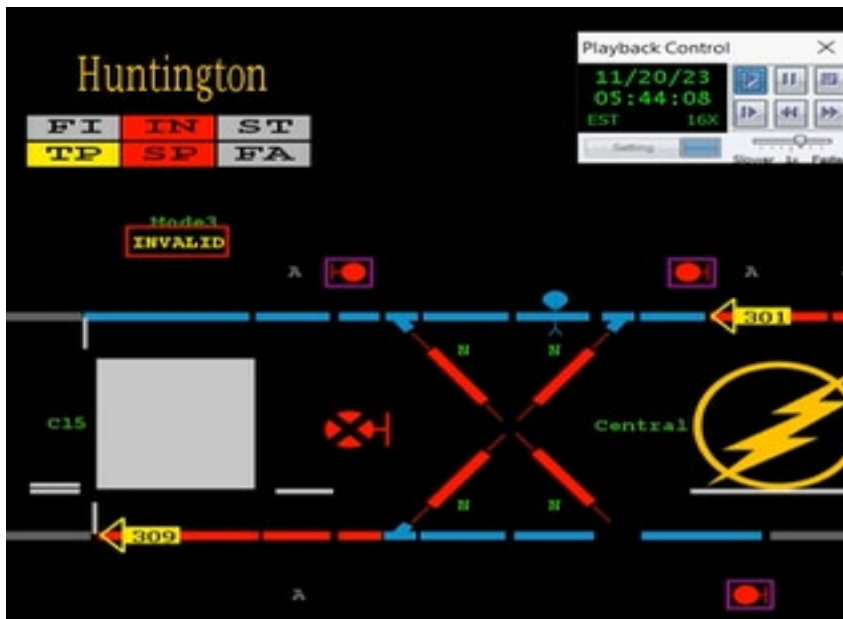
Figure 5 - AIMS depicts Train ID 309 back on the platform of Huntington Station, Track 1.

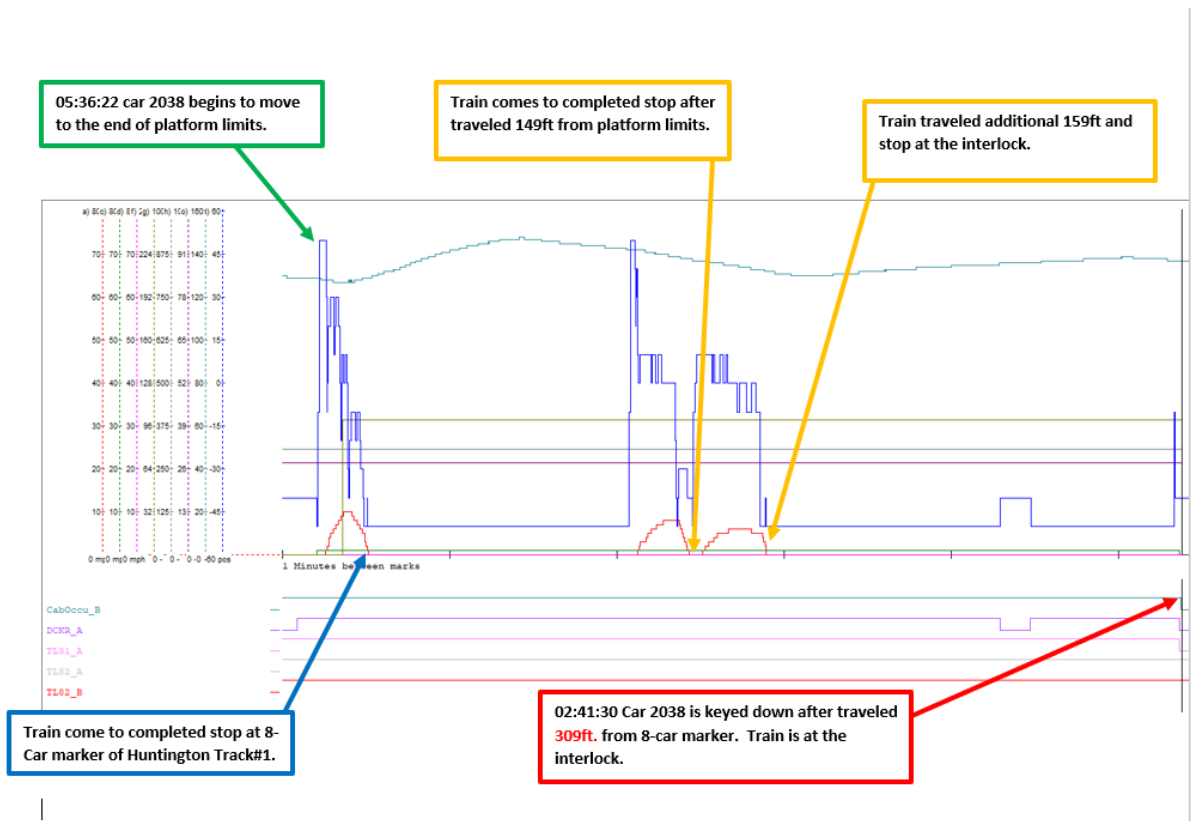
Figure 6 - depicts the VMS graph from Railcar 2038.
