## Red Signal Overruns

At or Near Ronald Reagan Washington National Airport Station, West Falls Church Yard and Spring Hill Station

July 23, 2023 – November 19, 2023 – November 25, 2023

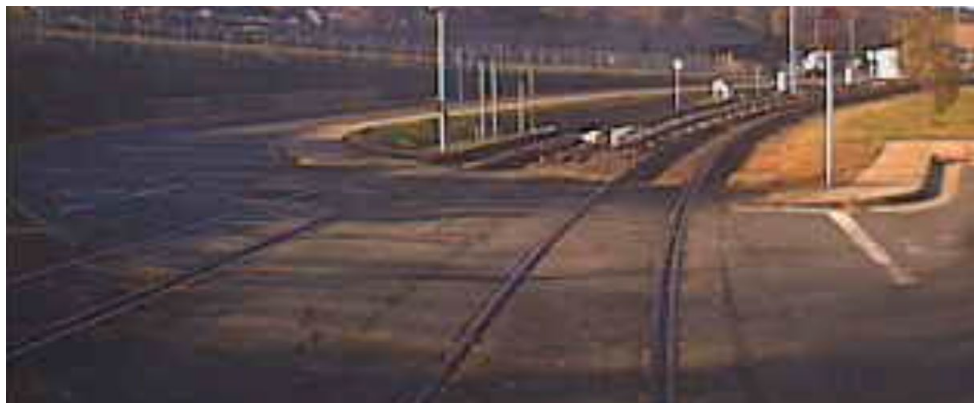
Image 2 - Forward-facing Camera Image of the consist located at the road crossing near the Train Operators Administration Building.

The Closed-Circuit Television (CCTV) revealed that the consist arrived at the road crossing at 09:12 hours, stopped briefly, and then continued across the road crossing, exceeding the absolute block and instructions from the Interlocking Operator. Seconds later, the consist passed signal K99-302, displaying a red aspect traversing switch 301 and trailed switch 303A.

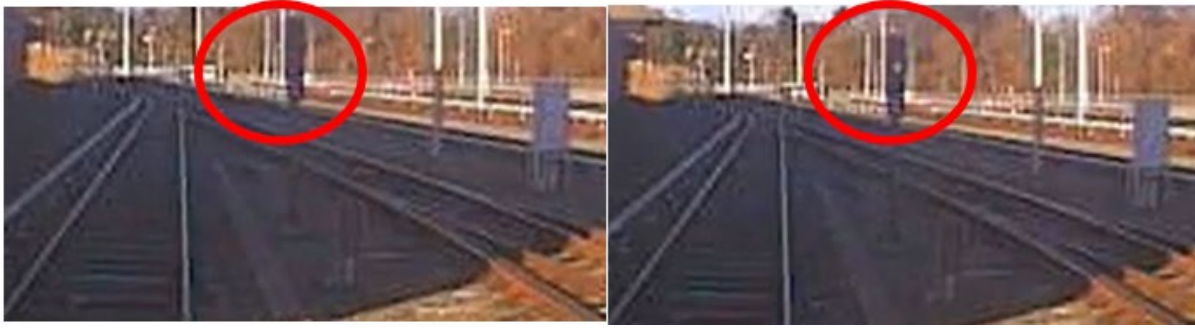
At 09:13 hours, the Train Operator reported to the Interlocking Operator stopped at signal K99-134 red. The Interlocking Operator instructed the Train Operator to hold at that location. Seconds later, signal K99-134 changed from red to lunar.

Image 3 - Forward-facing Camera Image of the consist located at K99-134 when the signal changed from red to lunar.

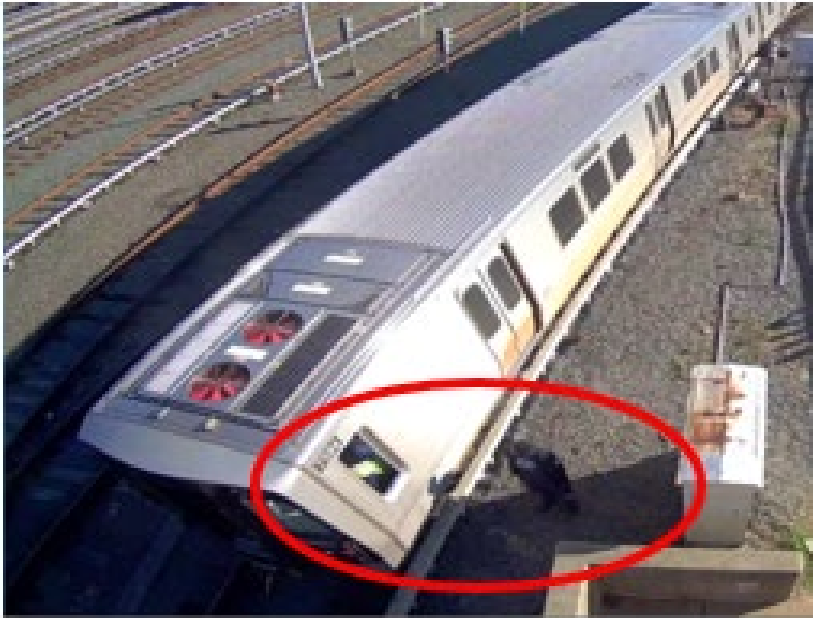
At 09:18 hours, the Interlocking Operator had a conversation with the Train Operator.

*Image 5 – Image of the Interlocking Operator having a conversation with the Train Operator at 09:18 hours.*

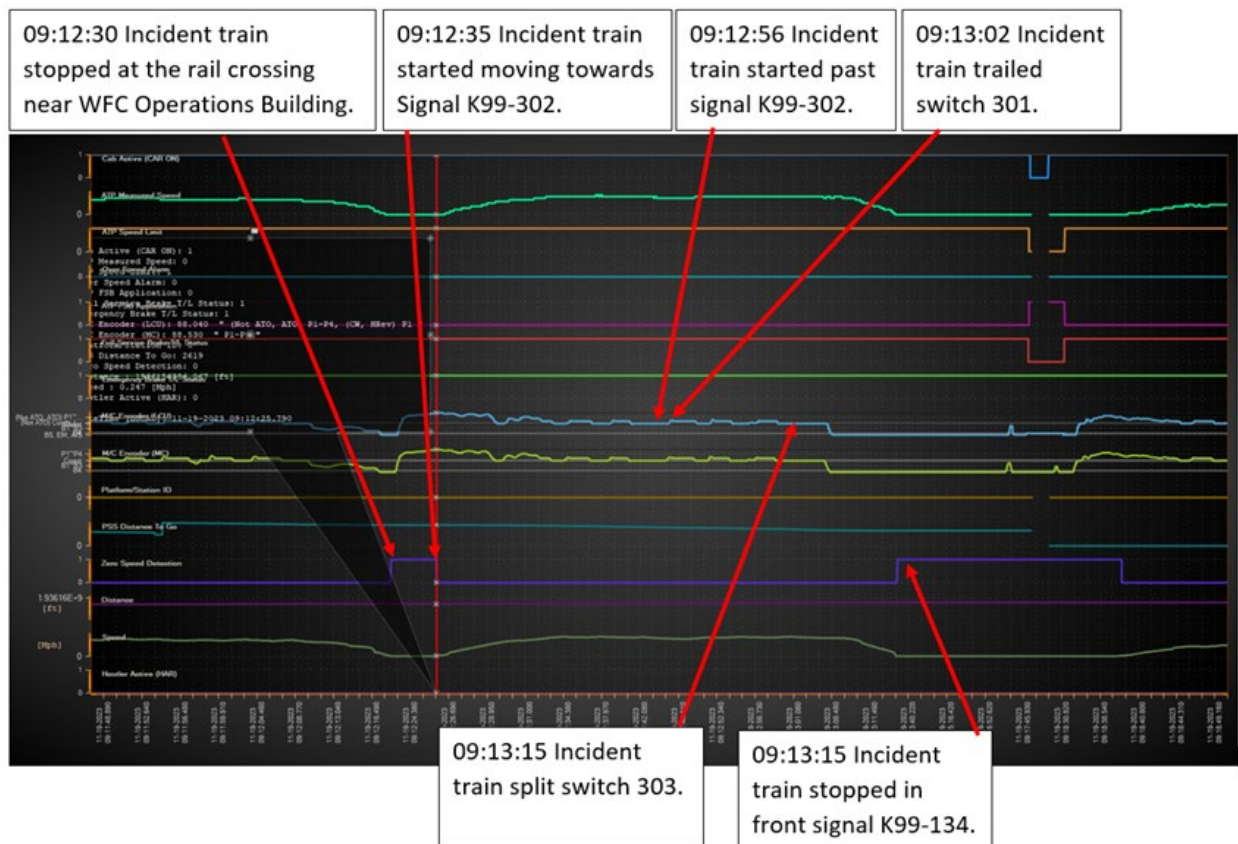
Graph 1 – Data Analysis

Time	Description
09:12:30 hours	The incident train stopped at the road crossing near the WFC Operations Building.
09:12:35 hours	The incident train started moving towards signal K99-302.
09:12:56 hours	The incident train started past signal K99-302.
09:13:02 hours	The incident train trailed switch 301.
09:13:15 hours	The incident train split switch 303.
09:13:15 hours	The incident train stopped in front of signal K99-134.

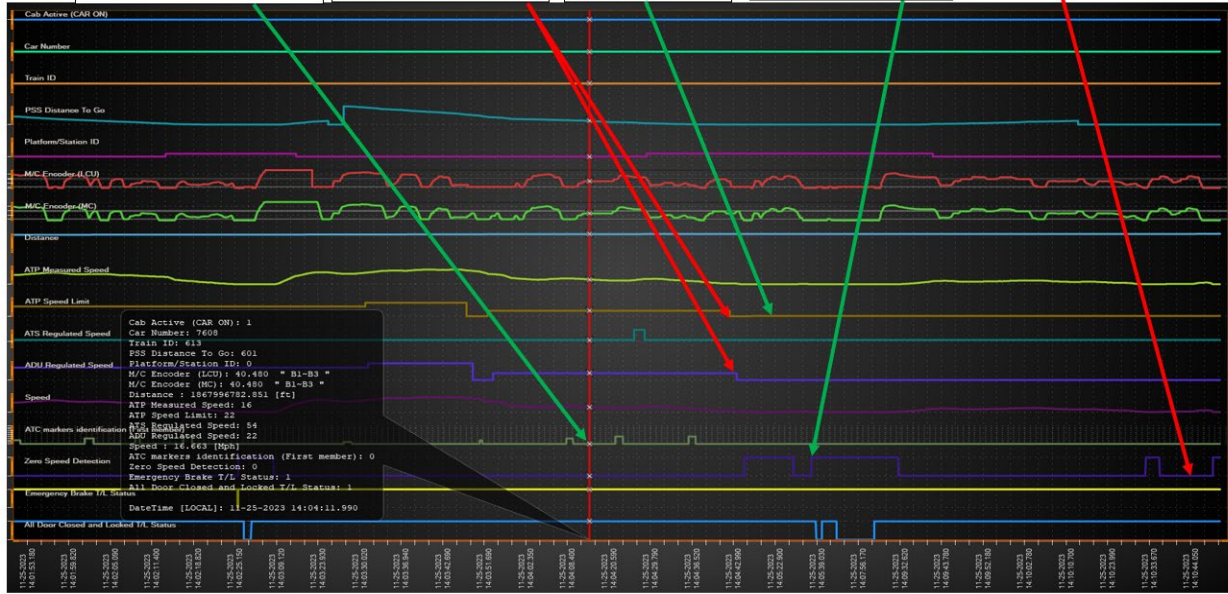
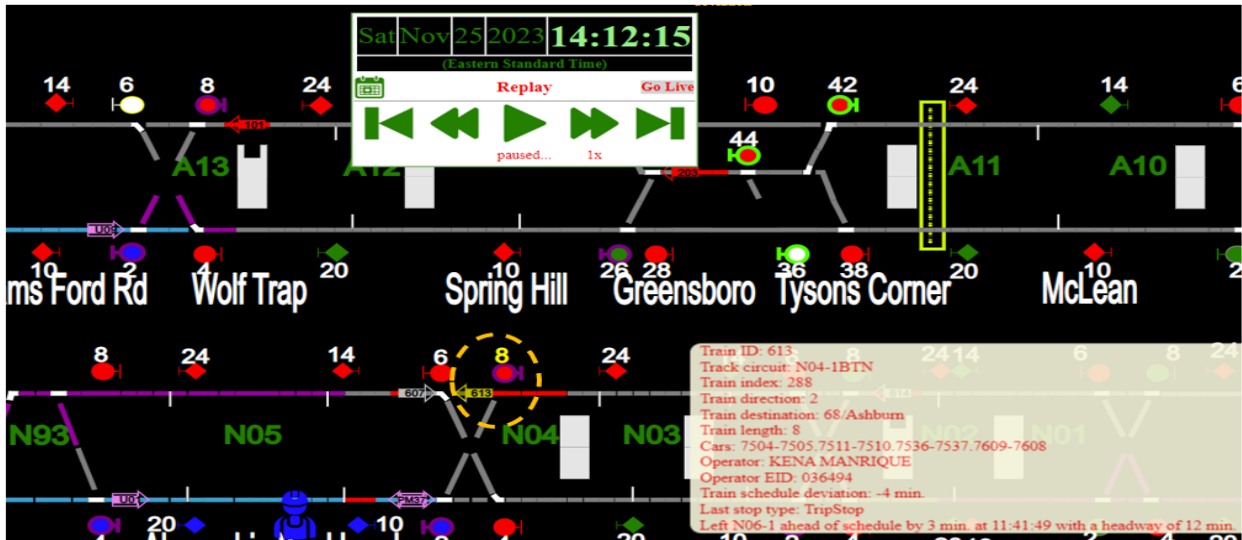
Train came to a complete stop at Spring Hill's 8<sup>th</sup> car marker.

The train passed RED N08-02 signal and 4 Mph
