W-0304 Derailment – Near Ronald Reagan Washington National Airport Station – September 29, 2023

Document Purpose

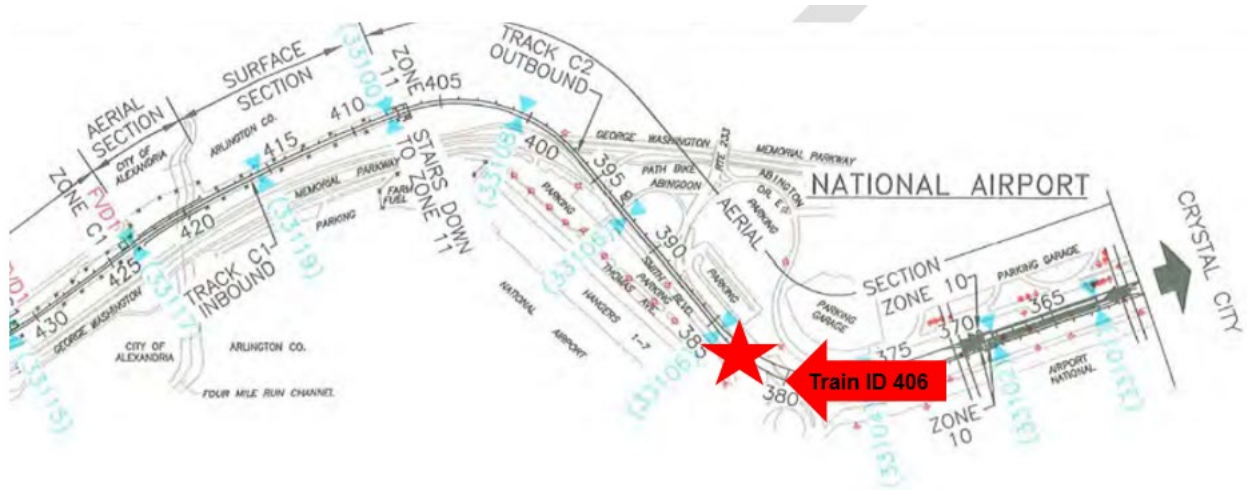
Field Sketch/Schematics

Track 2, direct fixation tracks, split aerial structure, curved section of track

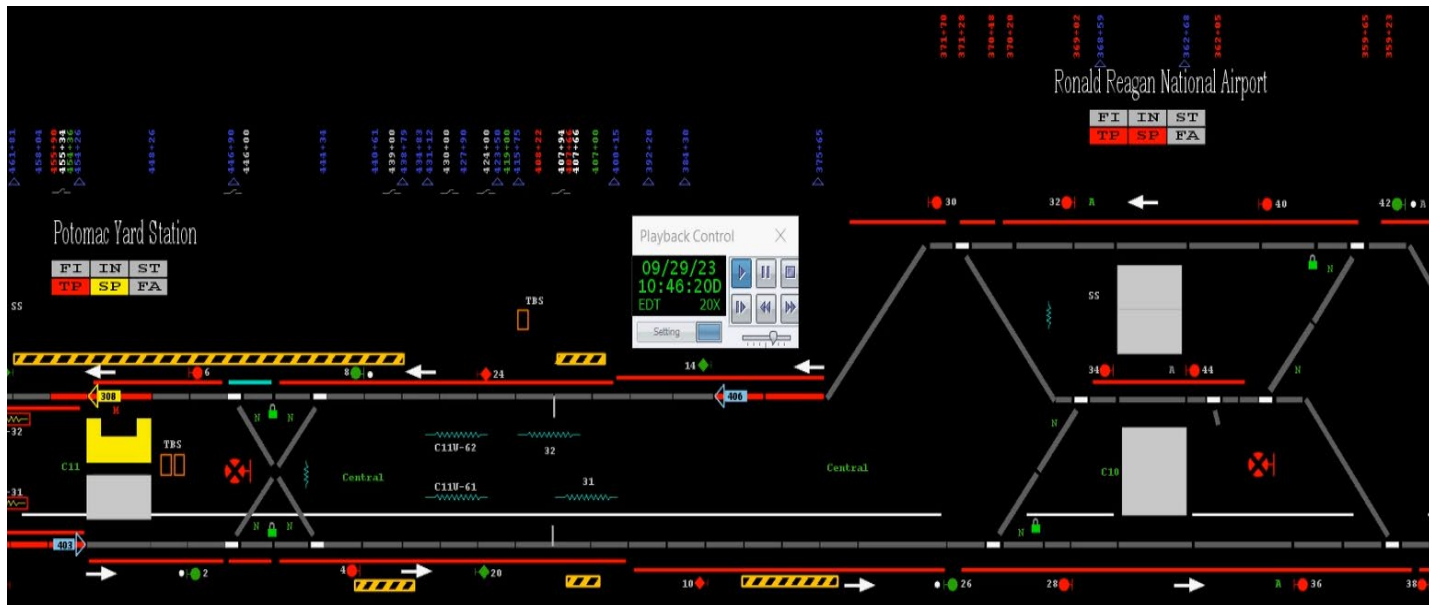
Figure 1 - AIMS Playback of Train ID 406 located at CM C2 384+00 at 10:46 hours.

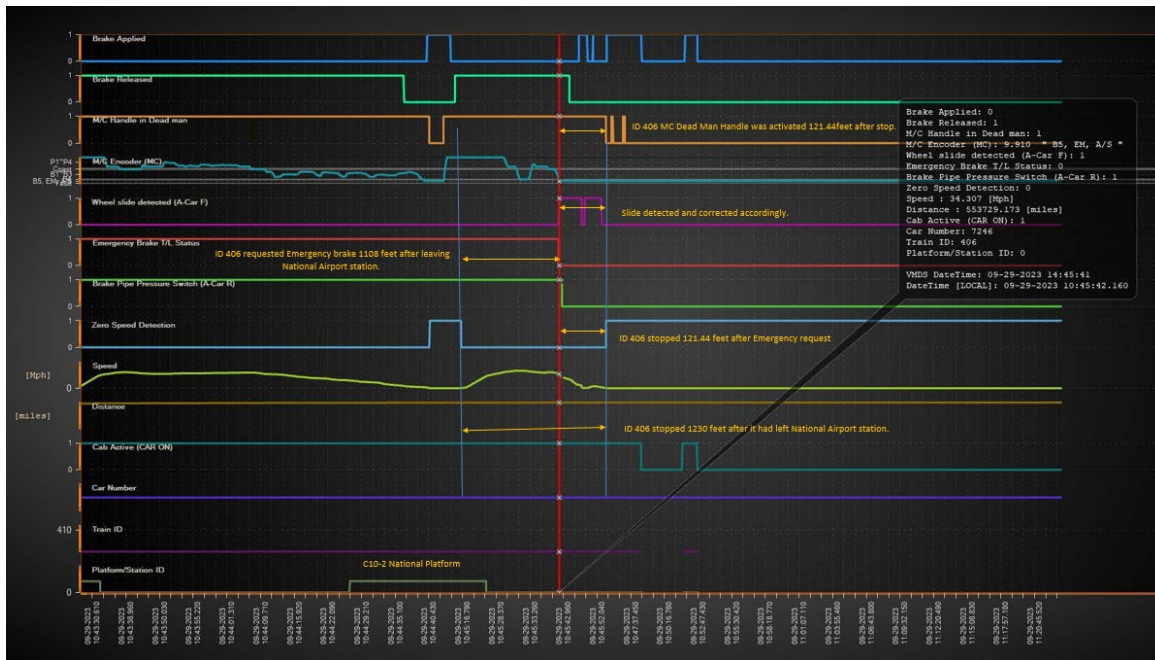
The VMDS and equipment logs have been reviewed as well—and nothing wrong was found in the train function that could have contributed to this derailment other than the brake disc seen in the video below at 10:46:08, which coincides with the time in step 3) where EM brake application was requested from ID 406.

According to the video, ID 406 stopped at 10:46:20—26 seconds ahead of local time in step 10).”

Figure 2 - Event Recorder data visualization.

The VMS Time listed within the Event Recorder is approximately 4 hours faster than Local time and 26 seconds behind the video.

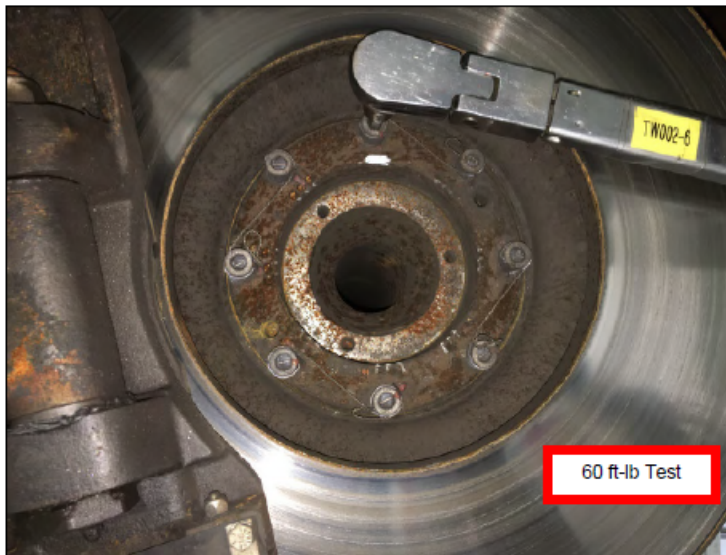
Figure 1. Torque wrench set-up with white mark under the highest bolt, which marks it as the first bolt to be checked, then progress in a clockwise direction.

- 3.1.1 Make a new and noticeable white mark under the highest ALP bolt on the first disc to be checked. This white mark will identify the first bolt to be checked (see Figure 1).

- 3.1.2 Without removing the safety wire, apply a tightening torque of 60 ft-lbs. If any bolt turns, then all 8 bolts in this disc must be replaced with new ALP bolts per **MSI 180246 Rev. 01 (2-3K Instruction And Replacement of ALP Brake Discs Hub-to-Wheel Mounting Hardware)** (See Attachment A).

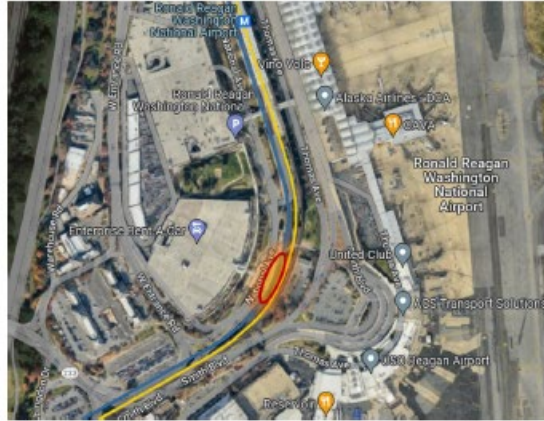
On the morning of September 29, 2023, at approximately 10:45 a.m., a Blue-Line revenue service train leaving National Airport (C10) and heading towards Potomac Yard (C11) on the outbound track (Track 2) derailed while traversing a right-hand curve on the C10 aerial structure (Figure 1).

Figure 1: Satellite View of Derailment Area

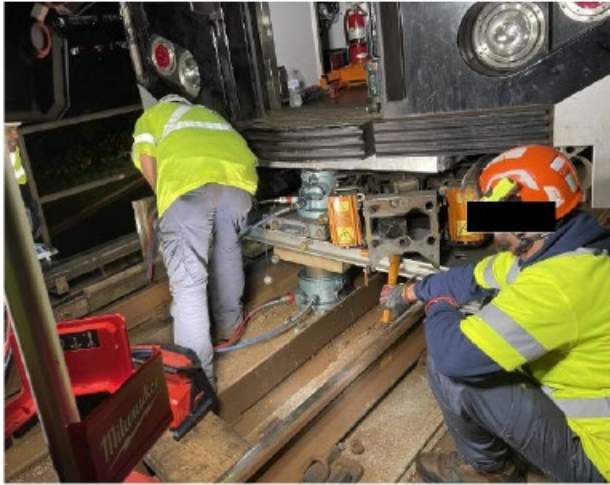
The derailed train was re-railed during the night of September 29 (Figure 11)

Figure 11: Lead Car Re-railed

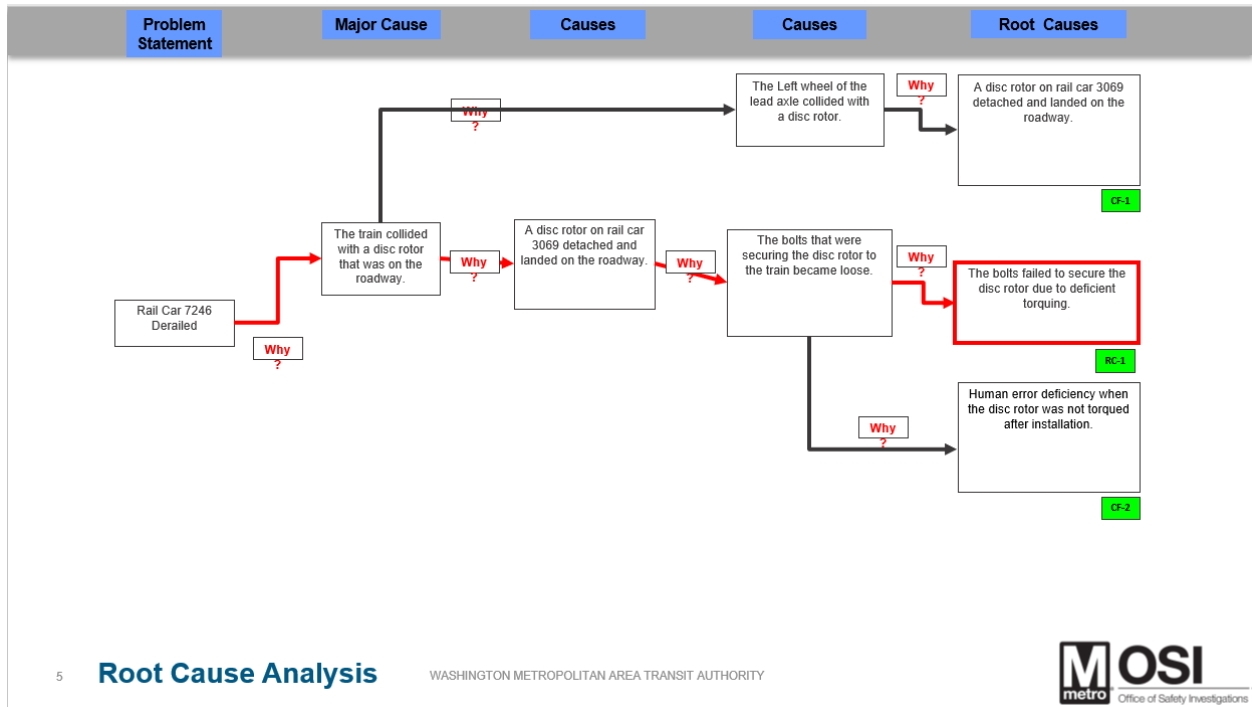
Appendix G – Why Tree Analysis

Results of initial round of metallurgical testing showed the analysis of failed bolts revealed material degradation and signs of fatigue, indicating potential quality issues or inadequate stress tolerance.

The stress analysis evaluation of bolted connections identified instances of insufficient torque or improper tightening procedures, leading to compromised integrity. The engineering evaluations assessment of maintenance practices and historical data highlighted discrepancies in bolt installation protocols and maintenance procedures.
