W-0305 Train Operator Removed for Fatigue, Drug and Alcohol – Orange Line – September 10, 2023

FINAL REPORT OF INVESTIGATION A&I E23636

Date of Event:	September 10, 2023
Type of Event:	Operator Removed from Service (Fatigue – Drug & Alcohol) - Failure to Service Stations
Incident Time:	07:50 Hours
Location:	Multiple Stations
Time and How received by SAFE:	09:30 Hours – SAFE/MAC
WMSC Notification Time:	11:12 Hours
Responding Safety Officers:	None
Rail Vehicle:	Train ID 909 (L7690/91x7639/38x7372/73x7399/98T)
Injuries:	None
Damage:	None
Emergency Responders:	MTPD (Metro Transit Police Department)
SMS I/A Number	20230910#111280

**Foggy Bottom Station – Operator Removed from Service
(Fatigue – Drug & Alcohol) - Failure to Service Stations**

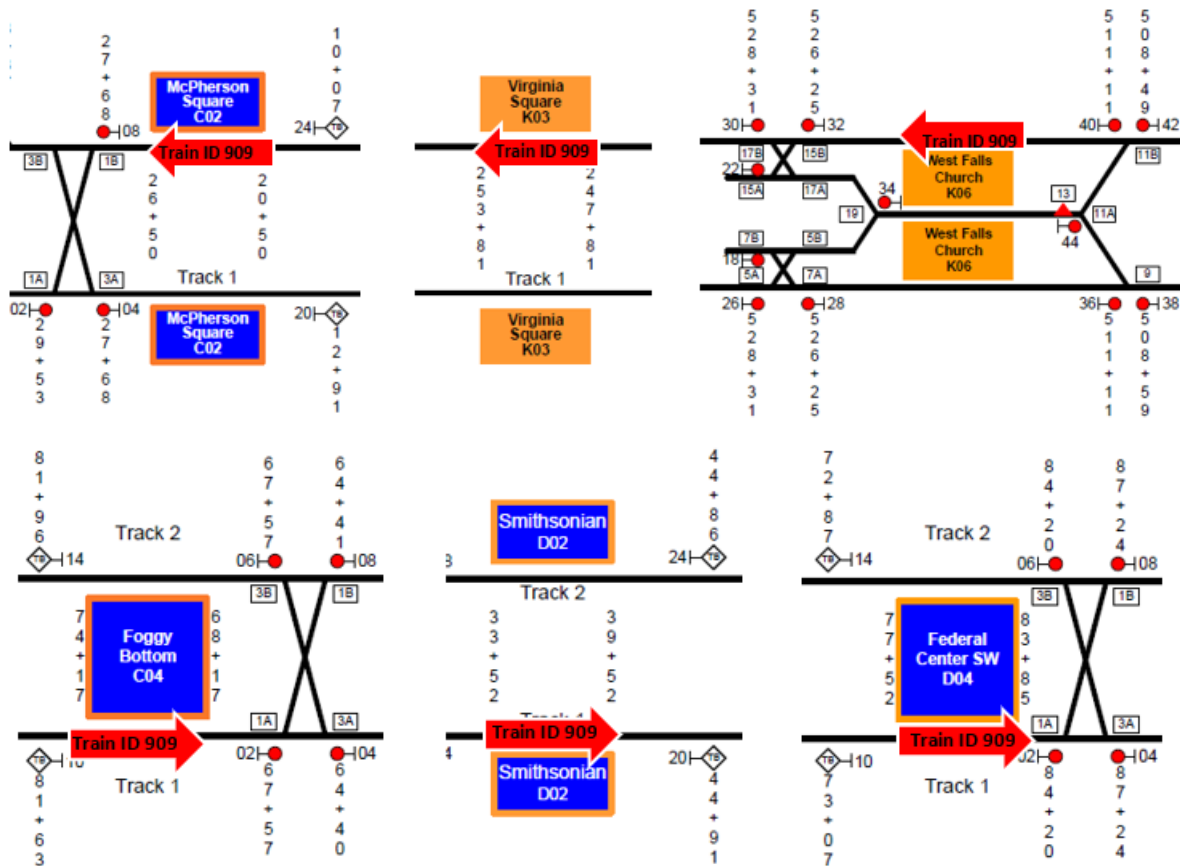
Field Sketch/Schematics

- 07:29 hours – Stadium-Armory Station, track 2, overran by five feet
 07:32 hours – Potomac Avenue Station, track 2, overran by seven feet
 07:51 hours – Farragut West Station, track 2, overran by two feet
 08:49 hours – Virginia Square Station, track 1, overran by six feet
