## W-0325 & W-0326 Hazardous Materials Spills – Green Line, Red Line – August 9, 2023

#### **W-0325 – Track tamping machine hydraulic hose bursts while in use on Green Line (WMATA ID: E23550)**

#### **W-0326 – Hydraulic failure upon activation of RMM boom at Medical Center Station (WMATA ID: E23551)**

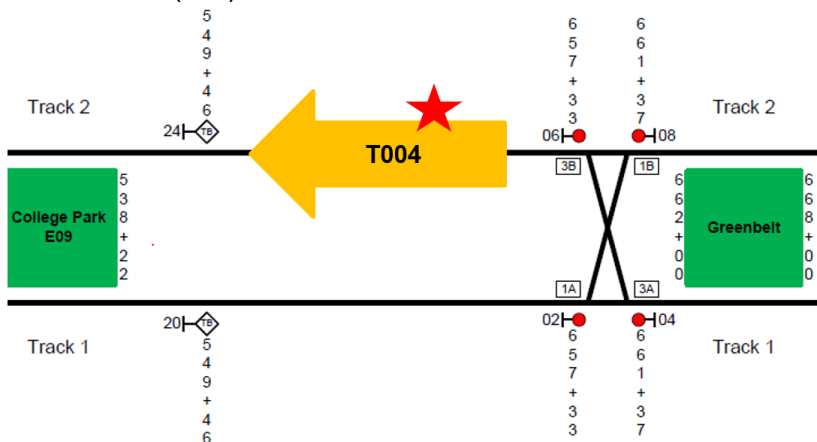
#### **First Event (E23550)**

Chain Marker (CM) E2 636+00, Track 2

On August 9, 2023, at 00:44 hours, the MC notified MOC of a hydraulic leak from Metro 4X4 Tamping Machine Unit T004 at CM E2 636+00, Track 2. It was estimated that 200 Gallons of hydraulic fluid leaked onto the ballast.

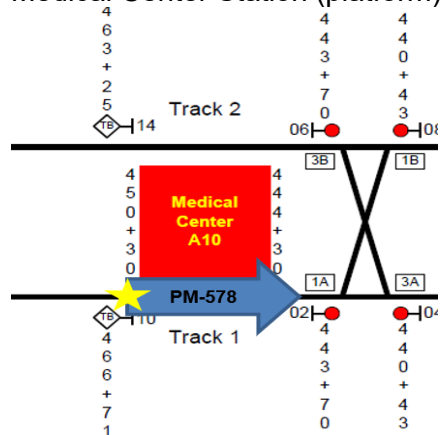
## Second Event (E23551)

On August 9, 2023, at 02:35 hours, the MAC was notified of a hydraulic leak from Prime Mover PM-578 at Medical Center Station while headed to Shady Grove Rail Yard. It was estimated that 10 to 20 gallons of hydraulic fluid leaked onto track 1.

Medical Center Station (platform), track 1.
