Red Signal Overruns

At or Near New Carrollton Rail Yard, Rhode Island Ave-Brentwood Station, and West Falls Church Station

January 3, 2024 – February 13, 2024 – February 15, 2024

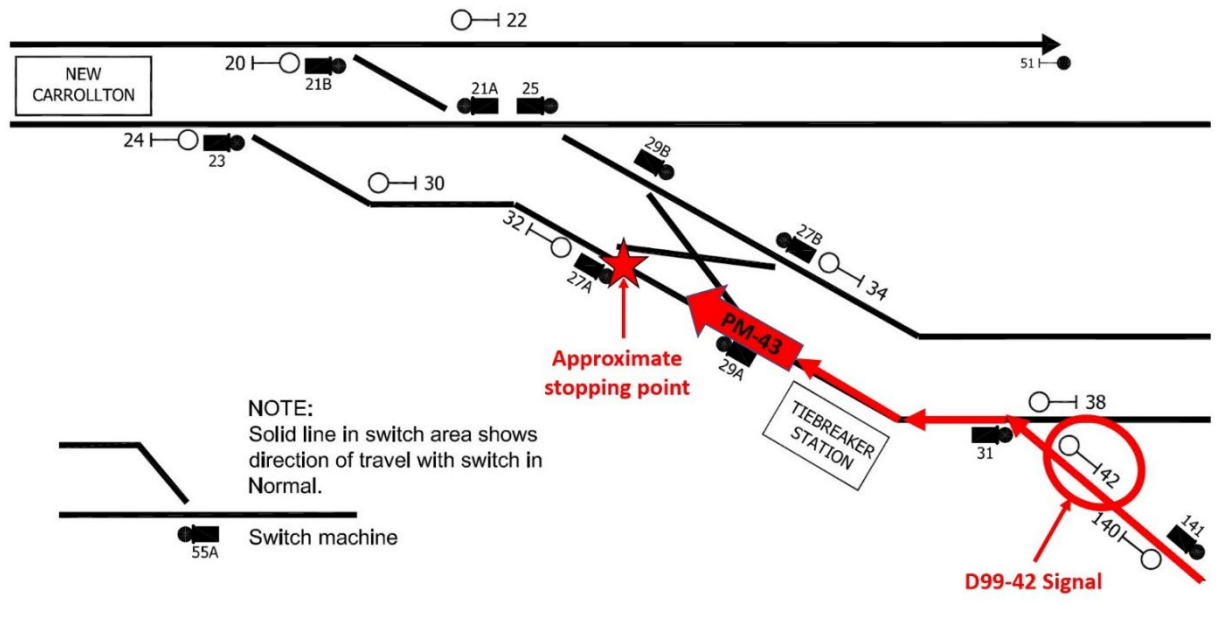
Field Sketch/Schematics

D99-42 Signal is located within the New Carrollton Yard and governs rail vehicle movement from the yard to New Carrollton Station. (Orange Line).

At 00:52 hours, the IO observed² PM-43 with F-533 overrun signal D99-42 and directed them to stop moving. PM-43 with F-533 stopped 320 feet beyond signal D99-42. PM-43 with F-533 traversed switches 31, 29A, and 27A.

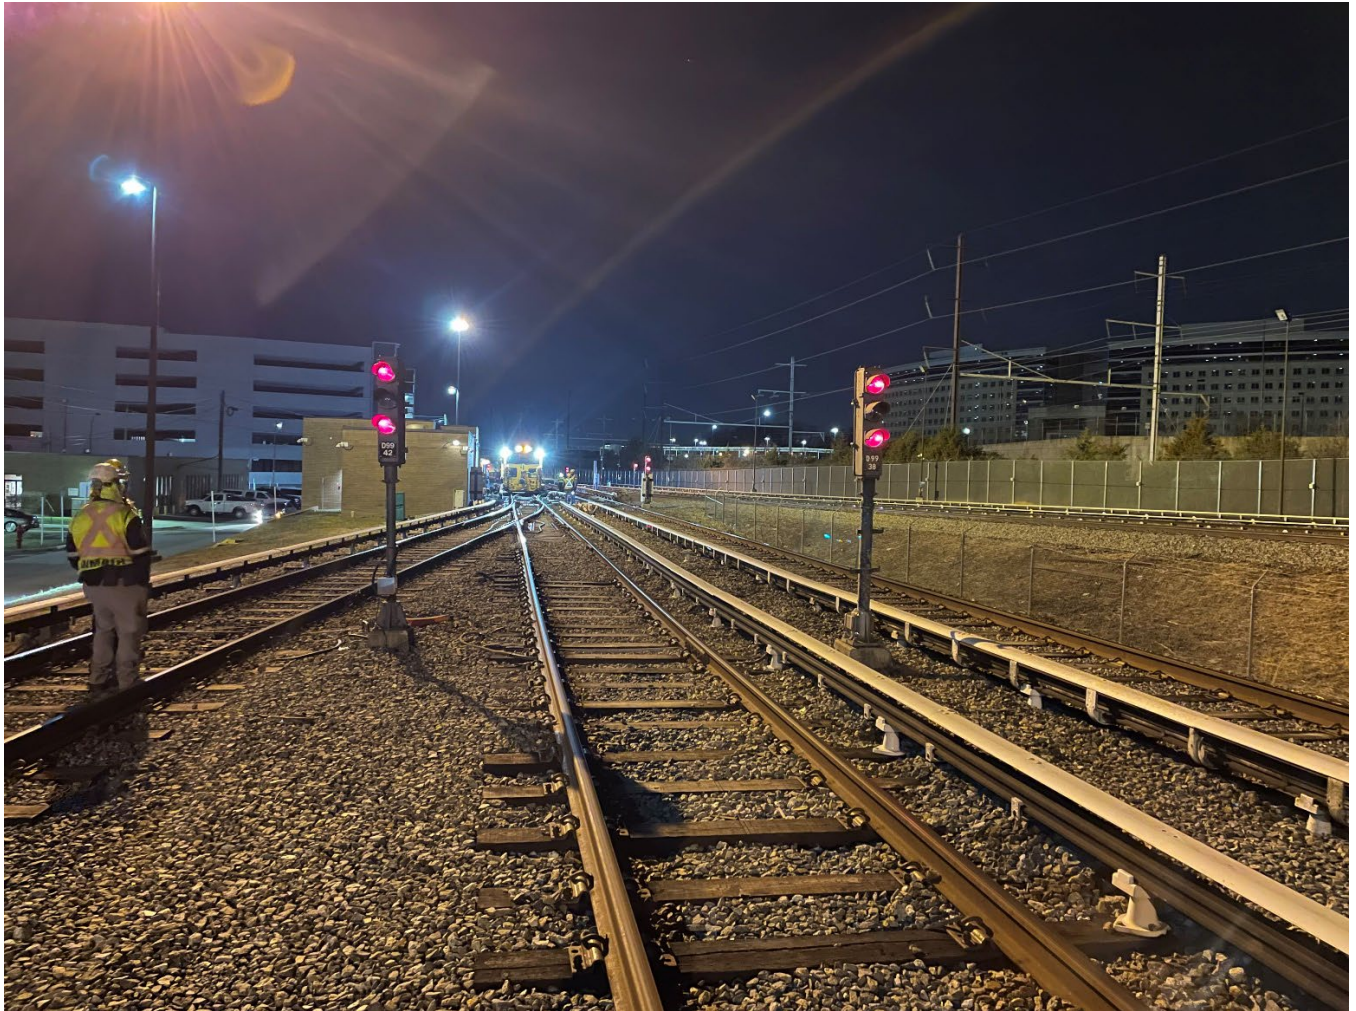
Image 6 – Signal D99-42 and adjacent Signal D99-38.

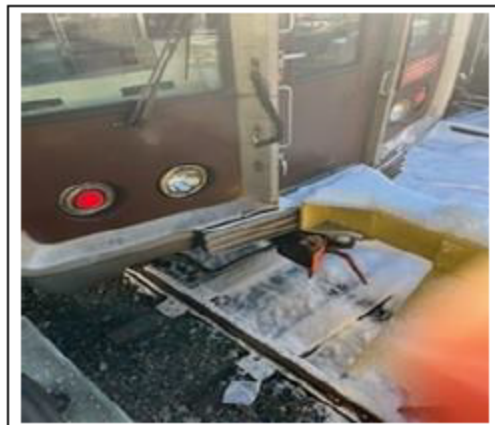
Image 10 - Lesson Learned RTRA-303-10-00.

- ✓ Ensure operating personnel understand the importance of maintaining radio communication when moving trains, particularly during 3rd car operations.
- ✓ Always remember, to follow MOR 11.18.4.6 when radio communication becomes distorted or is not heard.

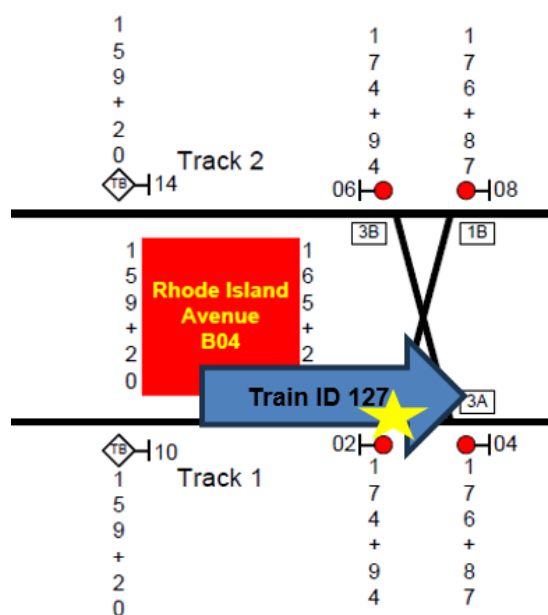
Field Sketch/Schematics

Rhode Island Avenue Station, Track 1, B04-02 signal at CM 174+94

16:35:38.900	The train comes to a complete stop after traveling 199 feet beyond the B04-02 signal, an additional 556 feet after departing Rhode Island Avenue station, and a total of 1,173 feet traveled after Rhode Island Station.

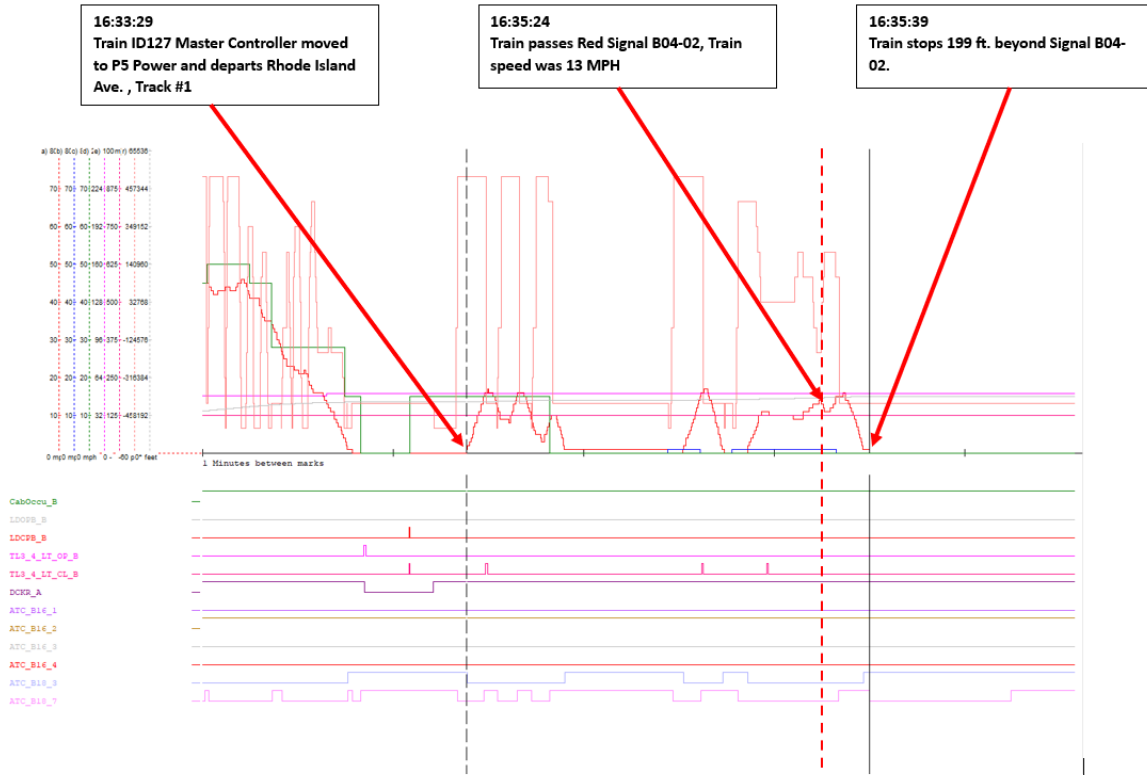
Table 1 - depicted when Train ID 127 passed the B04-02 signal red.

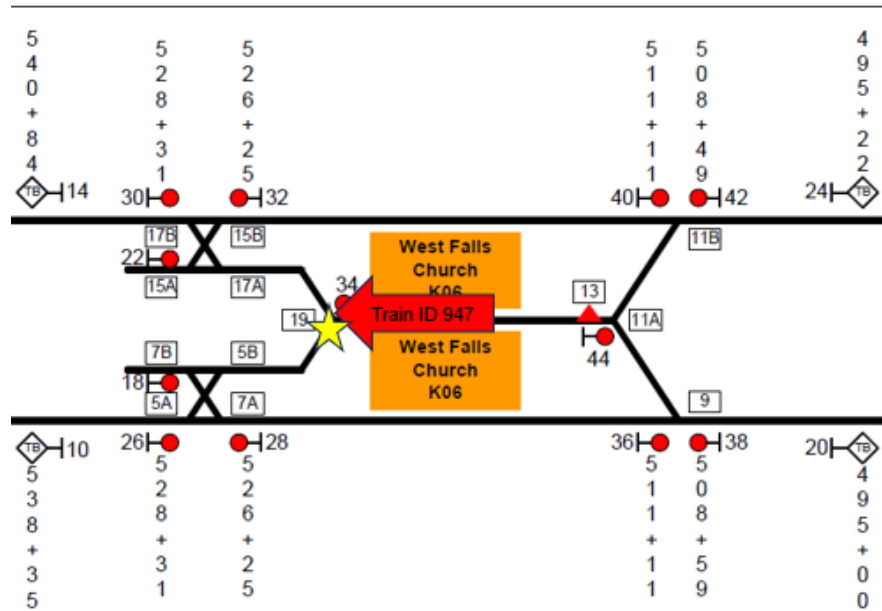
Field Sketch/Schematics

West Falls Church Station Track 3, signal K06-34 at CM 524+50.

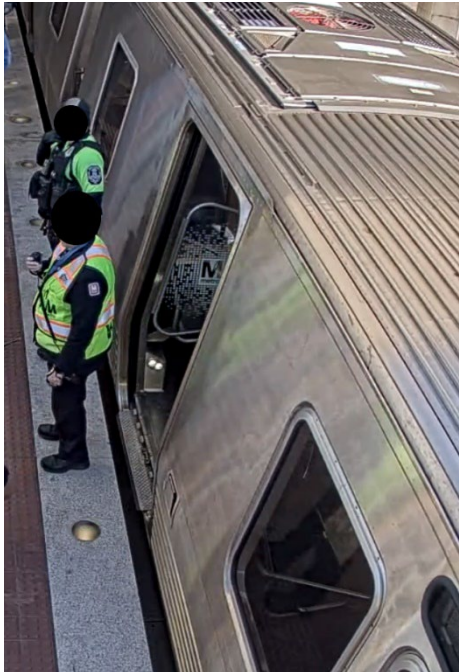
At 15:01 hours, CCTV shows MTPD and the Train Operator of train ID 918 exiting the train after all customers were evacuated. Based off the CCTV footage reviewed, a total of 34 customers were evacuated from the incident train.

Figure 3 MTPD and 918 Train Operator exiting the incident train after all customers were evacuated.

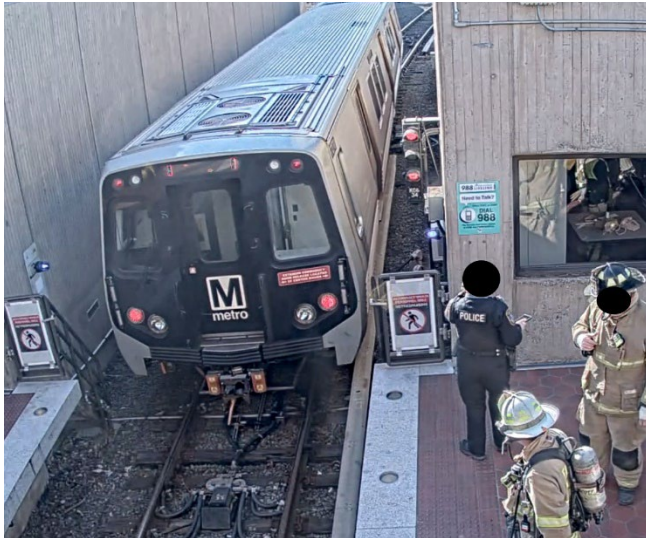
At 15:39 hours, CCTV shows the incident train began moving into West Falls Church yard.

Figure 4 Train ID 918 moving into West Falls Church rail yard.

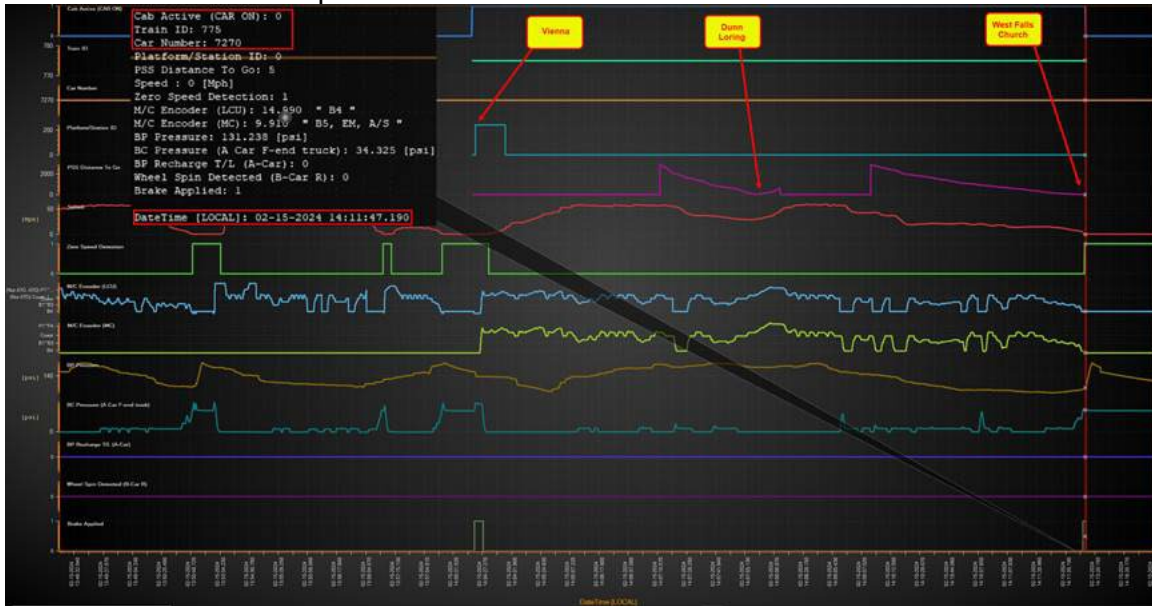
1. At 14:03:37, Train ID 775 (Lead Car 7270) was keyed up at Vienna Station.
2. At 14:03:46.420, the Train detected Platform ID 244.
3. At 14:08:00.580, the Train passed Dunn Loring Station, detecting the without stopping.
4. At 14:11:46.110, the Train approached the 8-car Marker at West Falls Church and came to a Stop.
5. At 14:11:47.190, the Train Keyed Down.

6. Reference the EEM Graphic for Car 7270 below.

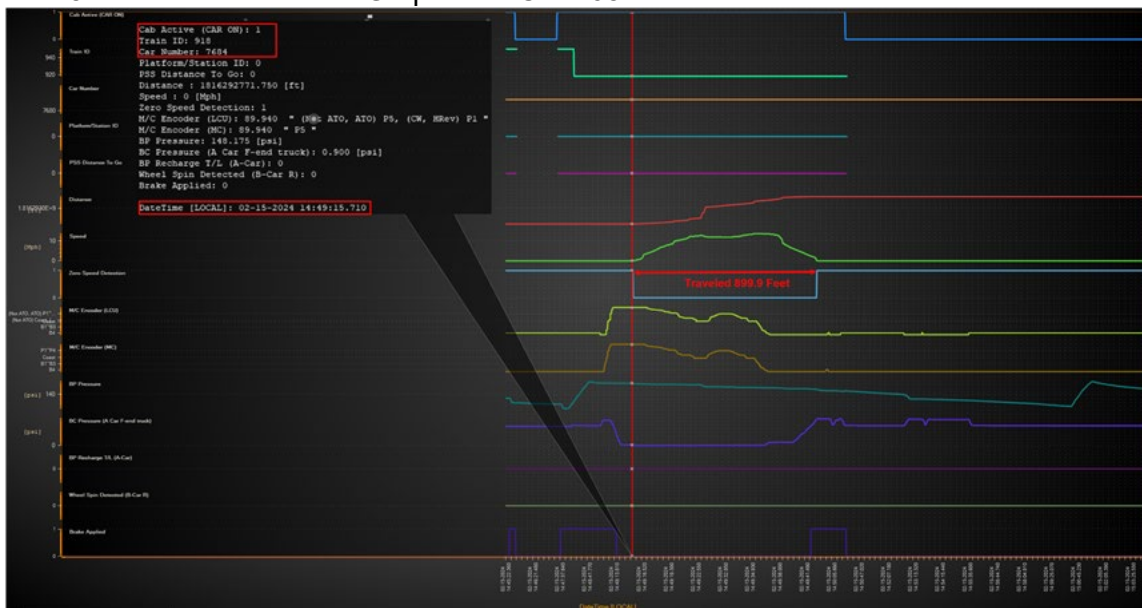
7. At 14:47:32.970, Car 7684 Keyed Up.
8. At 14:48:04.590, the Train ID was changed to 918.
9. At 14:49:13.630, the Master Controller was moved to "P5" power.
10. At 14:49:15.810, Train Zero Speed went to Zero; the train began to move.
11. Reference the MP4 Video Combined Forward and Console Cameras from Car 7684.
12. Signal K06-34 was RED when the train began to move.
13. At 14:49:43.550, the train stopped after moving 899.9 Feet.
14. At 14:50:16.20, the train keyed down.
15. Reference the EEM Graphic for Car 7684 below.

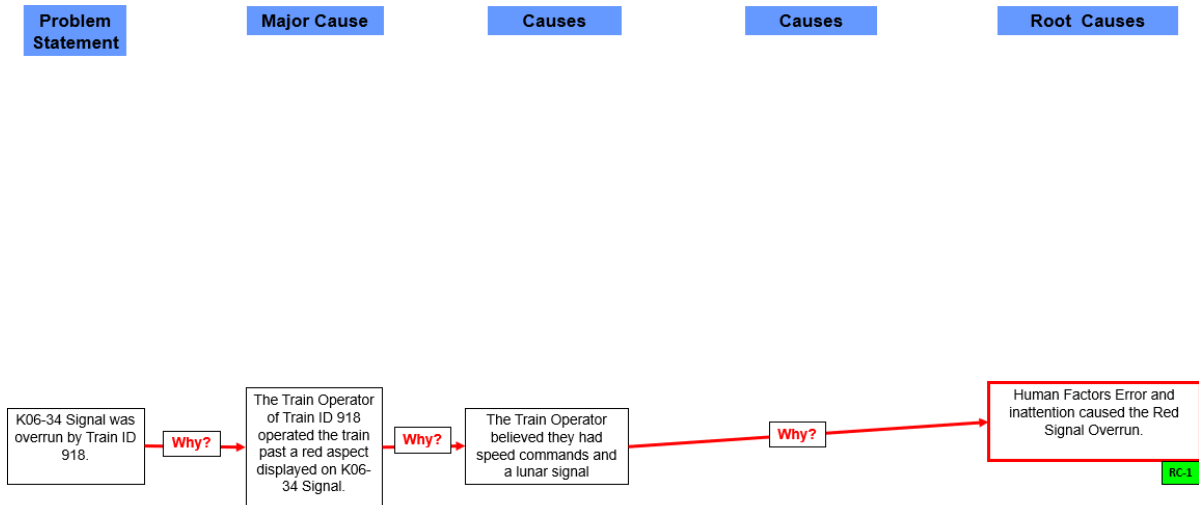
Appendix D – Why-Tree

Root Cause Analysis
