Improper Roadway Worker Protection

At or Near Smithsonian, Spring Hill, Rhode Island Ave-Brentwood, College Park-UMD and Glenmont stations

March 14, 2023 – January 26, 2024 – February 27, 2024 – July 4, 2023 – January 18, 2024

Smithsonian Station – Improper Rail Vehicle Movement

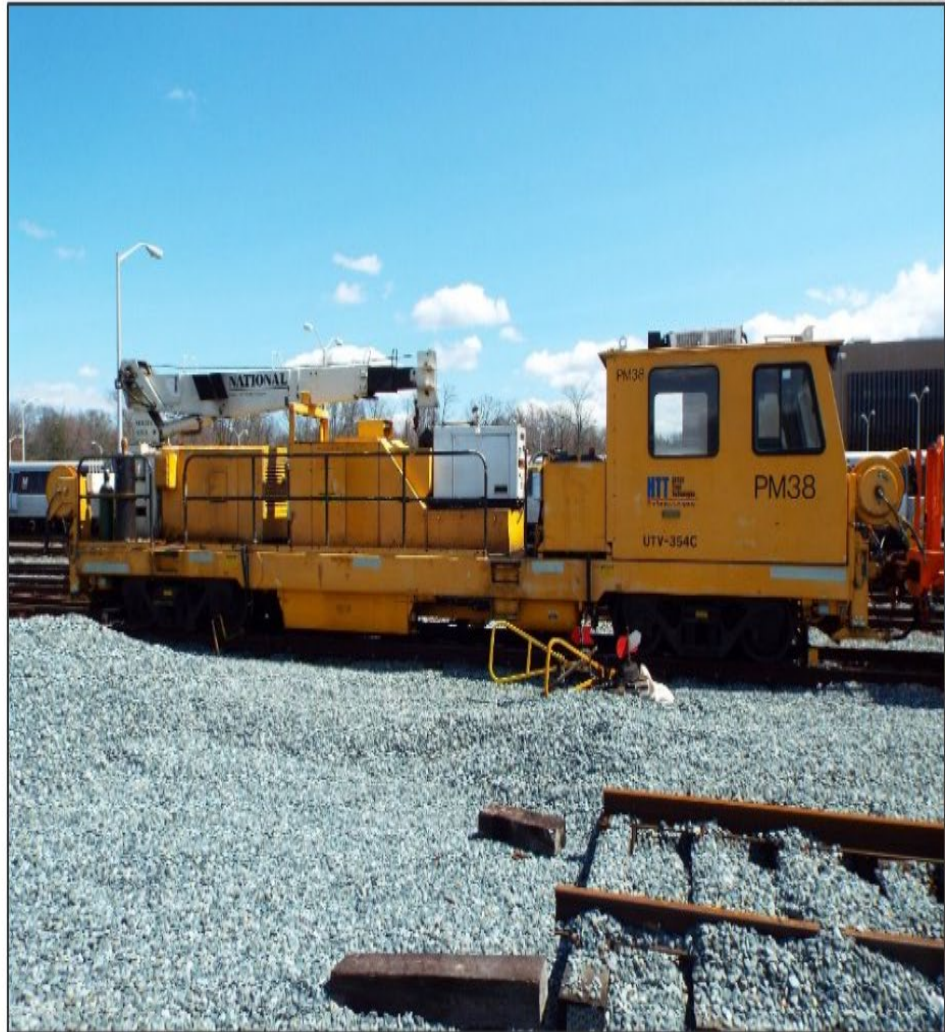
PM 38 Harsco Prime Mover

The Crew Leader was assigned to replace a frog at the Smithsonian interlocking. Once the work was complete, the Crew Leader directed the Equipment Operator to push the PM back 100 feet to the next switch.

Soon after, they realized they had hit a WSAD installed on the roadway. The Crew Leader indicated they were needed to brief on the device being deployed or any other WMATA employees working on track 2 in that work zone. The Crew Leader identified the lack of communication as a leading cause of the event.

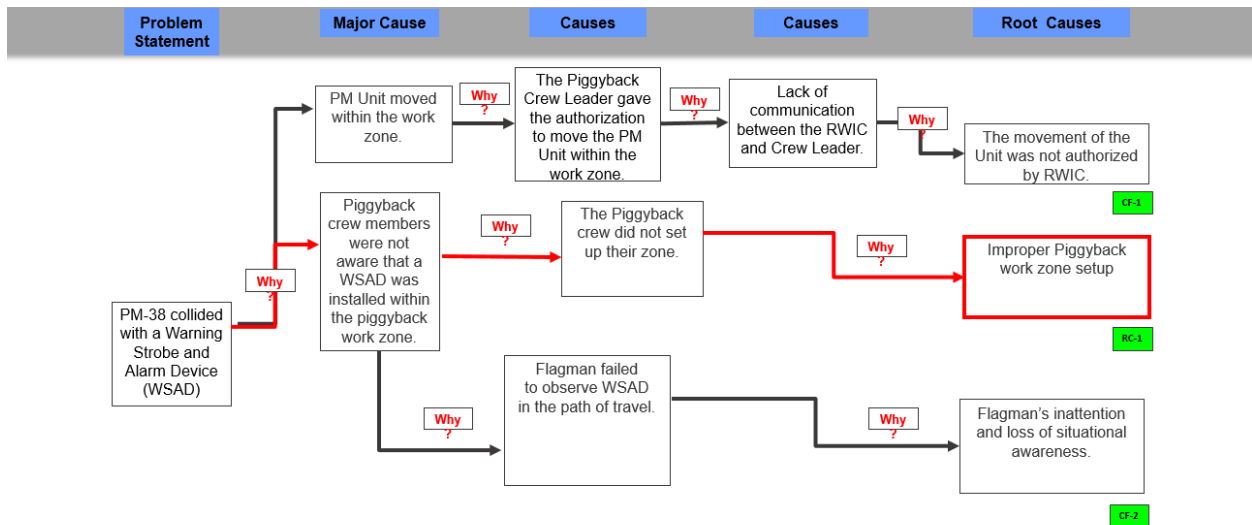
Appendix E – Root Cause Analysis

The probable cause of the Improper Rail Vehicle Movement event on March 14, 2023, was a failure to follow established Roadway Worker Protection rules, including piggyback work zone setup and rail vehicle movement within a work zone. Contributing Factors to the event include a failure to adequately perform Flagman's duties.

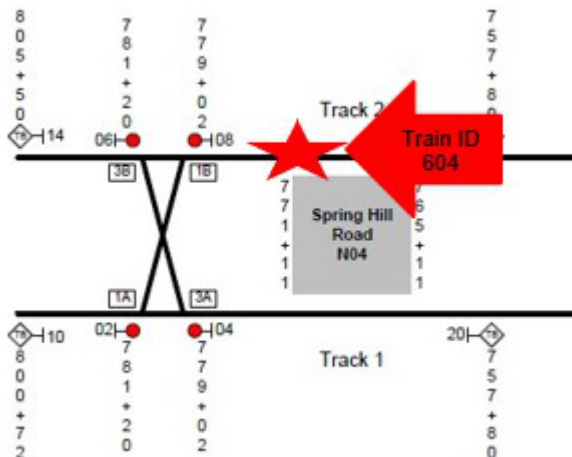
Field Sketch/Schematics

Spring Hill Station, track 2 – CM N2 1056+00

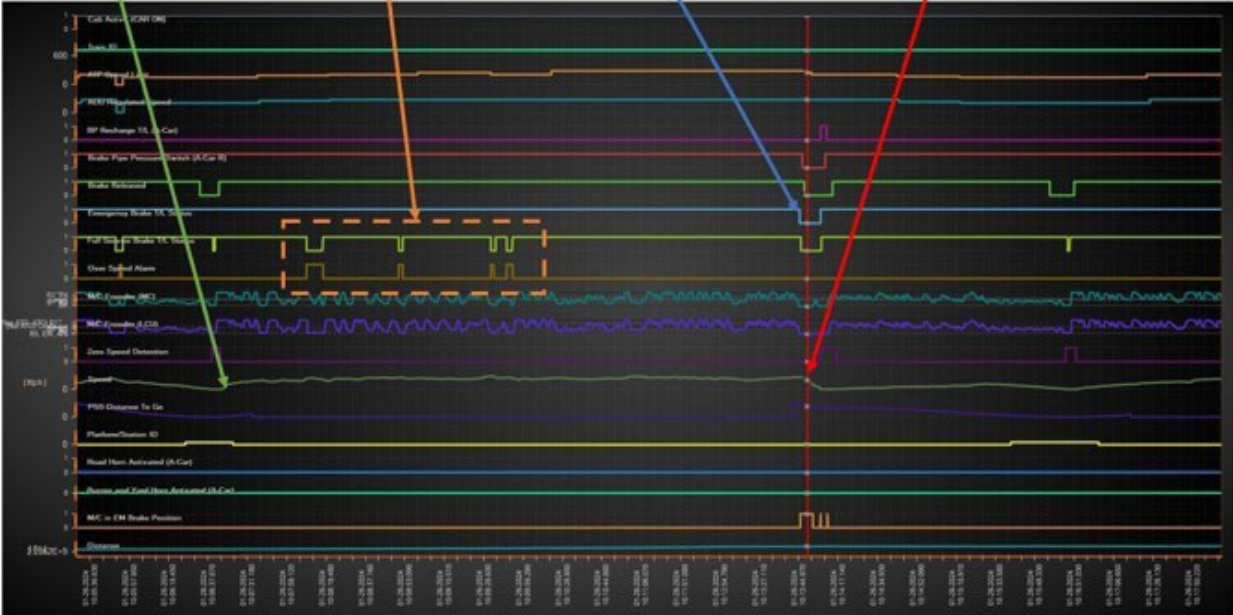
10:13:45
Master Controller moved to EMER, initiating emergency Braking.

10:13:49
Train passes Wayside workers with emergency Braking applied. 1,724 ft. before Wiehle-Reston

TRST determined that the RWIC and AMF would receive discipline in accordance with the Disciplinary Administration Program. The AMF received refresher training on the AMF procedures.

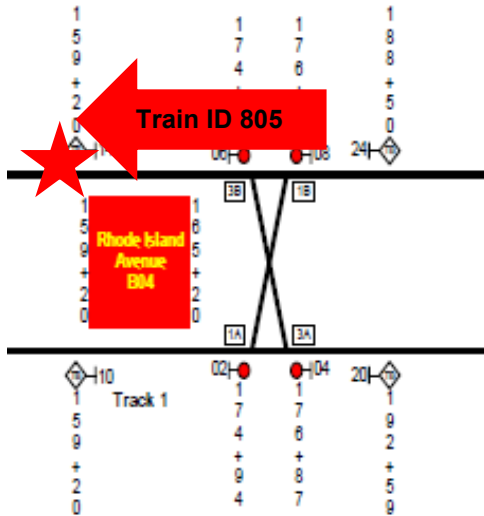
Field Sketch/Schematics

Rhode Island Station is an outdoor aerial station with a center platform and direct fixation tracks. There is an interlocking on the outbound end of the station.

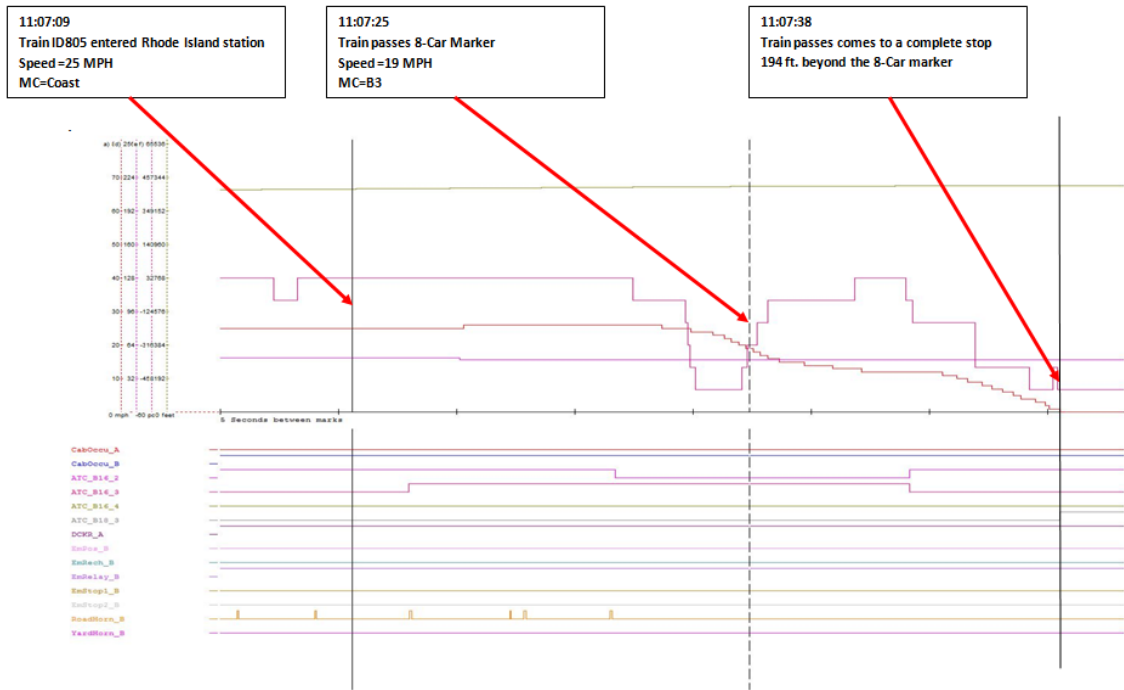
11:07:34.972	Master Controller placed in B4 Braking position, train speed was 9 MPH, 17 feet beyond the 8-Car Marker.
11:07:38.551	Master Controller was placed on B5 as the Train came to a complete stop 194 feet beyond the 8-Car marker.

11:12:36.184	The Master Controller moved to the P2 Power position, and the train began to move.
11:12:40.116	The Road Horn sounded 2 times, 6 feet after moving from stop.

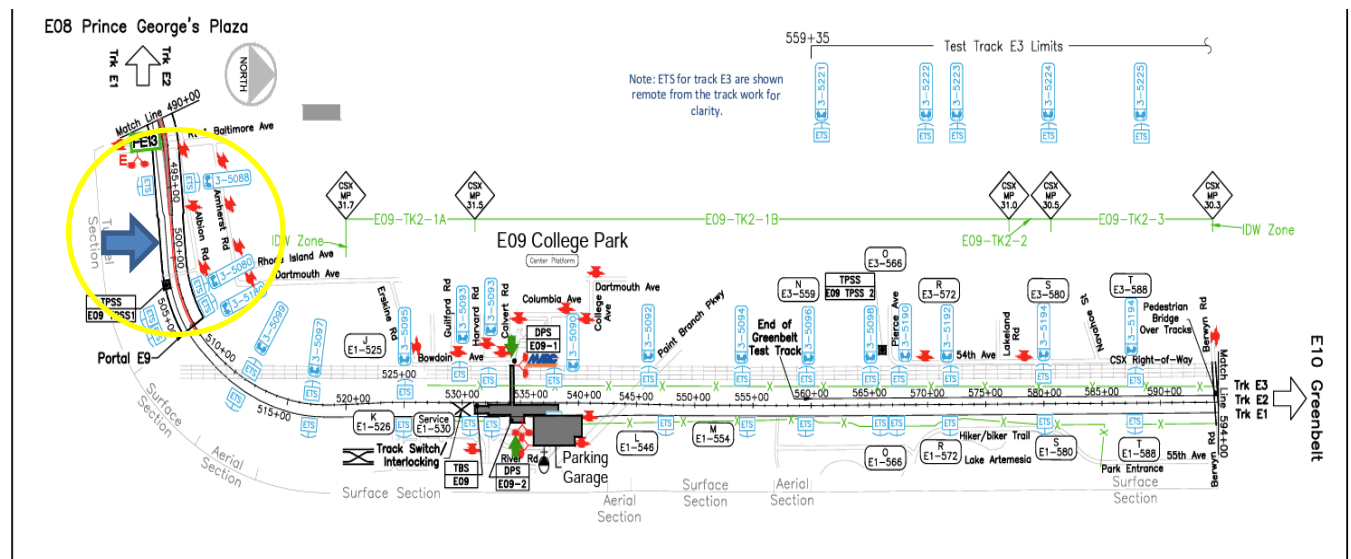
Field Sketch/Schematics

College Park Station Chain Marker E1 500+00

Figure 1 - Map of area with event location circled in yellow

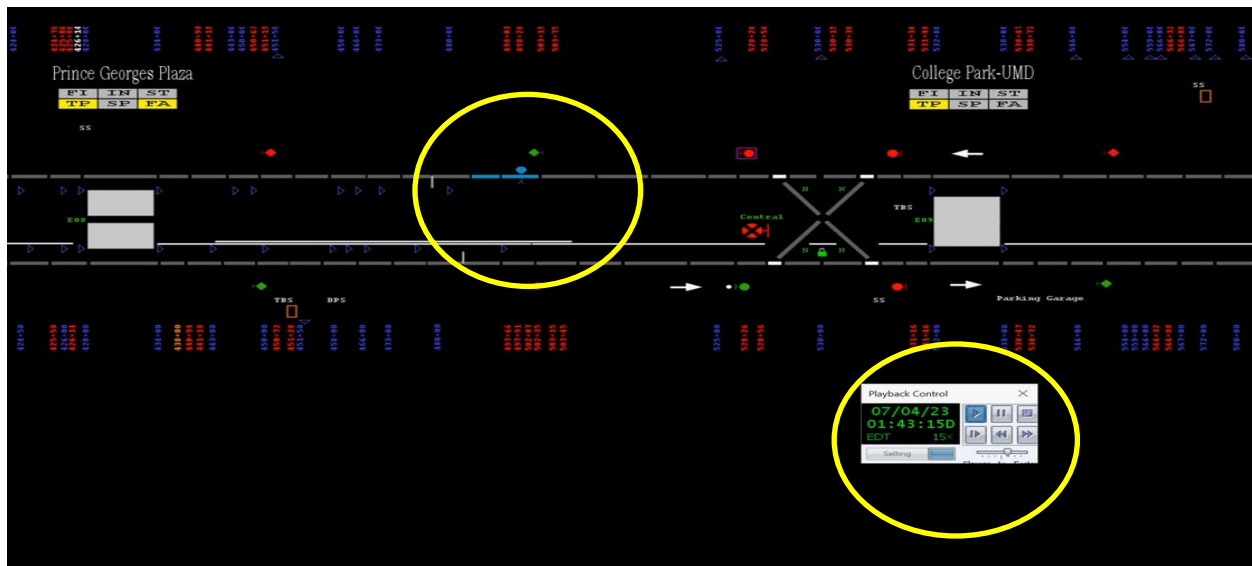
Figure 2 AIMS - Foul time Track #2 CM 491+00-493+00

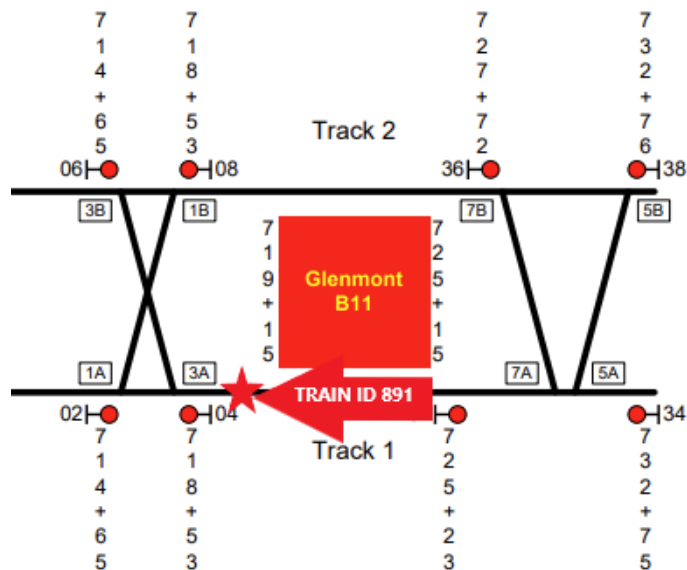
Field Sketch/Schematics

Glenmont Station, track 1

Incident site notated by a red "star." Not to scale.

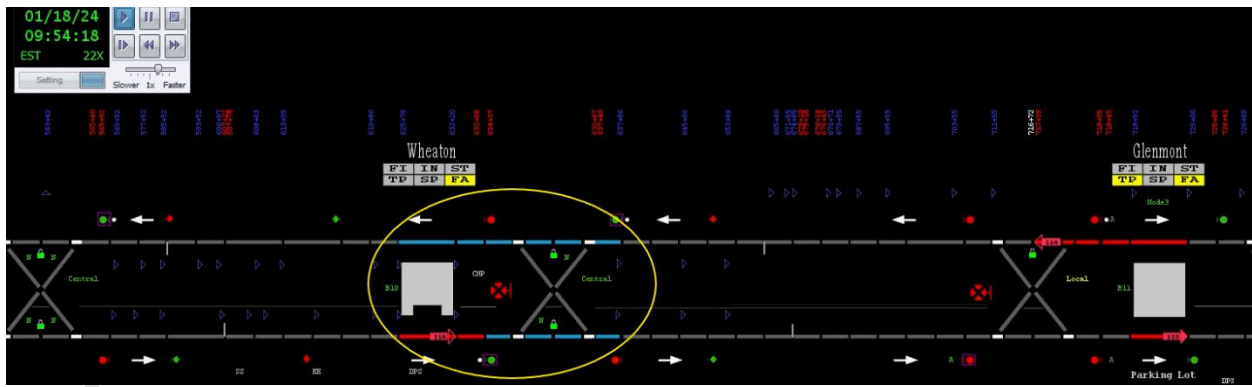
Figure 1 – A work zone is set up on both tracks of Wheaton Station at 09:54 hours.
