Improper Door Operation

Columbia Heights, Federal Center SW, and Rhode Island Ave-Brentwood stations

November 28, 2023 – January 11, 2024 – February 17, 2024

Columbia Heights Station – Improper Door Operation

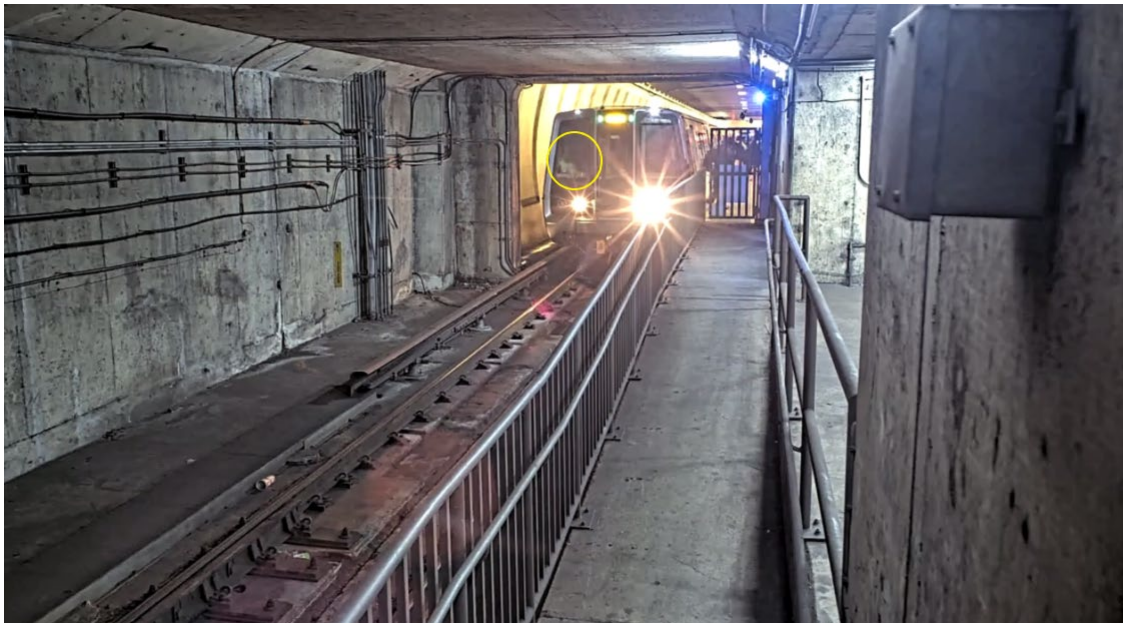
Image 1 - Train ID 515 arrived at Columbia Heights Station Track 1 at approximately 20:38 hours, and the platform side doors were activated to service the station.

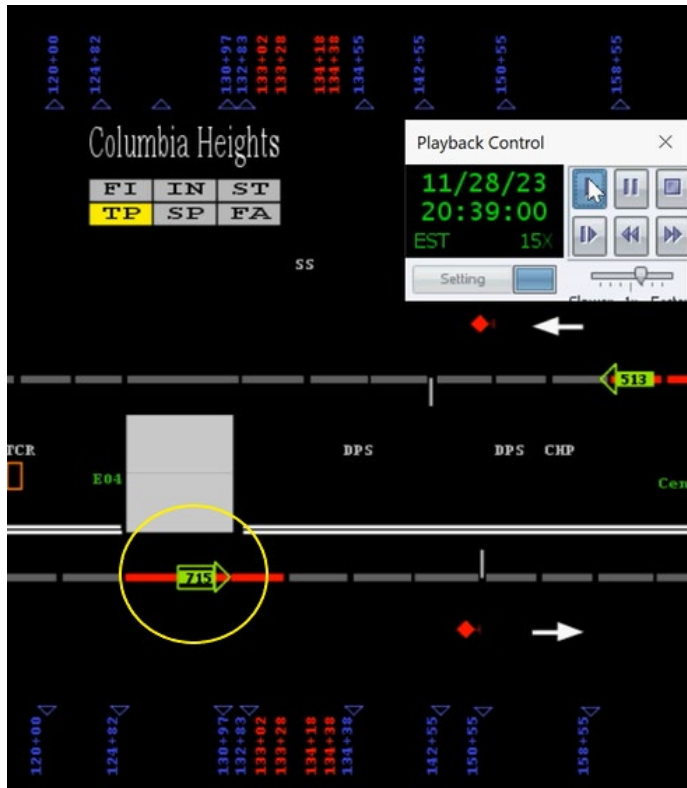
Figure 1 – AIMS depicting Train ID 515 located at Columbia Heights Station at 20:39 hours.

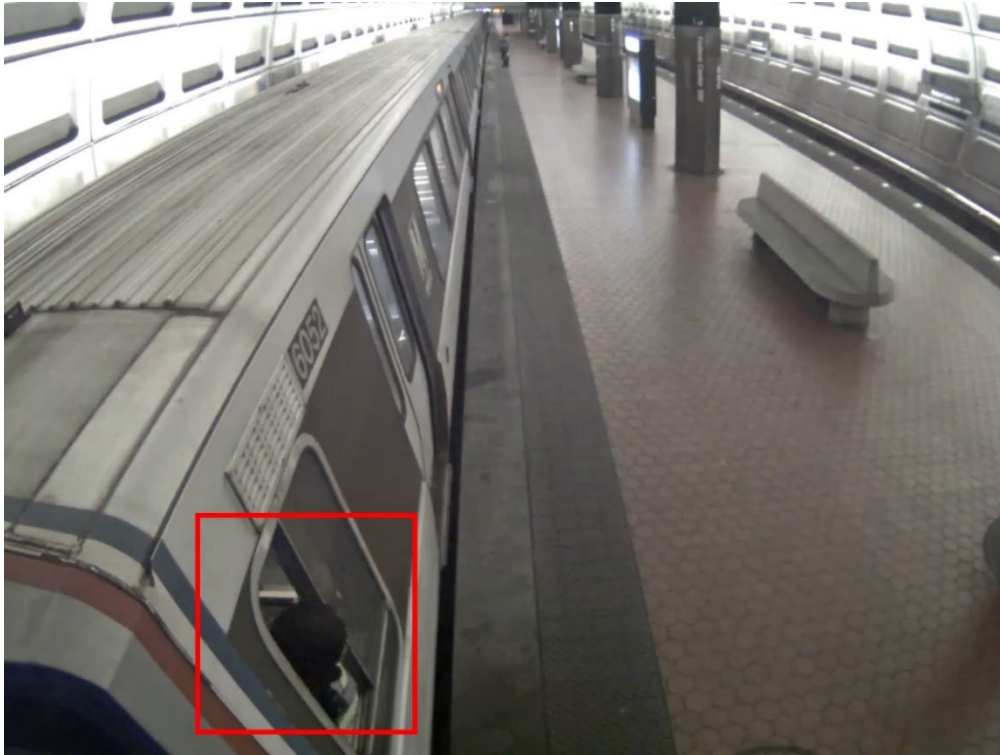
Image 3 - At 23:26:12 hours, the Train Operator of Train ID 411 opened the left-side cab window and looked down the left side (platform side) of the train.

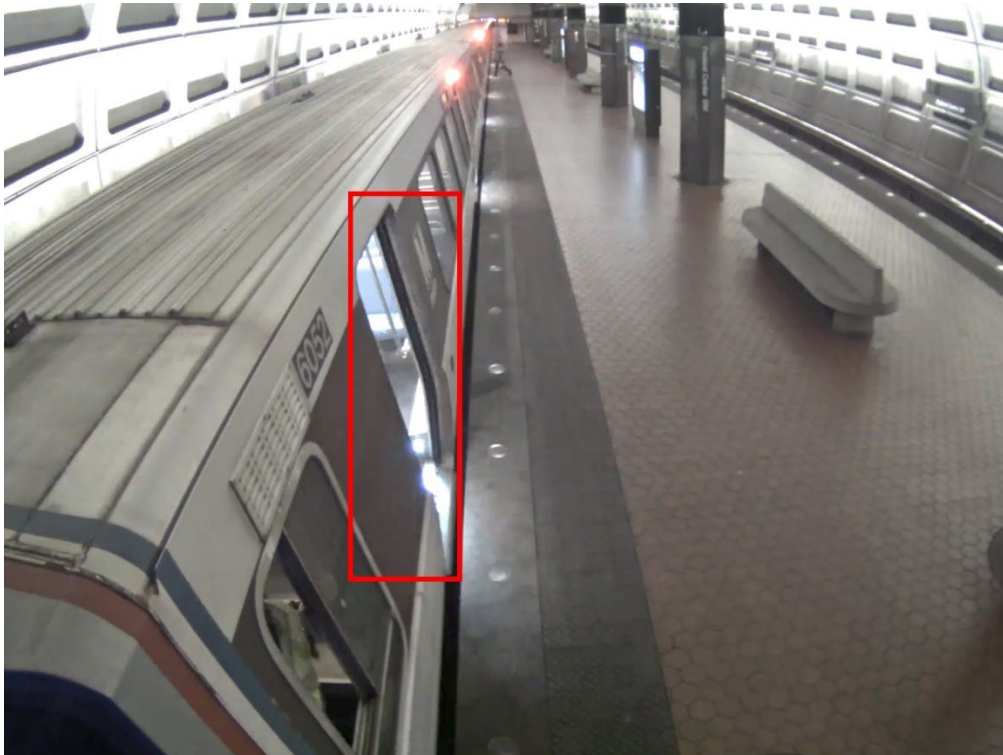
Image 4 - The platform side doors are opened at 23:26:13 hours.

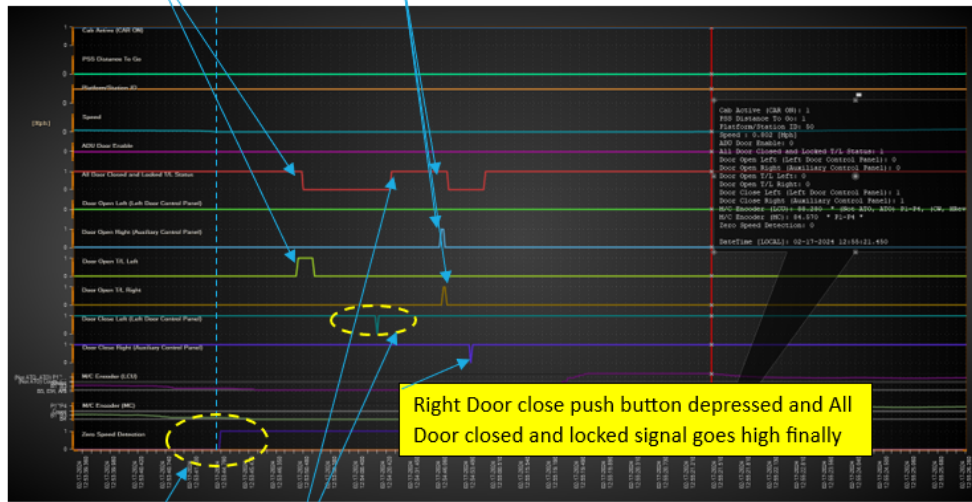
02/17/24 12:53:50.18 Left Door open Train line command goes high, ALL Door closed and locked signal goes low indicating Door opened left side

02/17/24 12:54:46.06 Right Door open push button depressed, Right Door open Train line command goes high, All Door closed and locked signal goes low indication Door also opened on the Right as seen in the NVR Video

02/17/24 12:53:45.49 lead Car 7094 came to a complete stop on Track-2 at Rhode Island Ave (B04)

02/17/24 12:54:18.12 Left Door close push button is depressed and ALL Door closed and locked signal goes high indicating Door closed Left hand side. the correct side of Platform

Figure 3: Lead Car 7094 ER Analysis Graph #1 of this Incident.
