Evacuation for Life Safety Reasons

Farragut West, Dupont Circle and Stadium-Armory stations

October 14, 2023 – December 18, 2023 – February 19, 2024

FINAL REPORT OF INVESTIGATION A&I E23717

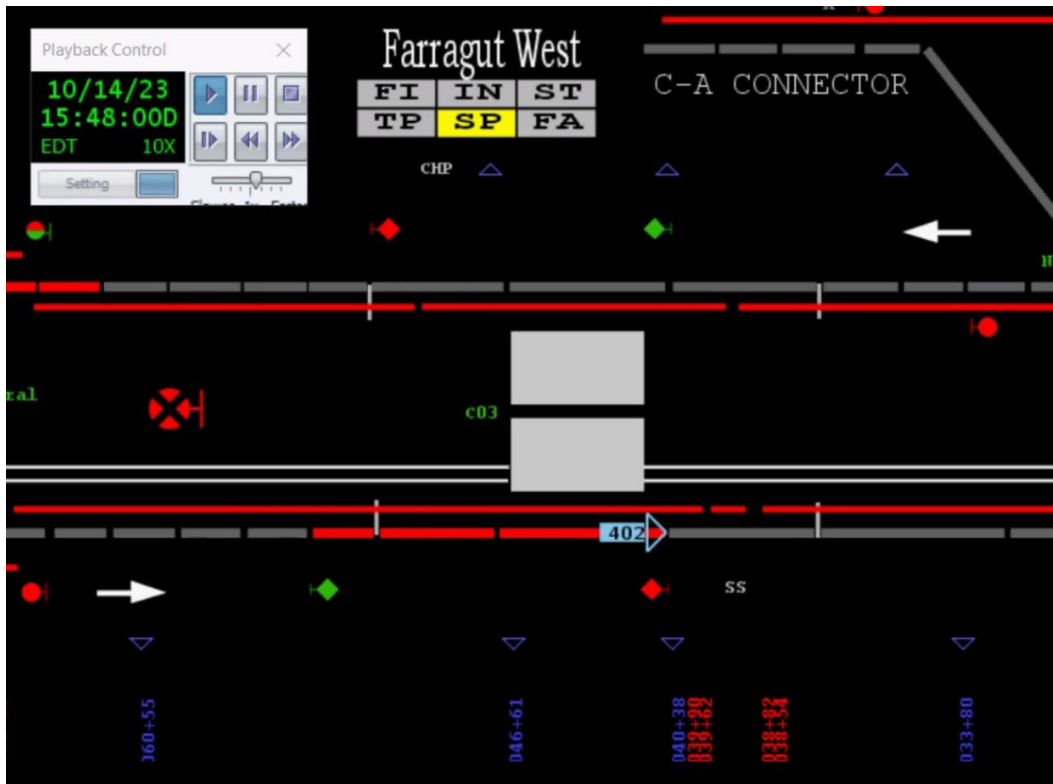
Figure 1 – Train 402 arriving at Farragut West Station, Track 1 at 15:48 hours.

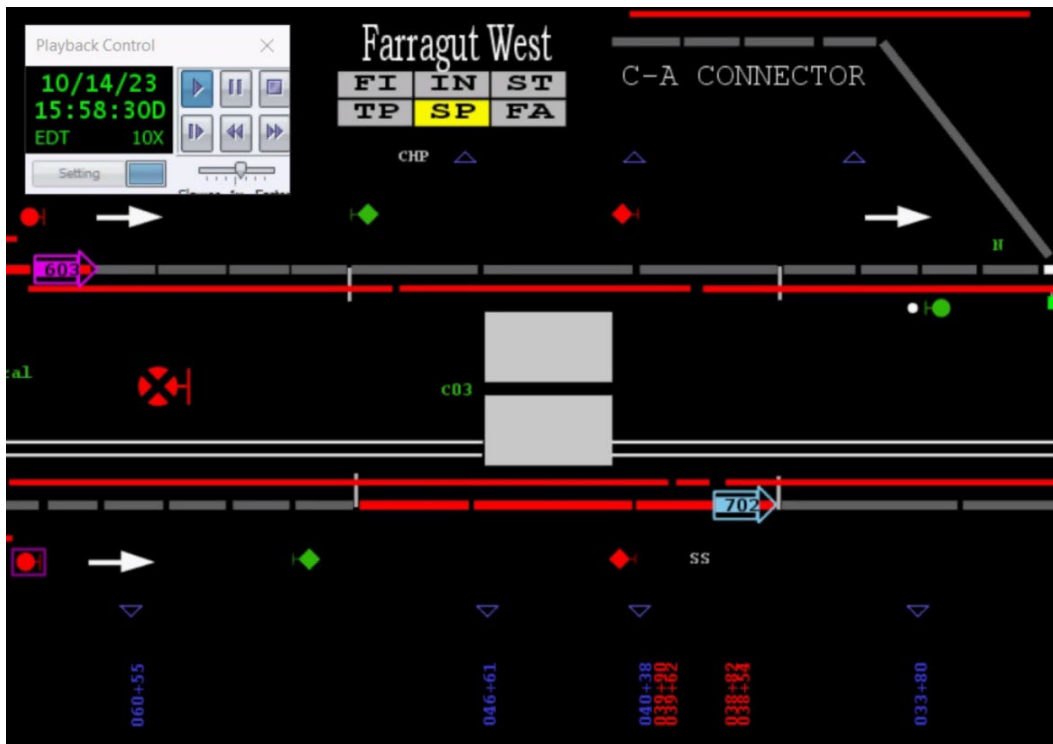
Figure 2 – Train ID 402 changed their identification marker to Train 702 at 15:58 hours.

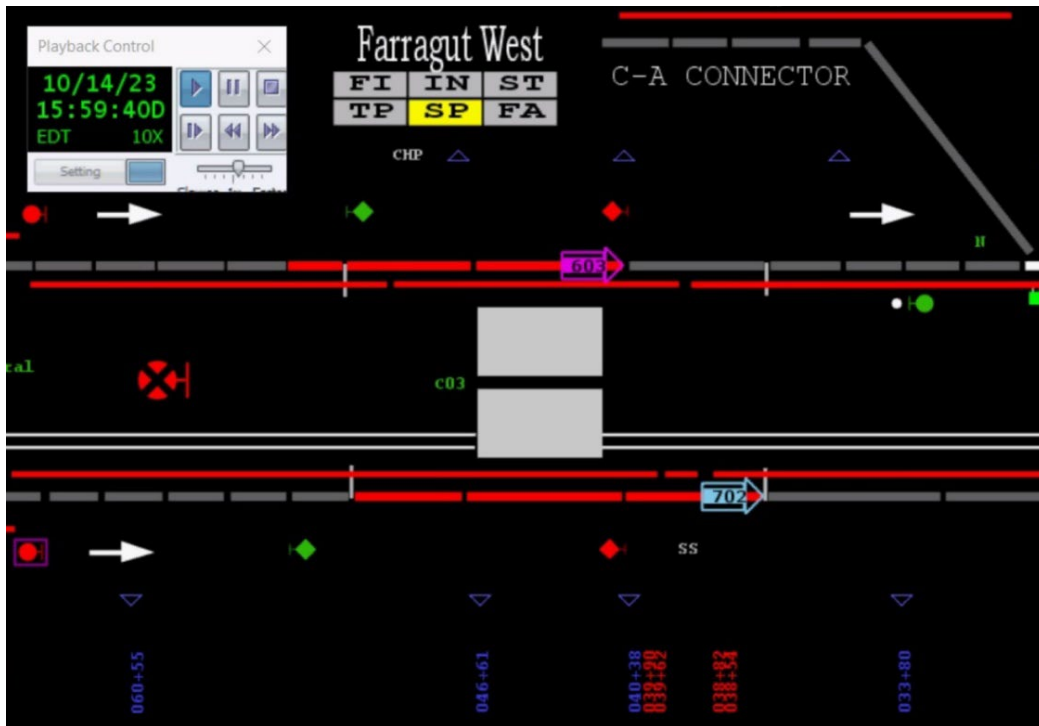
Figure 3 – Train ID 603 single tracking around incident Train ID 702 and servicing Farragut West Station on Track 2 in the direction of New Carrollton at 15:59 hours.

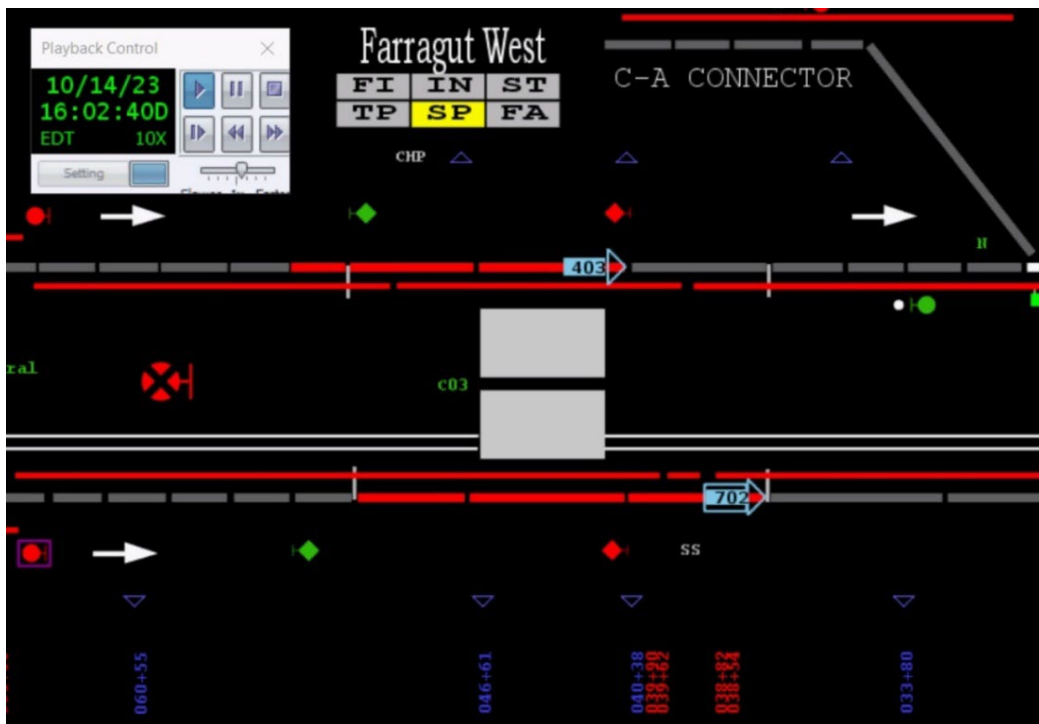
Figure 4 – Train ID 403 single tracking around incident Train ID 702 and servicing Farragut West Station on Track 2 in the direction of New Carrollton at 16:02 hours.

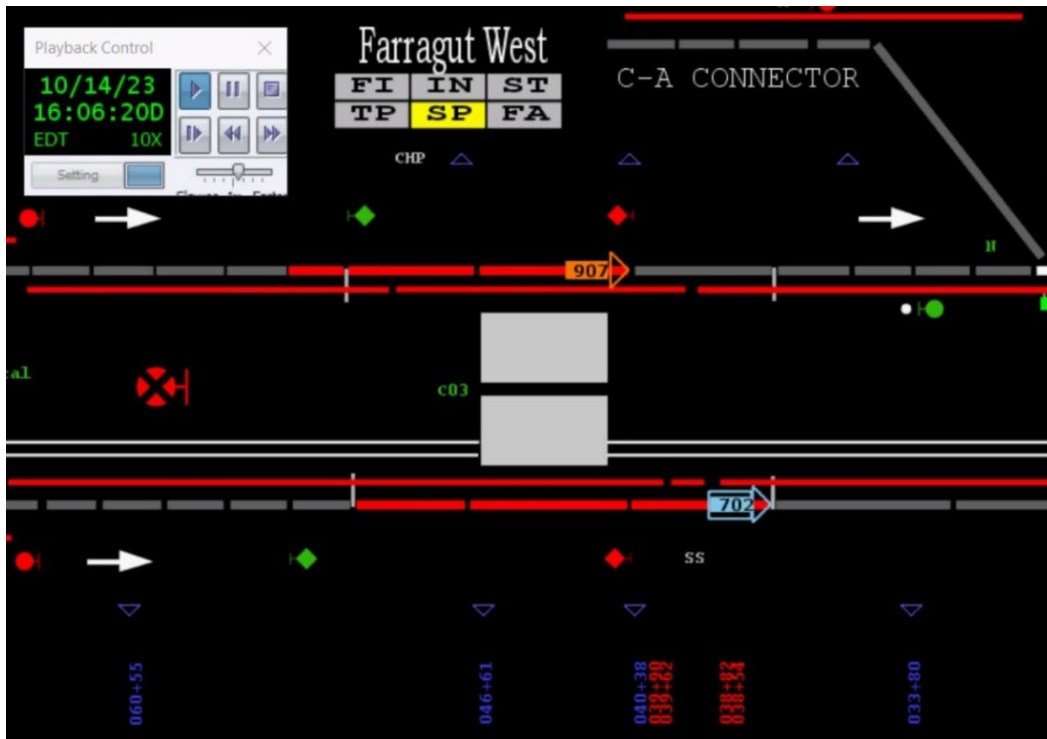
Figure 5 – Train ID 907 single tracking around incident Train ID 702 and servicing Farragut West Station on Track 2 in the direction of New Carrollton at 16:06 hours.

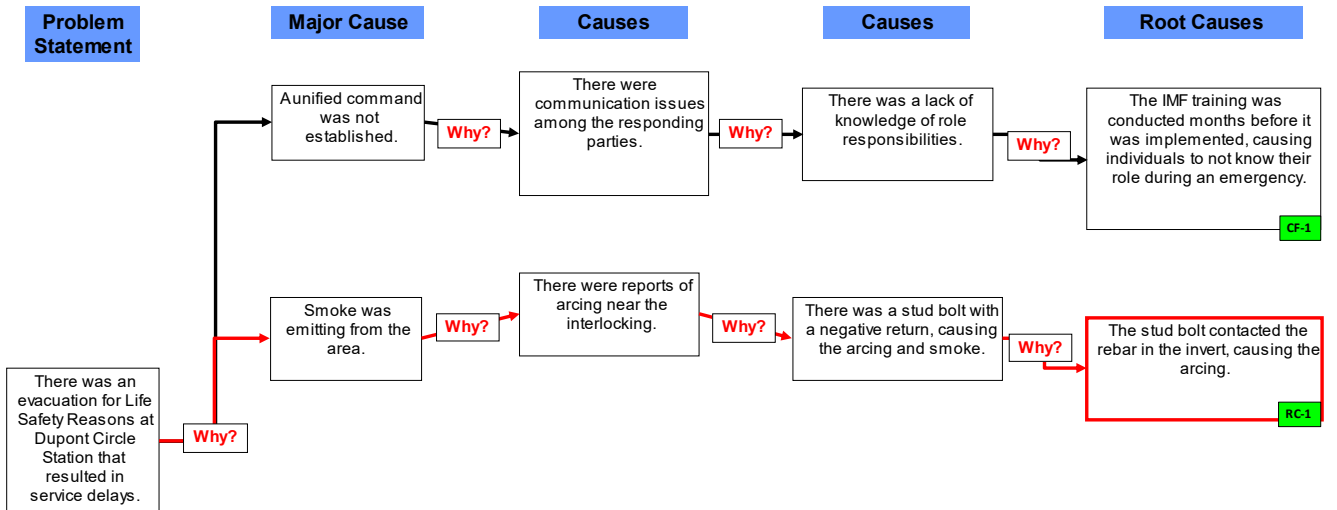
Appendix B – Why-Tree Analysis

The probable cause for the Evacuation for Life Safety Reasons at Dupont Circle Station on December 18, 2023, was equipment failure. A stud bolt with a negative return was causing the arcing and smoke in the station due to making contact with the rebar in the invert.
