**Red Signal Overruns**  
**At or Near Brentwood Rail Yard and Anacostia Station**  
**April 11, 2024 – April 19, 2024**

Washington Metropolitan Area Transit Authority  
Department of Safety  
Office of Safety Investigations  
**FINAL REPORT OF INVESTIGATION A&I E24287**

**B99-06 Signal, CM B1 114 + 60 – Red Signal Overrun**

<b>Date of Event:</b>	April 19, 2024
<b>Type of Event:</b>	O-8: Red Signal Overrun
<b>Incident Time:</b>	22:05 hours
<b>Location:</b>	Anacostia Station, track 2 - Signal F06-08
<b>Time and How received by SAFE:</b>	22:11 hours, Mission Assurance Coordinator (MAC)
<b>WMSC Notification Time:</b>	22:49 hours
<b>Responding Safety Officers:</b>	WMATA: Office of Safety Investigations (OSI) WMSC: Other:
<b>Rail Vehicle:</b>	Train ID 528 (L7678-7679x7511-7510x7386-7387x7519-7518T)
<b>Injuries:</b>	None
<b>Damage:</b>	None
<b>Emergency Responders:</b>	None
<b>SMS I/A Number</b>	20240420#116295MX

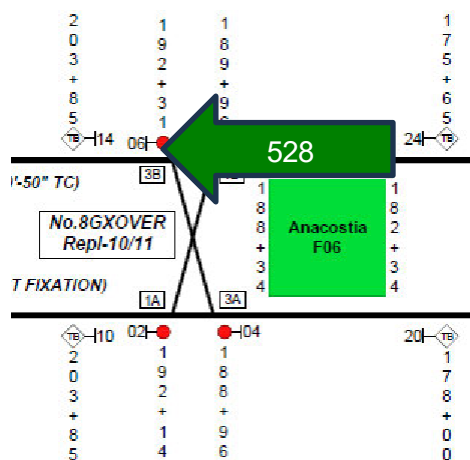
Anacostia Station, track 2 – Signal F06-08

The train passes signal F06-08 red at a speed of 12.9 MPH with the Master Controller in “B5” position, coming to a complete stop 48 feet beyond the signal F06-08. The emergency brake was not initiated. There were no faults with the train that contributed to the cause of this incident, the train performed as designed.

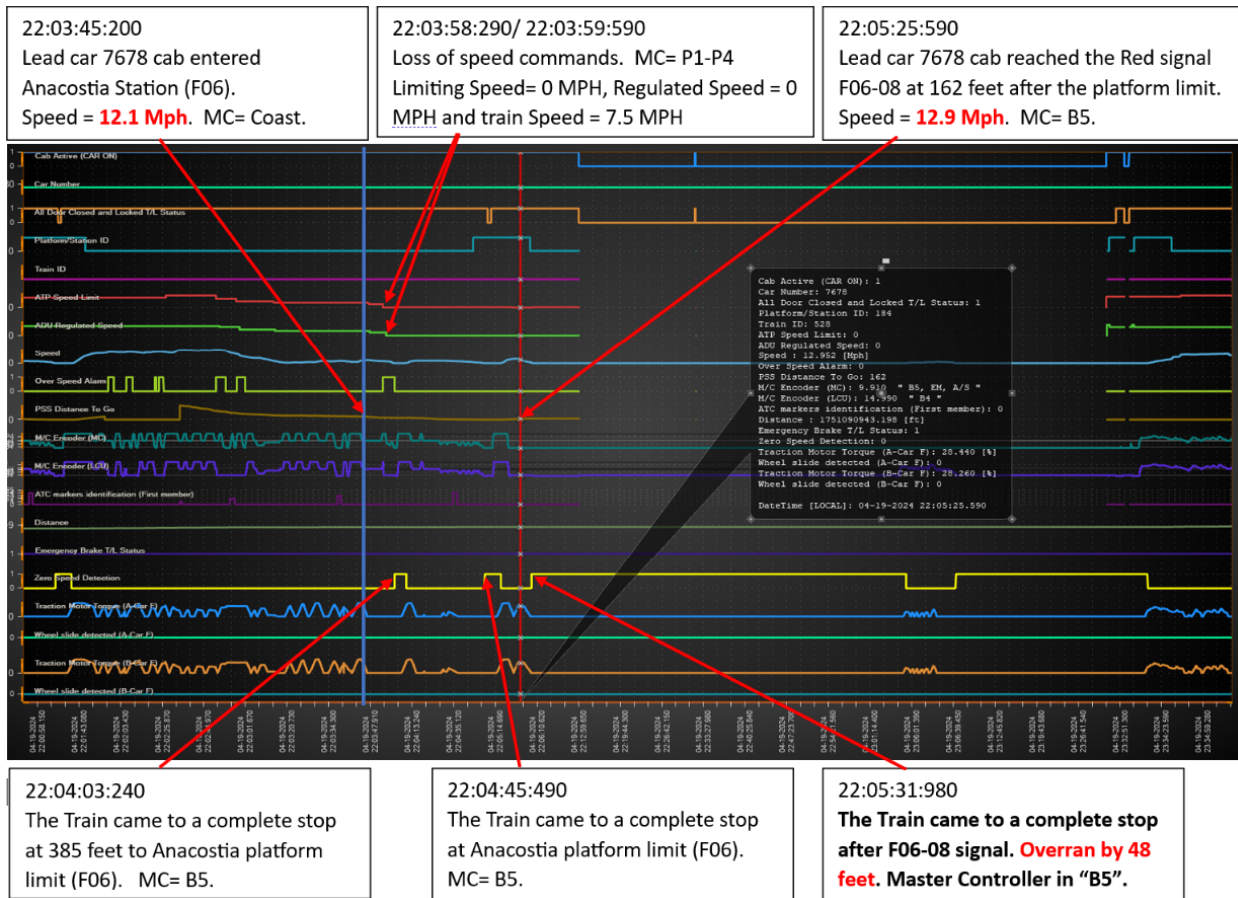
22:05:31:980	<b>The Train came to a complete stop after F06-08 signal. Overran by 48 feet. Master Controller in "B5".</b>	<i>B5</i>	<i>0 MPH</i>	<i>0 MPH</i>	<i>0 MPH</i>	<i>-48 feet.</i>

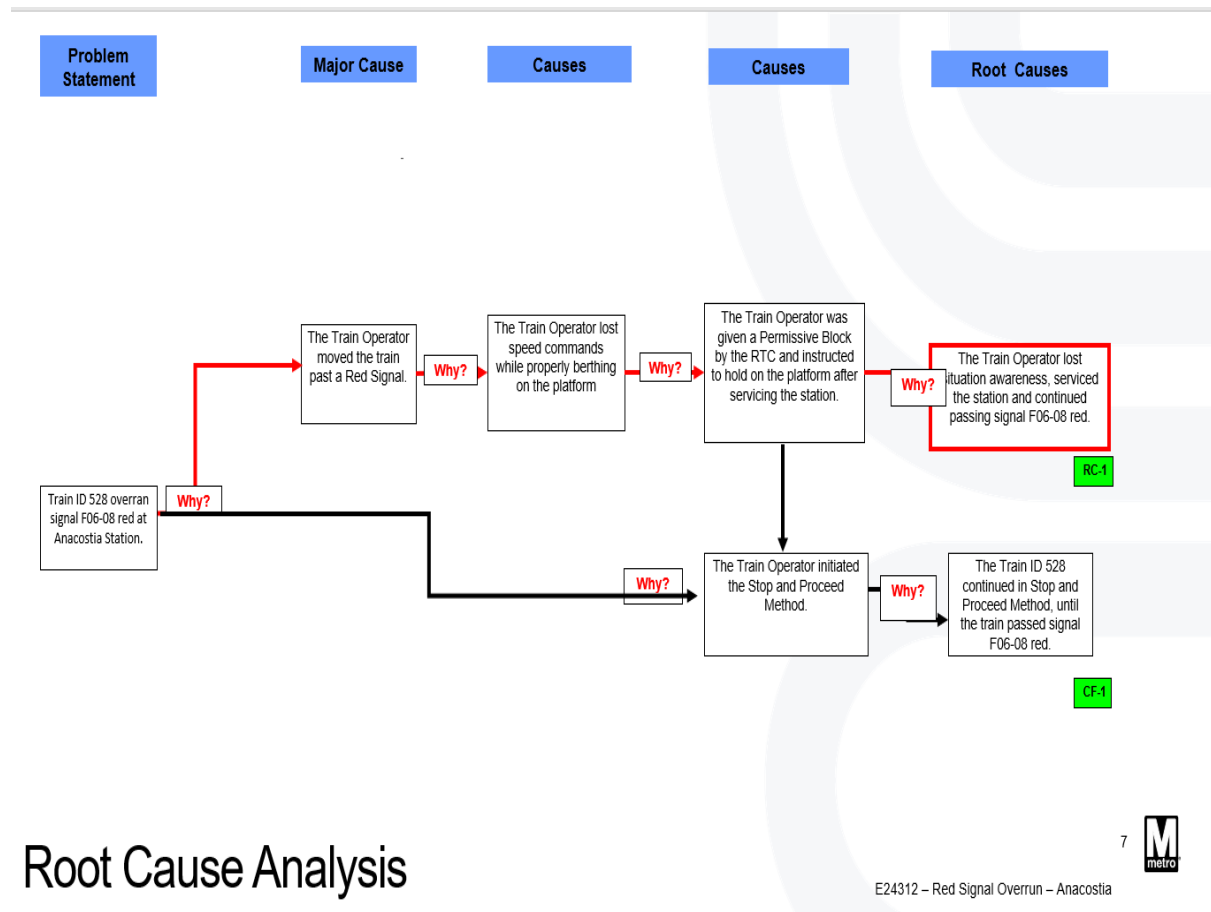
# Appendix X – Why-Tree Analysis

The probable cause of the Red Signal Overrun event on April 19, 2024, at Anacostia Station was the lack of situational awareness by the Train Operator, and the Train Operator's failure to follow the instructions given by the Radio RTC. A contributing factor was the Stop and Proceed method was still active, which allowed the train to move with speed commands displayed on the console; this inadequate safeguard is a contributing factor to this incident occurring.
