W-0353 – Derailment – near Stadium-Armory Station – December 16, 2023

FINAL REPORT OF INVESTIGATION A&I E23892

Stadium-Armory Station - Derailment

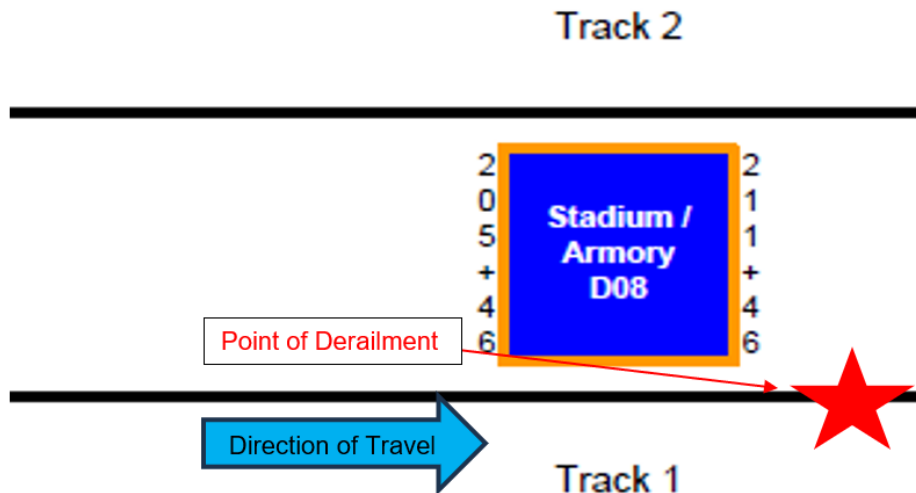
Field Sketch/Schematics

Stadium-Armory Station (D08) CM D1 215+00, in the area of the entrance to Stadium-Armory Station within an area that was shut down for Scheduled Track Maintenance.

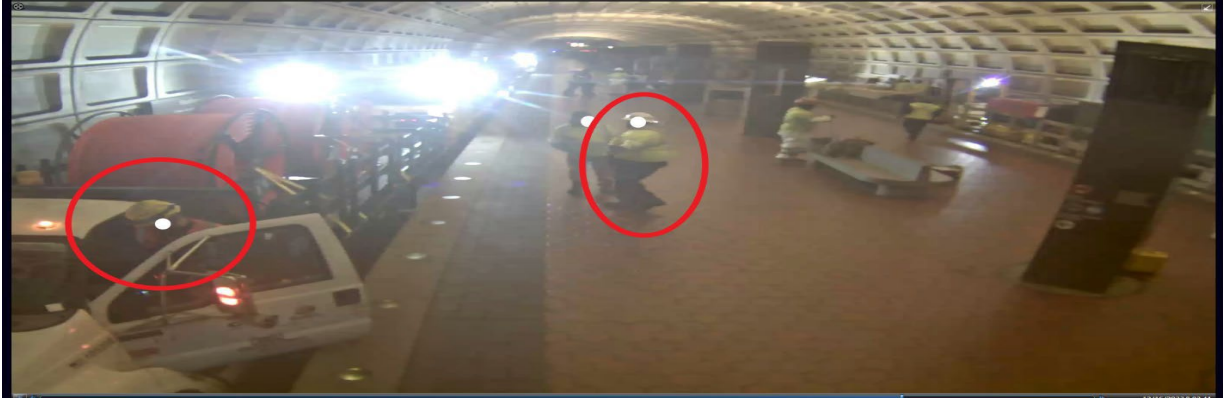
Image 2 - The Equipment Operator entering the cab and the Pilot located on the platform at Stadium-Armory Station, track 1, at 08:03:44 hours.
