W-0344 – Evacuation for Life Safety Reasons at Eastern Market Station – February 15, 2024

Document Purpose

Safety event summary:

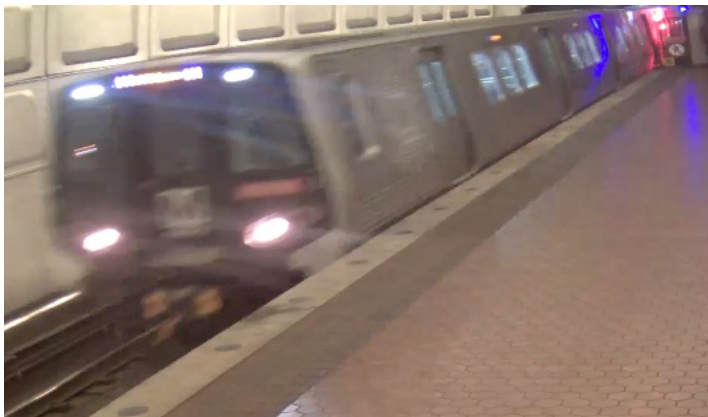
Image 1 – Image of Train ID 638 entering Eastern Market Station on track 2 at 12:49 hours.

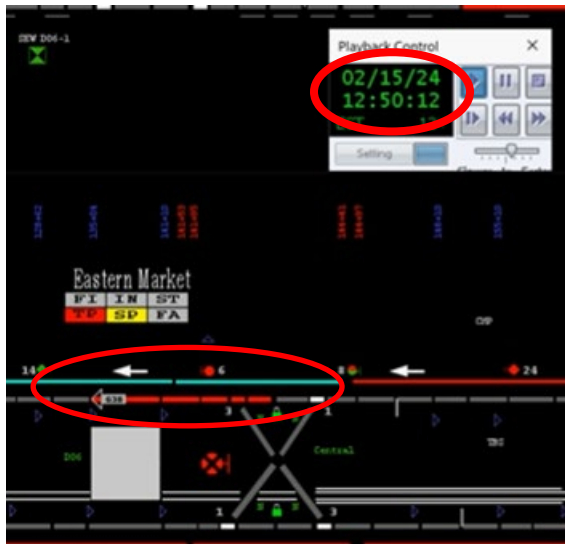
Figure 1 - Shows as Train ID 638 entered Eastern Market platform limits, third rail power dropped uncommanded.

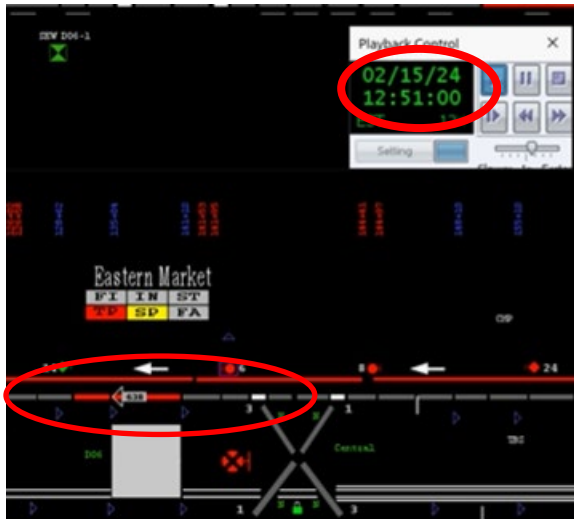
Figure 2 - Shows seconds later, third rail power was re-energized at Eastern Market Station track 2.

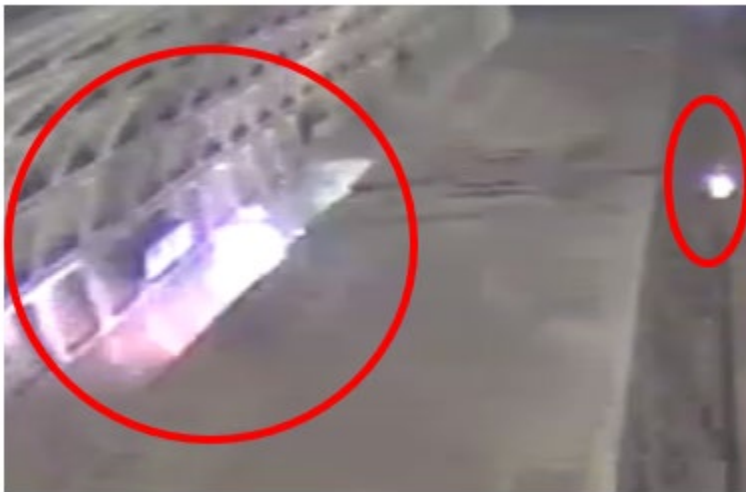
Image 3 – Image of an explosion that occurred, causing smoke at 12:50 hours.

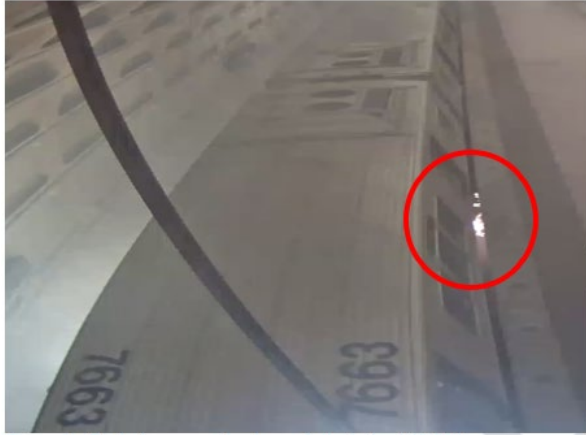
Image 4 – Image of an explosion occurring beneath the train at 12:50 hours.

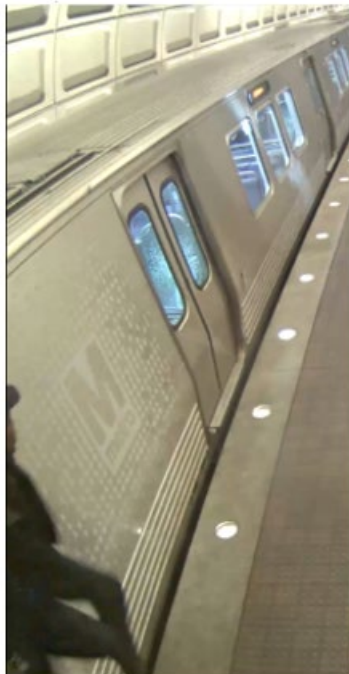
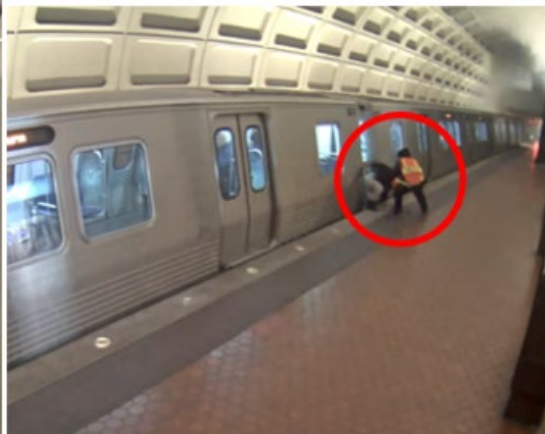
Image 5 - Images of the Train Operator evacuating through the Operator's cab window and a Security Guard assisting a customer evacuate between two railcars.

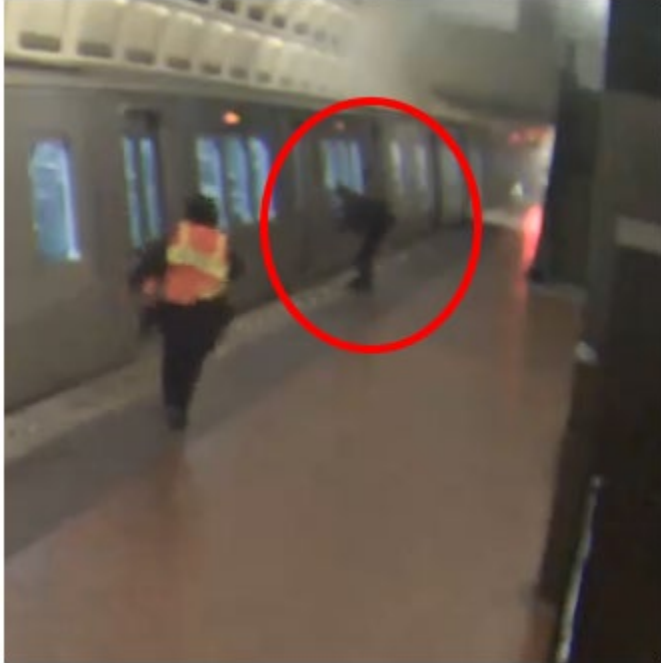
Image 6 - Image of the Train Operator manually keying the door open.

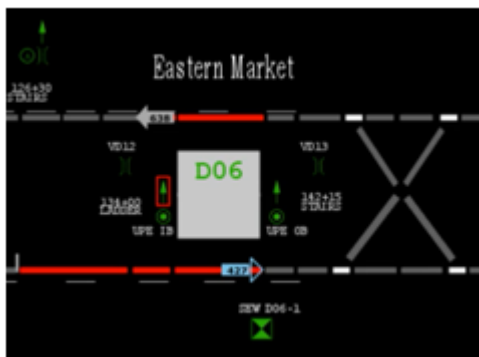
Figure 3 - UPE Inbound to the left of the station, and UPE Outbound to the right of the station set to exhaust at 12:54 hours.

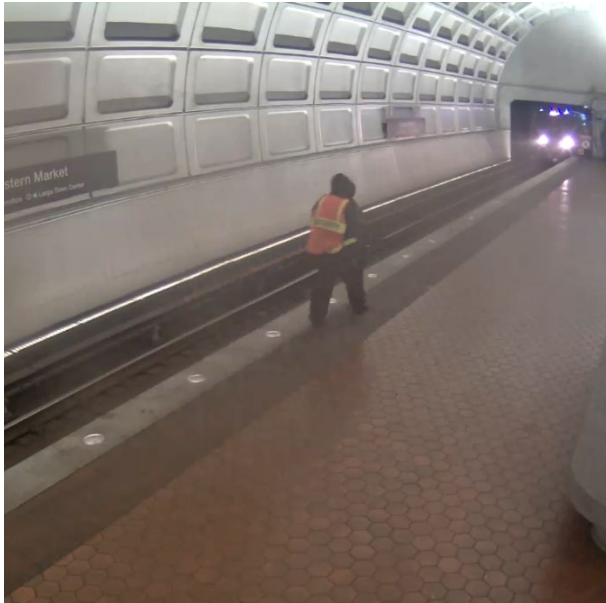
Figure 4 - Image of an Allied Security Guard walking towards Train ID 427.

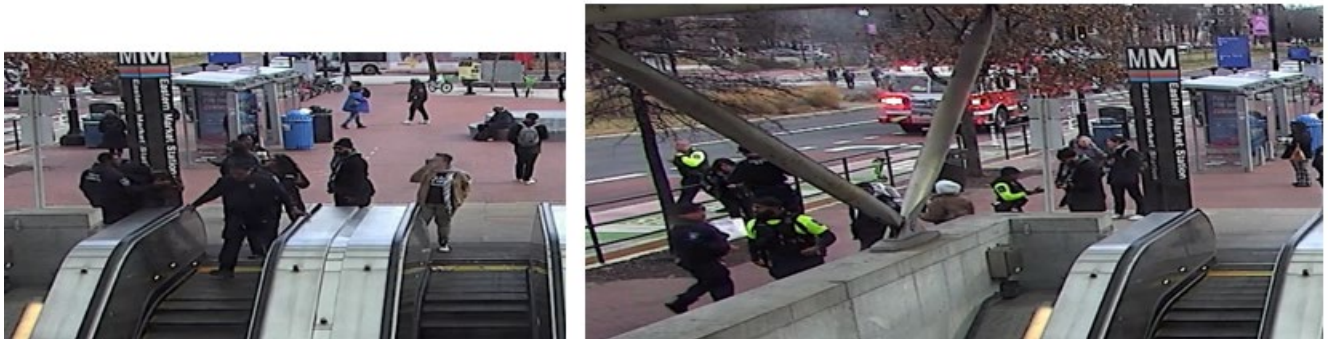
Image 7 – Image of MTPD arriving at Eastern Market Station and heading to the platform at 12:54 hours.

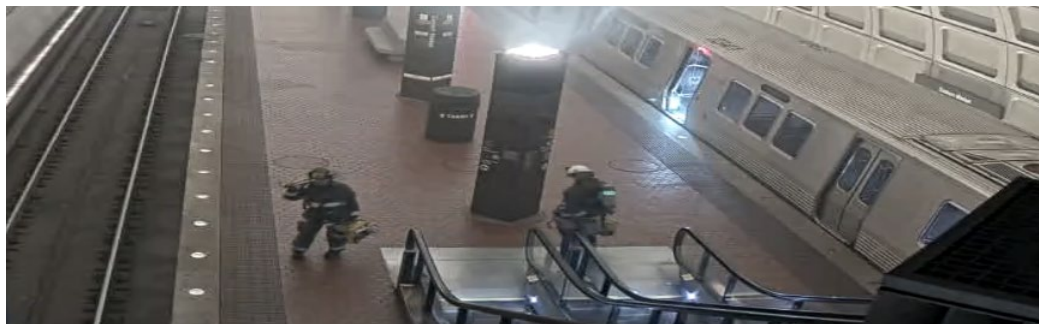
Image 8 – Image of DCFEMS on the platform at 12:59 hours.

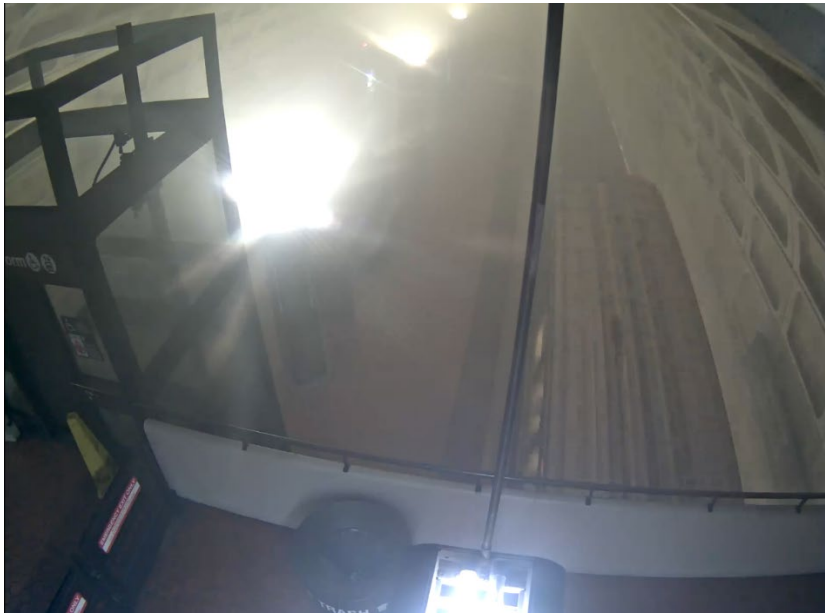
Image 9 - 6 Image of Train ID 427 entering Eastern Market Station at 12:59 hours with moderate smoke present.

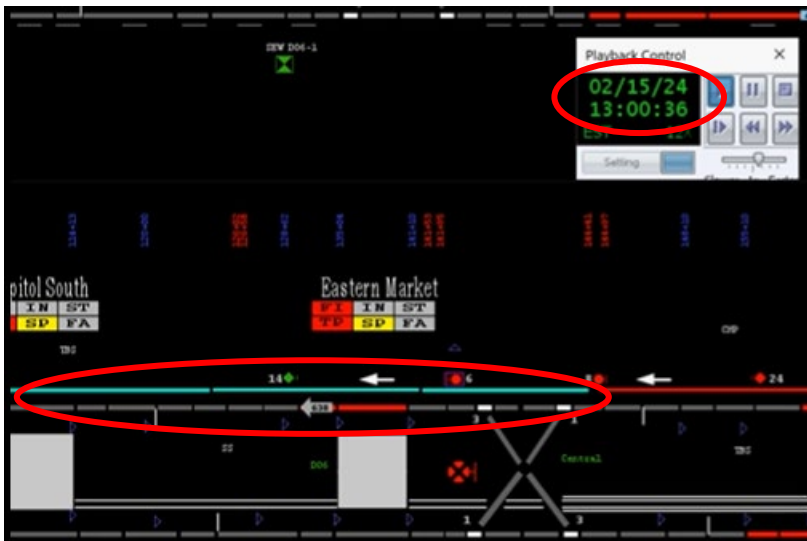
Figure 7 – Shows AIMS indicating third rail power was de-energized between Eastern Market and Capitol South Stations.

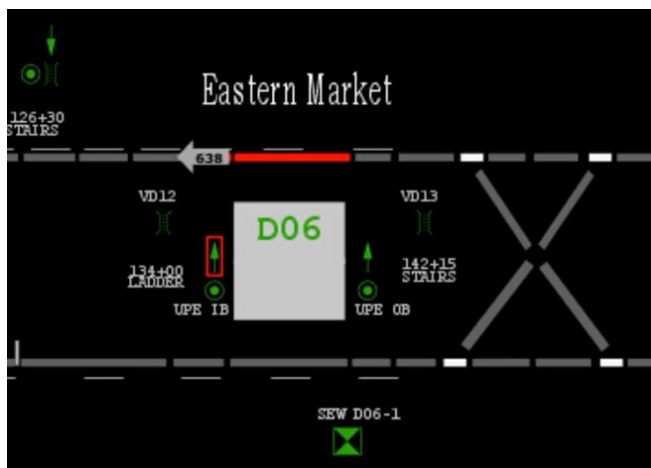
Figure 8 – Shows the Stair Fan was turned to supply.

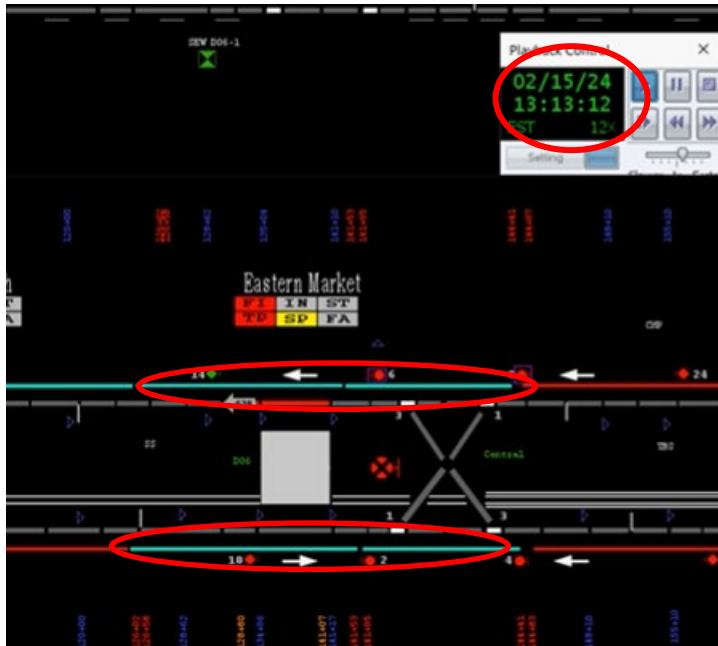
Figure 9 – Shows AIMS indicating third rail was de-energized on both tracks 1 & 2.

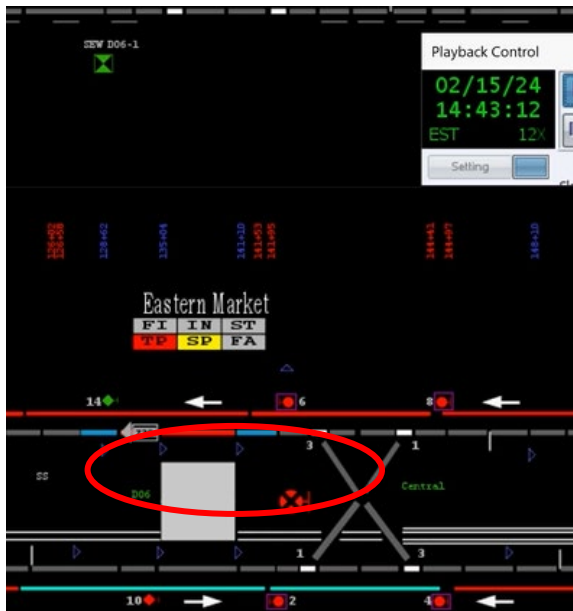
Figure 10 - Shows third rail power was restored on track 2 only to move the incident train.

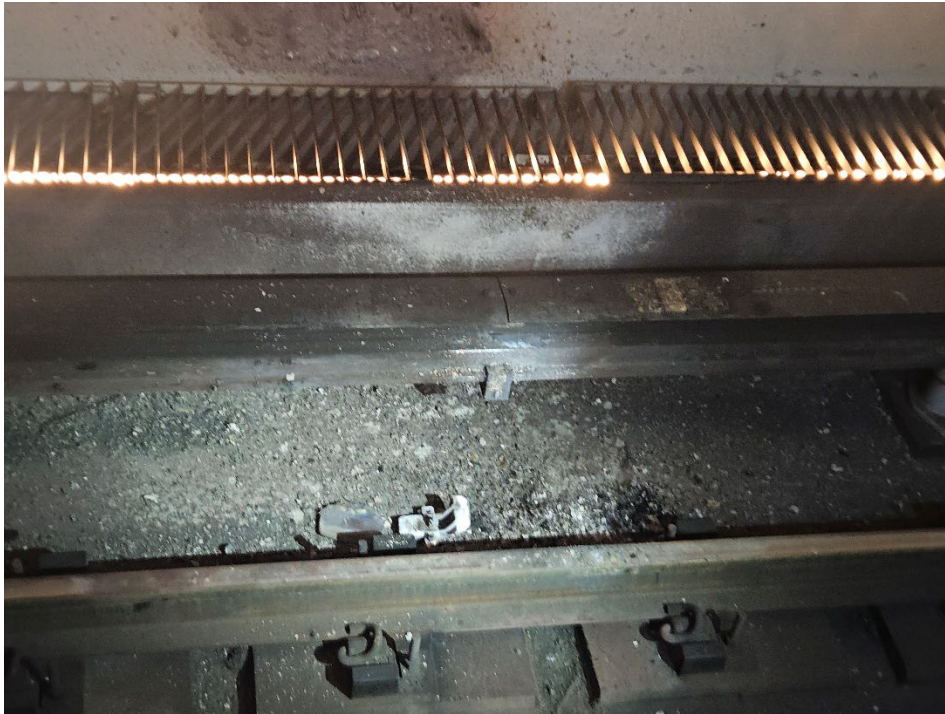
Image 10 - The above photo shows the arcing location at Eastern Market Station, approximately 450 feet from the 8-car marker.

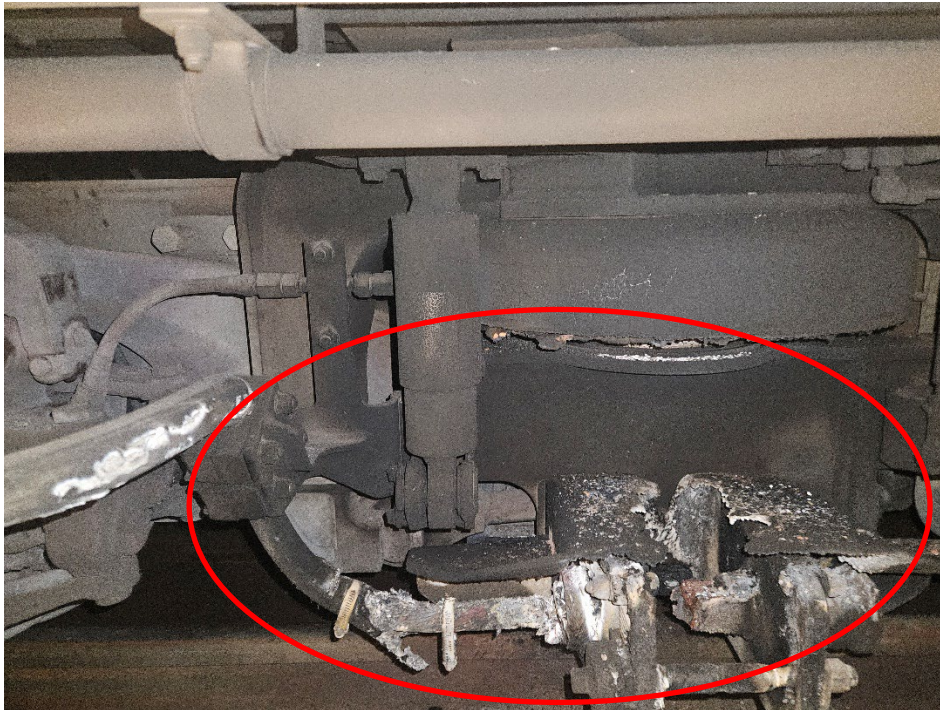
CMNT inspected railcars 7662 and 7663 and reported that the collector assembly on the rear truck of railcar 7663 was disengaged from the railcar and suspended by the shunt strap. Additionally, the collector assembly on truck one [front truck] of railcar 7663 exhibited signs of burning and melting. Heat damage was also observed on all collector shoes of both railcars.

Image 11 - The photo above depicts the #2 collector shoe assembly on Car 7663 primary power cable and mounted collector shoe assembly affected by the arcing event.

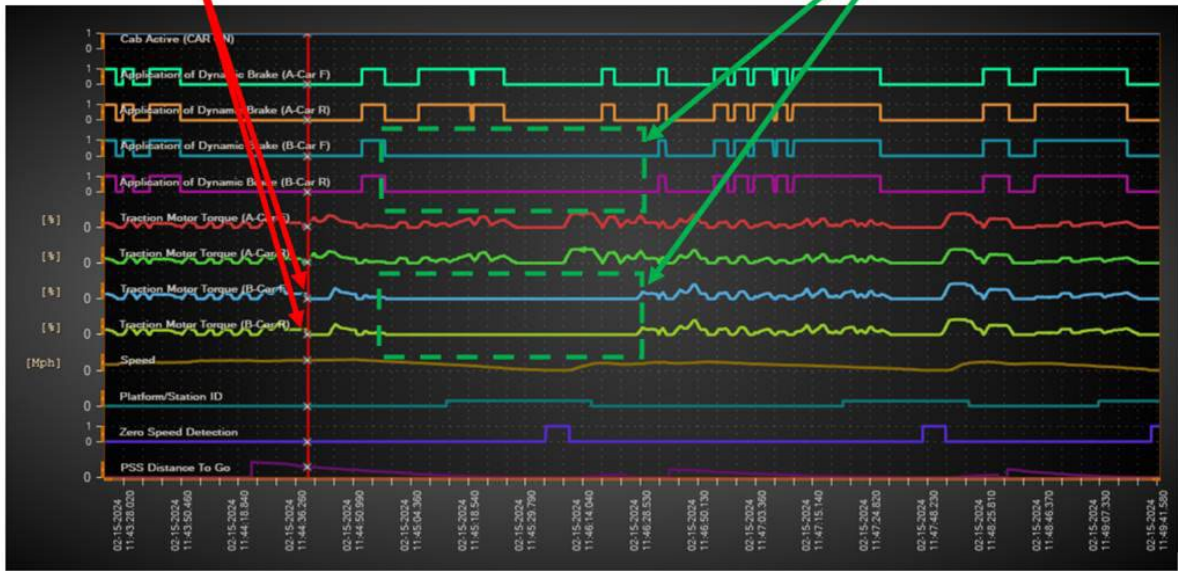
Car 7663 begins to experience Motor torque and Dynamic braking failures in approach to Rosslyn Station.

No Motor Torque and No Dynamics Braking

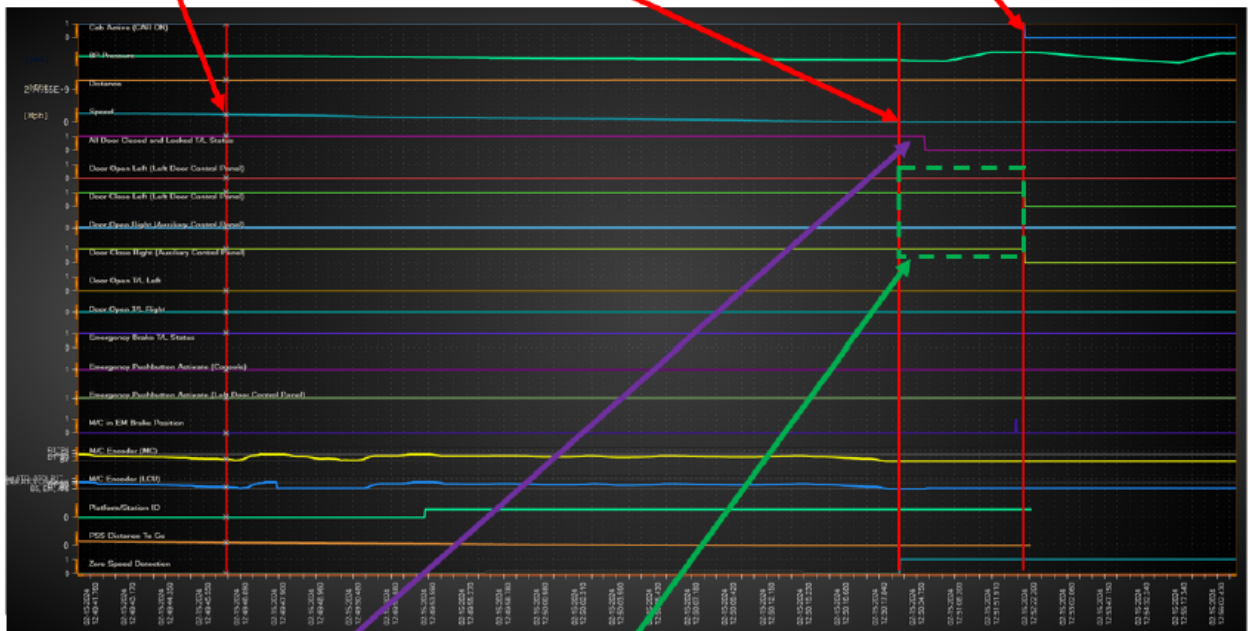
12:50:44
Loss of all doors due to keying off passengers at crew switch

After train comes to a complete stop, there's no activation of door pushbuttons.

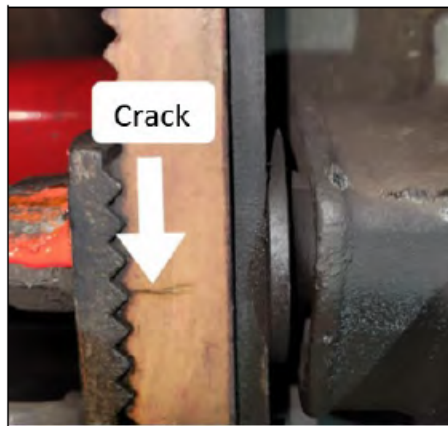
Figure 4. Example of a non-condemning defect

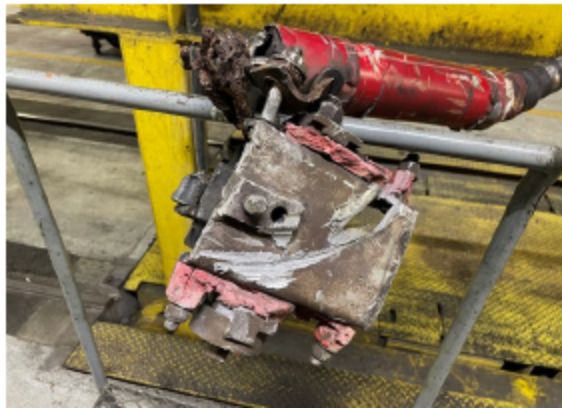
Figure 5, Circular scrapes on back of Collector Shoe Assy # 4

Figure 4 below depicts evidence of flashing of the primary cable to the #6 brake disc. Additionally, circular scrapes were found on the back of the collector assembly mounting channel #4, indicating it was lodged against the brake disc as shown in Figure 5.

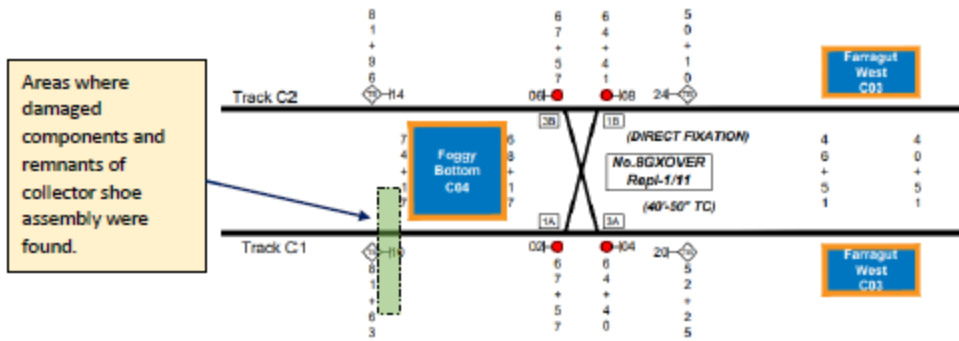
Figure 6, C1 Track Location of the Areas Affected

2. Fractured pieces of a collector shoe assembly were found between the Third Rail and Running Rail, located between chain markers C1 76+100 and C1 77+00.
3. Evidence of equipment being dragged, such as scuff marks and several chipped third rail grout pads, from chain marker C1 76+00 to C1 79+00.
4. Damaged face plates and third rail between chain markers C1 79+00 and C1 81+00.

Figures 6 and 7 below illustrate the areas where damaged components and remnants of collector shoe assembly were found on a track map and the system map.

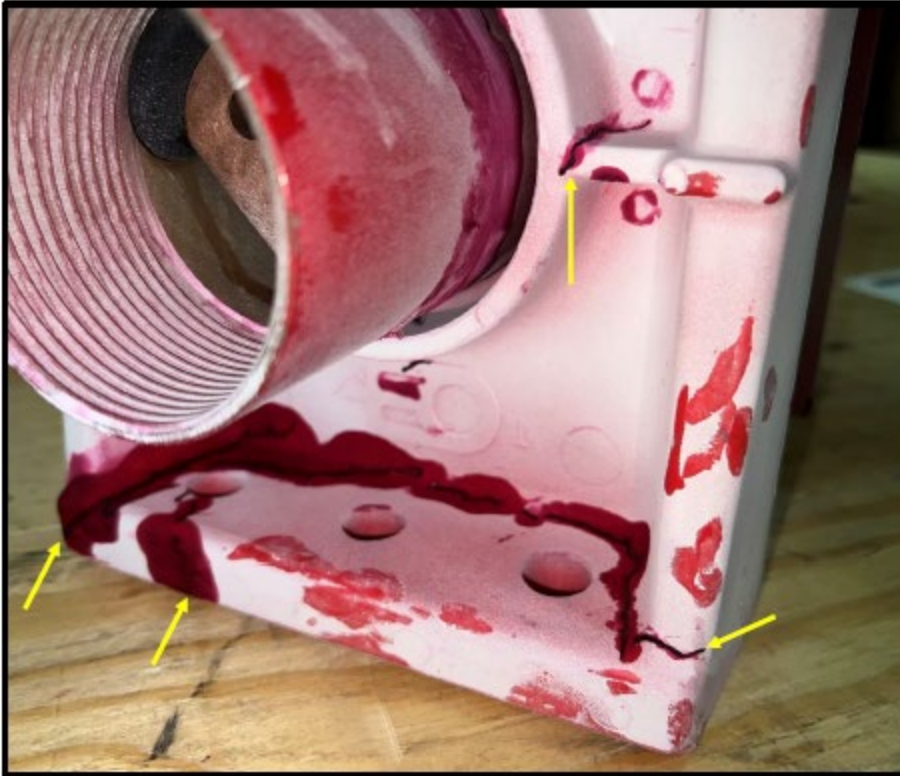
Figure 21: Dye penetrant testing on the new assembly after dynamic loading

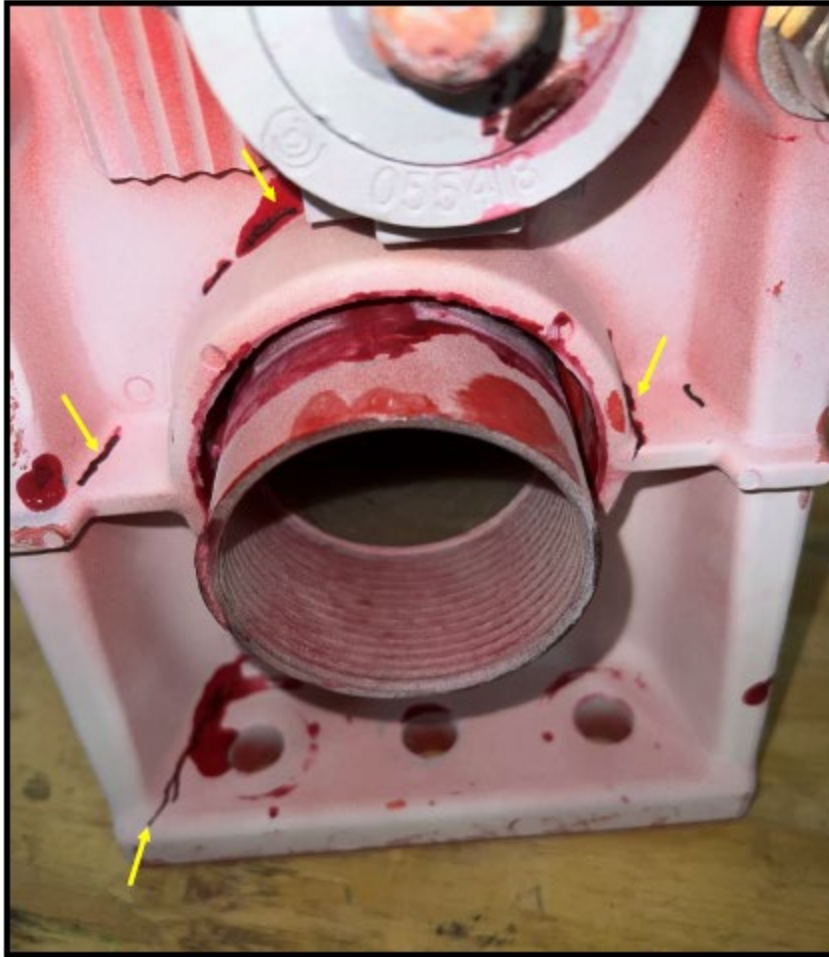
Figure 22: Second photo of dye penetrant testing used on the new assembly following the drop tests

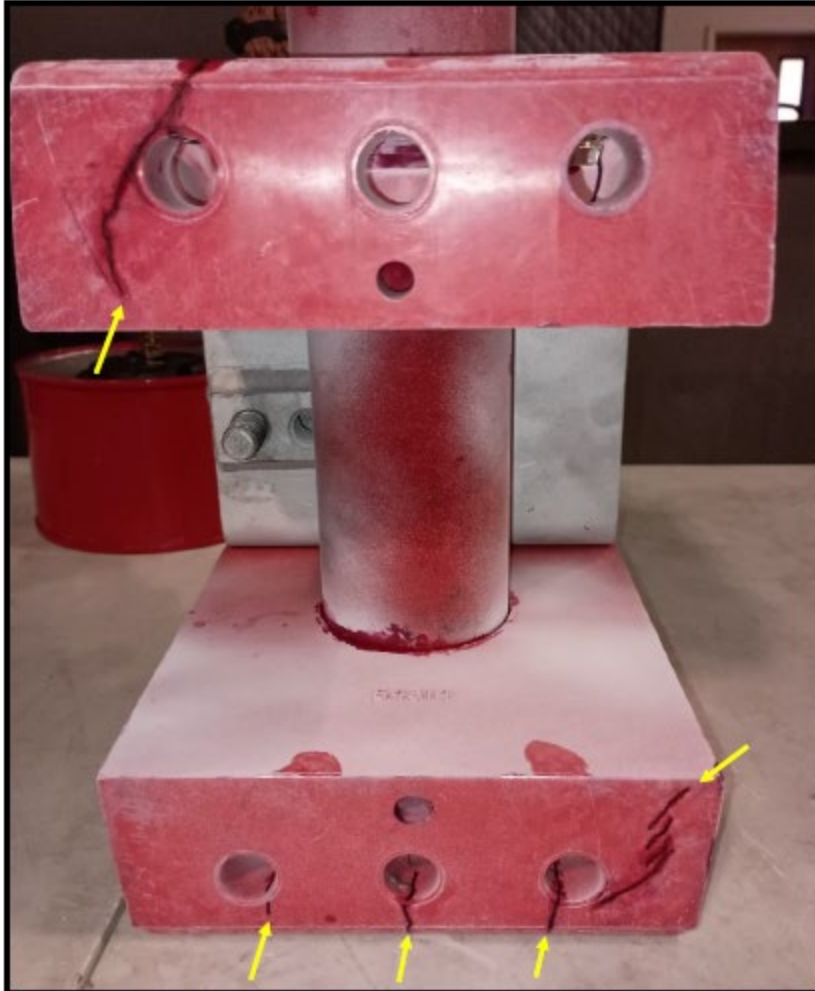
Figure 23: Bottom view of new unit after penetrant testing and drop tests

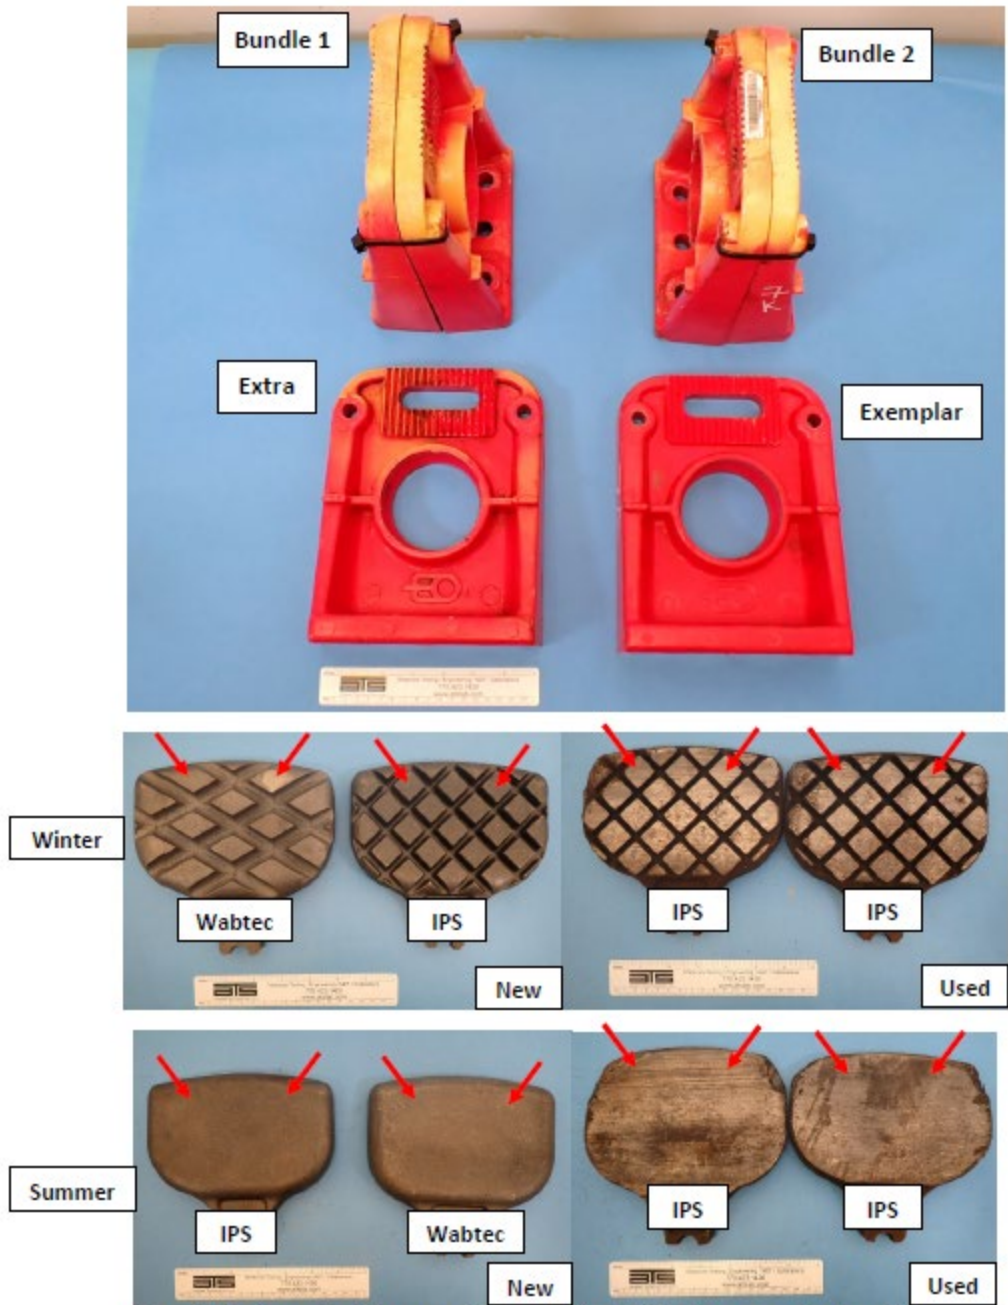
The current collector assembly brackets and shoes were documented in the as-received condition (Figure 1). Two pairs of cracked brackets, an extra cracked bracket, and exemplar bracket were received. Eight current collector shoes were received, post-mechanical testing, consisting of new and used shoes from different manufacturers for different seasons. Brinell hardness testing was conducted on the wear surfaces of the shoes.

Figure 1: Photograph of the current collector brackets in the as-received condition showing two bundles from assemblies, an extra bracket, and an exemplar bracket (top). Photographs of the current collector shoes received post-mechanical testing (bottom) show areas of the shoe surface that were tested for Brinell hardness (red arrows).

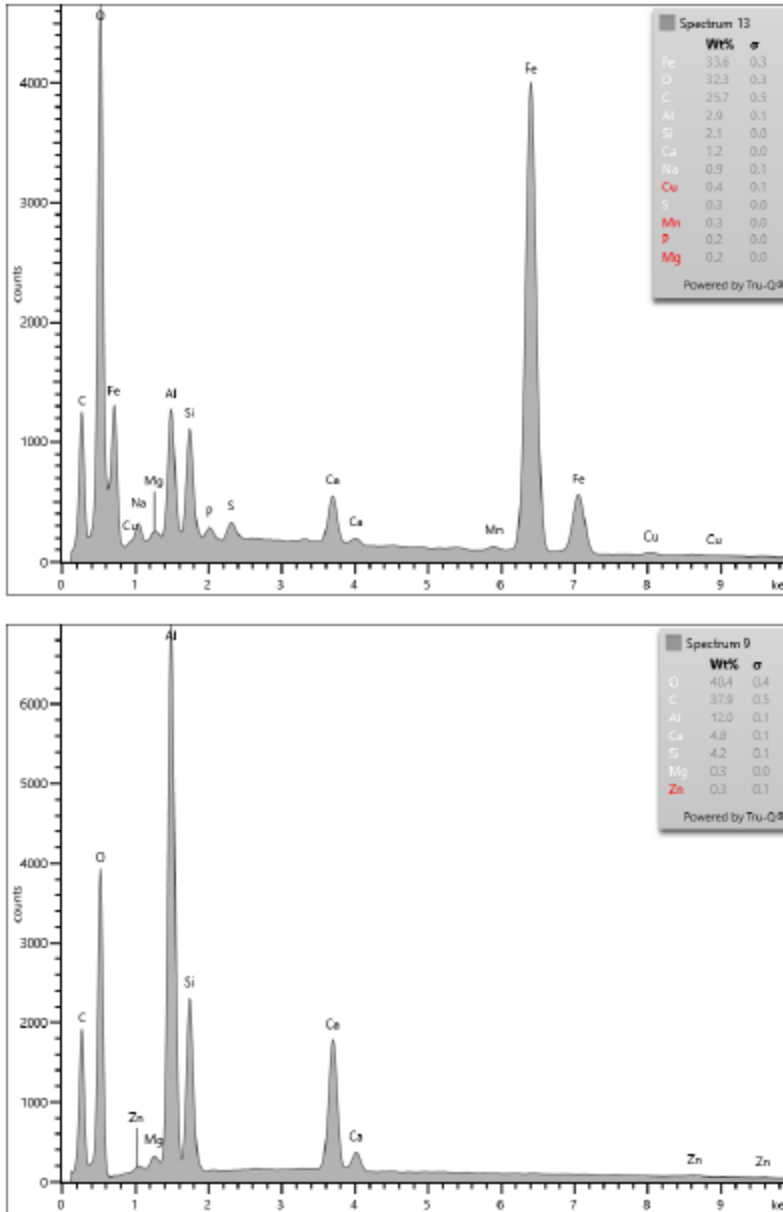
The opened fracture surfaces of the samples were further documented using a scanning electron microscope (SEM) coupled with energy dispersive spectroscopy (EDS), per ASTM E1508-12a(19), *Standard Guide for Quantitative Analysis by Energy-Dispersive Spectroscopy*. The fracture surfaces were predominantly smooth and followed along or parallel to the length of exposed fibers (Figure 8). Contamination was observed along the edges of the fracture surface near the exposed surfaces, which caused the appearance of a dark discoloration on the fracture surface. Typical EDS spectra (Figure 9) collected from the contamination exhibited elevated levels of iron and minor amounts of sodium, copper, sulfur, and phosphorus as compared to the base material which typically exhibited high levels of carbon, oxygen, aluminum, and silicon. Kaolinite ($\text{Al}_2\text{Si}_2\text{O}_5(\text{OH})_4$) and calcium carbonate (CaCO_3) are common filler materials in thermosetting resins, such as polyester.

Figure 9: EDS spectra collected from the contamination (top) and base material (bottom) from Sample 1-2.

Top: Carbon (C), oxygen (O), iron (Fe), copper (Cu), sodium (Na), magnesium (Mg), aluminum (Al), silicon (Si), phosphorus (P), sulfur (S), calcium (Ca), and manganese (Mn) were detected.

Bottom: Carbon (C), oxygen (O), zinc (Zn), magnesium (Mg), aluminum (Al), silicon (Si), and calcium (Ca) were detected.

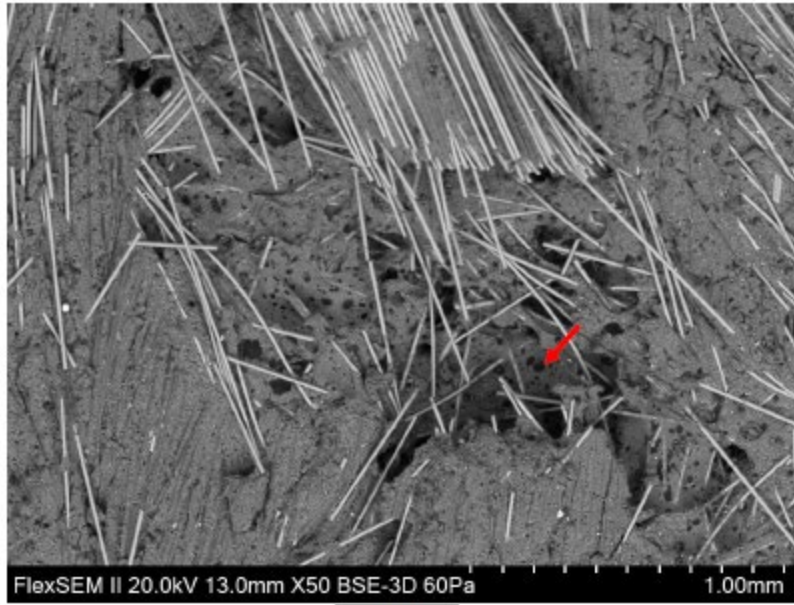
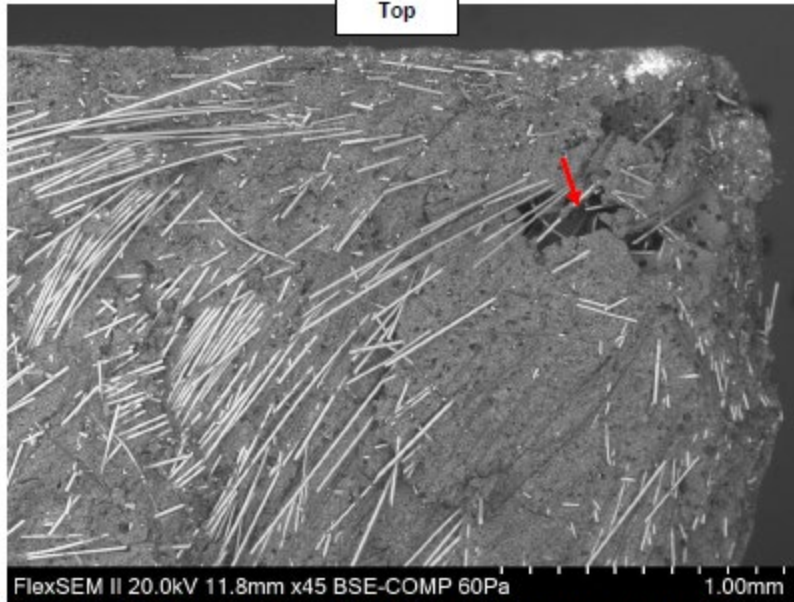
Large voids in the material were also observed along the service fracture surfaces (Figure 10). The typical service fracture surfaces observed exhibited a smooth appearance with either grooves in the surface of the matrix material where fibers had de-bonded or were covered with longitudinally exposed fibers with minimal matrix adhesion (Figure 11). The typical lab-induced fracture surface exhibited a coarser texture with fiber pull-out of transversely oriented fibers.

Figure 10: SEM images from the fracture surfaces of Samples 2-1 (top) 2-2 (bottom) exhibiting exposed fibers and relatively large voids along the fracture surface (red arrows).

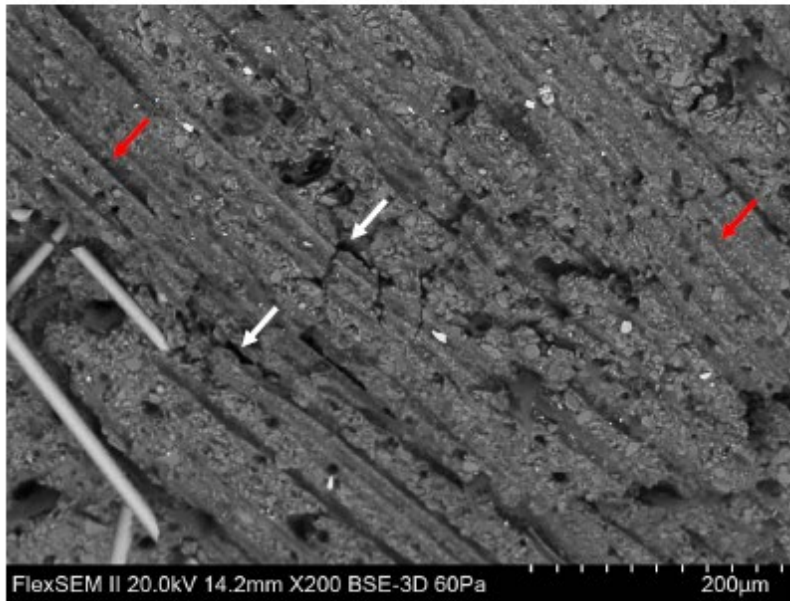
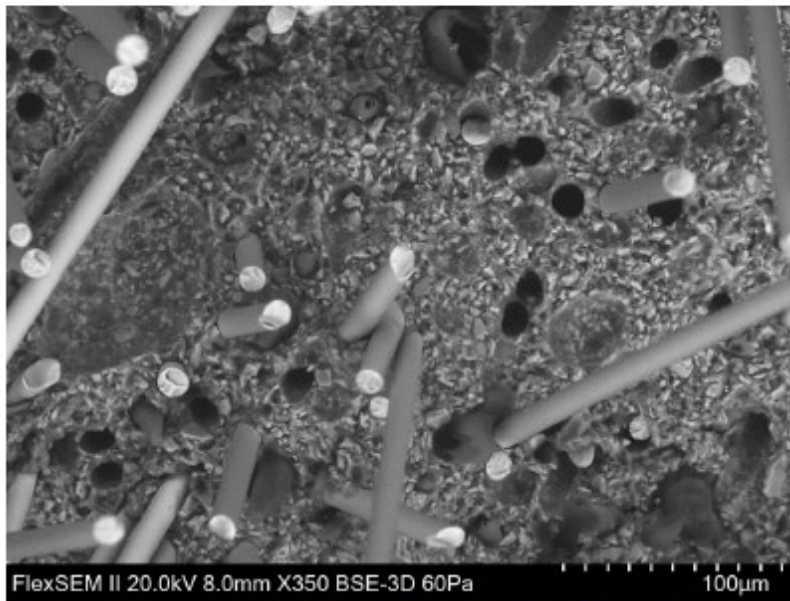
Figure 11: SEM image from Sample 2-1 (top) showing the typical fracture surface observed exhibiting a smooth surface with grooves (red arrows), indicative of fiber debonding, and micro-cracking of the matrix material (white arrows). An SEM image from Sample 1-2 shows the typical lab-induced fracture surface observed exhibiting fiber pull out (bottom).

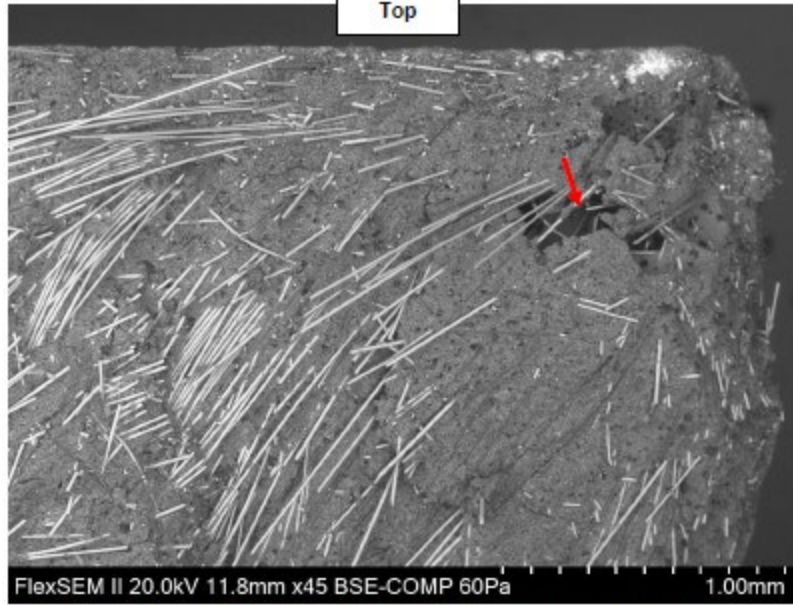
Figure 10: SEM images from the fracture surfaces of Samples 2-1 (top) 2-2 (bottom) exhibiting exposed fibers and relatively large voids along the fracture surface (red arrows).

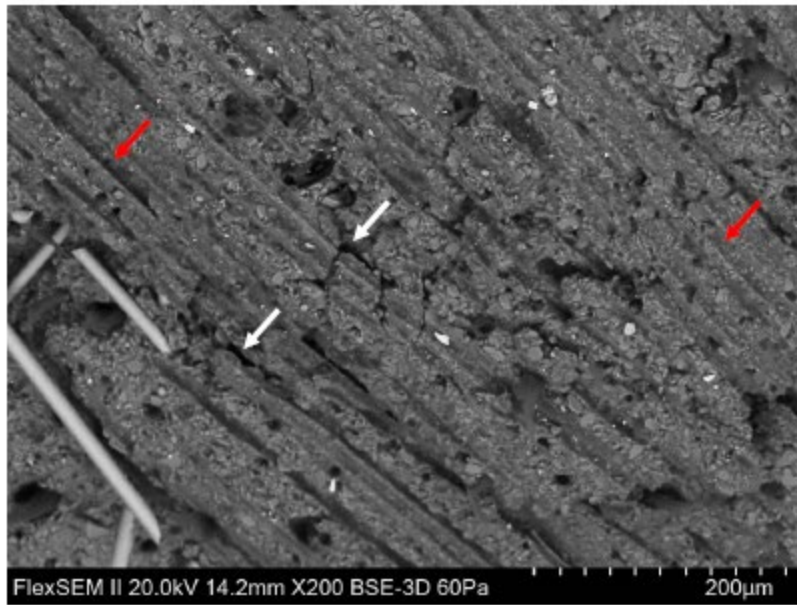
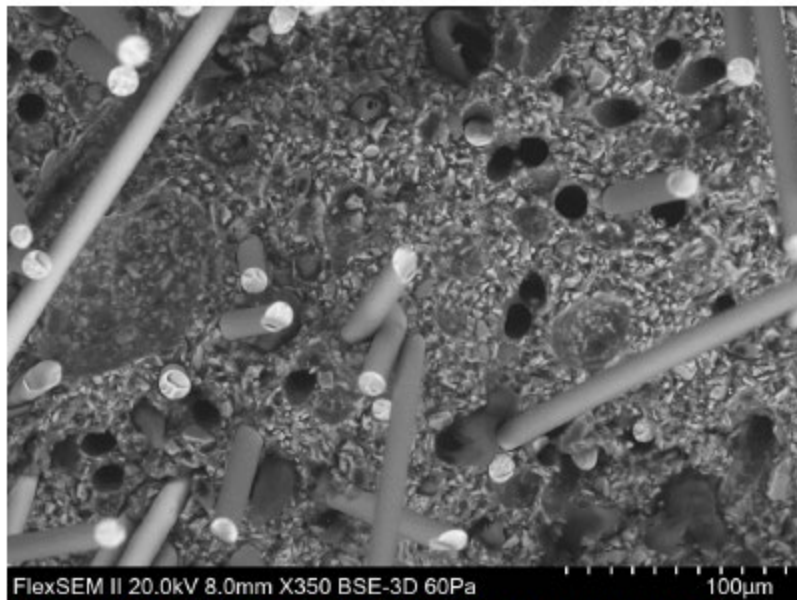
Figure 11: SEM image from Sample 2-1 (top) showing the typical fracture surface observed exhibiting a smooth surface with grooves (red arrows), indicative of fiber debonding, and micro-cracking of the matrix material (white arrows). An SEM image from Sample 1-2 shows the typical lab-induced fracture surface observed exhibiting fiber pull out (bottom).

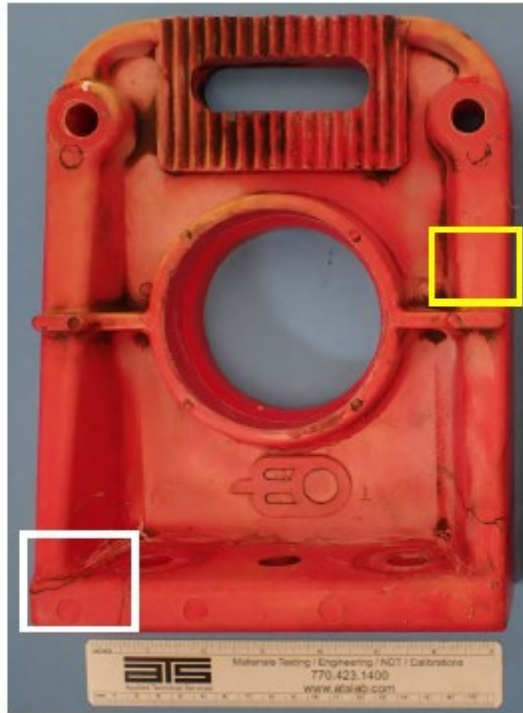
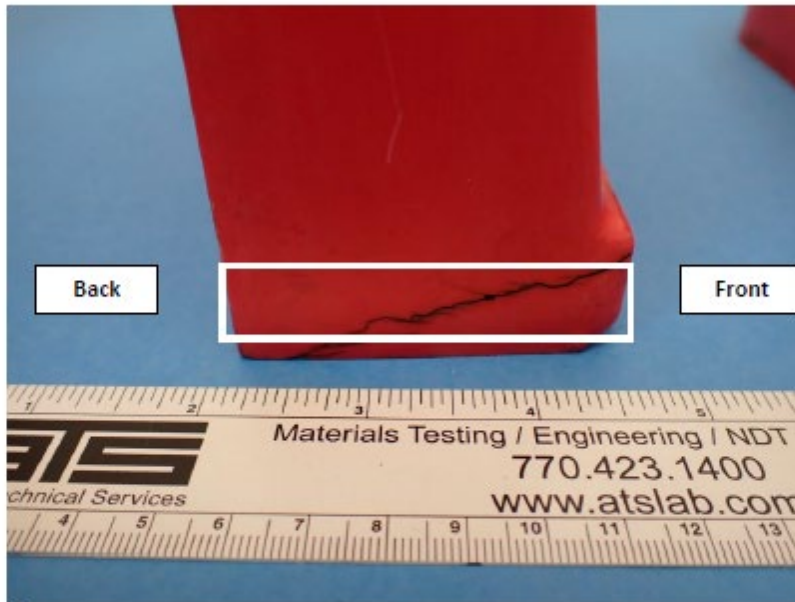
Transverse and longitudinal cross sections were taken from Sample 2-1 from a cracked area and an area remote from any cracking (Figure 12). The cross sections were prepared per ASTM E2015-04(21), *Standard Guide for Preparation of Plastics and Polymeric Specimens for Microstructural Examination*. Cross-sections through the cracked area exhibited relatively large voids and cracks throughout the material (Figure 13). The primary fracture surface was predominantly flat and exhibited grooves along the fracture surface where the matrix material detached from fibers (Figure 14). Cracks were also observed connecting and emanating from the large voids within the material. The cross sections taken remote from any observed cracking also exhibited large voids within the material with cracks connecting and emanating from the large voids (Figure 15). Various other cracks were also observed in the remote sections.

Figure 12: Photographs of Sample 2-1 showing where cross sections were taken from the cracked area (white rectangle) and a remote area (yellow rectangle) of the sample.

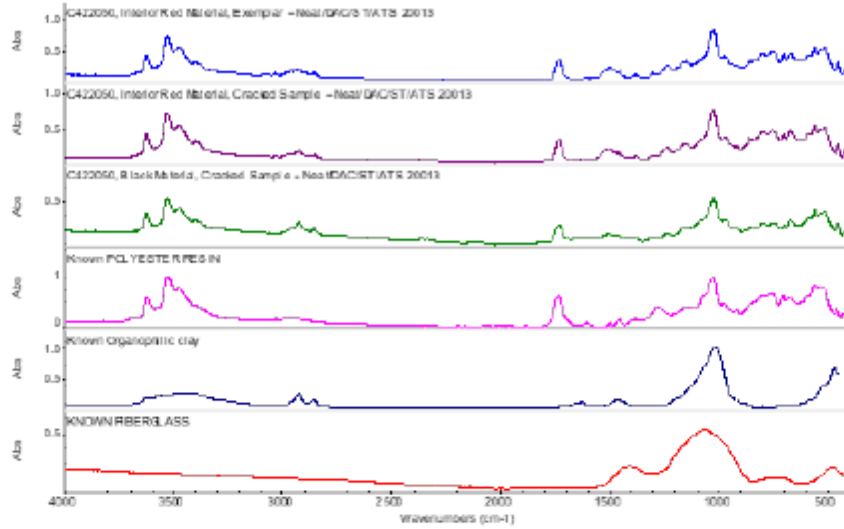
Differential scanning calorimetry (DSC) was conducted on material from Sample 2-1 to determine the glass transition temperature, enthalpies of fusion (ΔH_f), and the melting temperature per ASTM D3418-21, *Standard Test Method for Transition Temperatures and Enthalpies of Fusion and Crystallization of Polymers by Differential Scanning Calorimetry*. The glass transition temperature is the temperature at which the polymer undergoes a reversible change from a rigid to a rubbery state as it is heated. The enthalpy of fusion is the energy required to melt the crystalline material present in the sample. DSC results are shown in Table V and the collected thermogram is shown in Figure 16.

Figure 16: FT-IR spectra (top) collected from the exemplar sample (blue), a cracked sample (Sample 2-1, purple), and the black contamination observed on many of the fracture surfaces (green) compared to library spectra of polyester resin (pink), organophilic clay (indigo), and fiberglass (red). A DSC thermogram from material taken from Sample 2-1 exhibited no exothermic peaks that would indicate an incomplete cure of the resin (bottom).

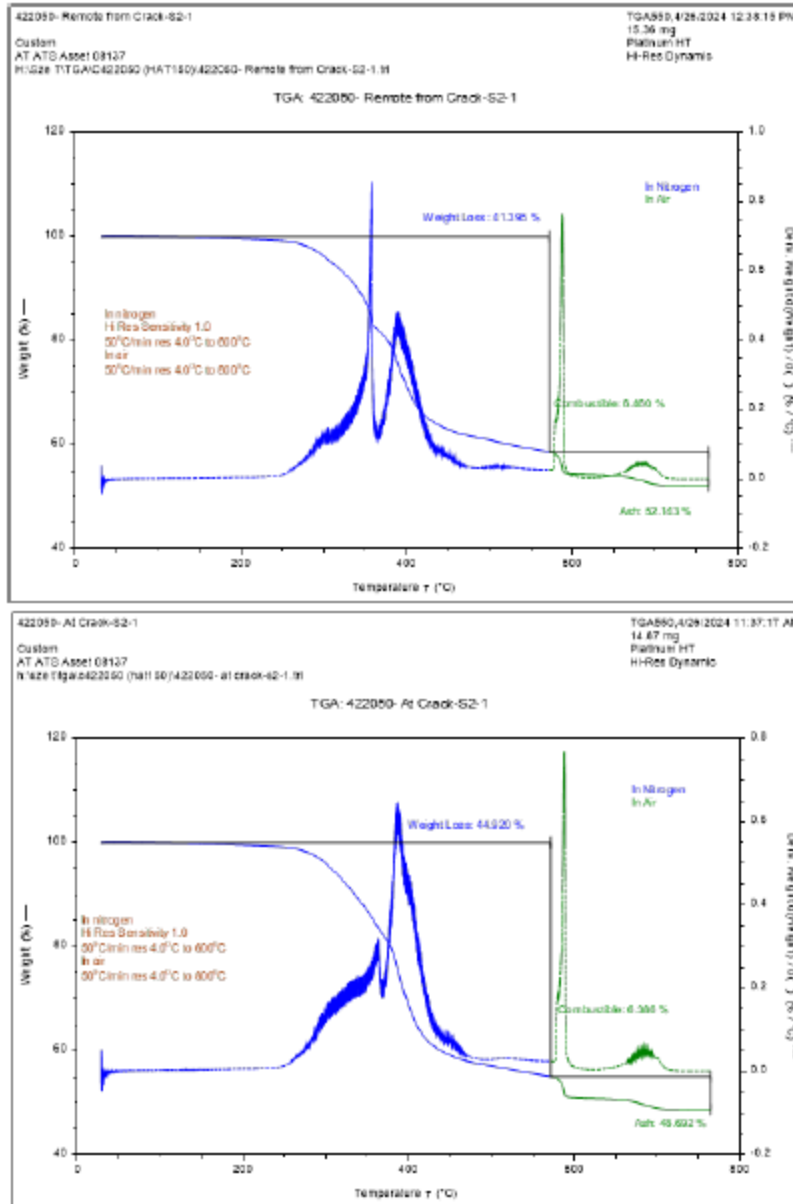
Thermogravimetric analysis (TGA) was conducted on the exemplar sample and Sample 2-1 from the cracked area per ASTM E1131-20, *Standard Test Method for Compositional Analysis by Thermogravimetry*. Tabulated results of the volatile, combustible, and ash contents of the samples are shown in Table VI. TGA thermograms are shown in Figure 17. Sample 2-1 exhibited slightly higher volatile and slightly less ash content than the exemplar sample.

Figure 17: TGA thermograms from Sample 2-1 of material taken remote from any cracking (top) and near cracking at the bracket base (bottom).
