W-0344 – Evacuation for Life Safety Reasons at Eastern Market Station – February 15, 2024

Document Purpose

Safety event summary:

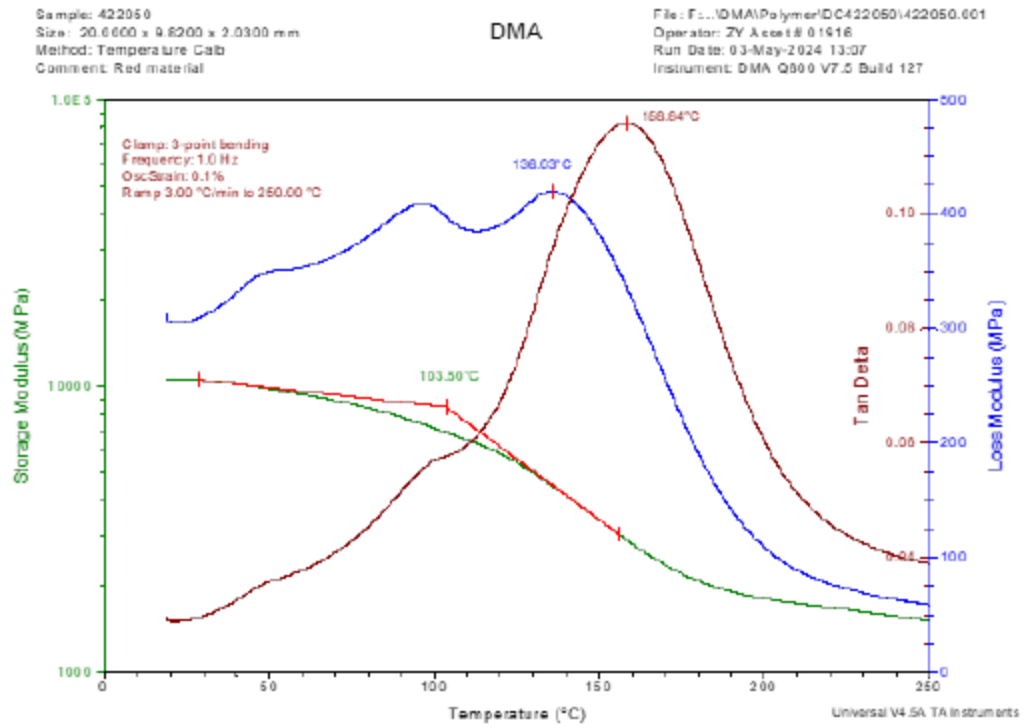
Dynamic mechanical analysis was conducted on material from Sample 2-1 to determine the glass transition temperature (T_g) of the material per ASTM E1640, *Standard Test Method for Assignment of the Glass Transition Temperature by Dynamic Mechanical Analysis*. The sample was heated at a rate of 3 °C/min while a force was applied to the sample at a frequency of 1.0 Hz with an oscillating strain of 0.1%. Tabulated results for the measured glass transition temperatures are shown in Table VII, and the collected DSC curve is shown in Figure 18. The glass transition occurred over a wide temperature range of 103.5 °C, determined from the storage modulus (E'), to 158.8 °C, determined from tan delta. The median glass transition temperature, determined from the loss modulus (E'') was measured to be 136.0 °C.

Figure 18: DMA thermograms collected from Sample 2-1 showing the glass transition temperatures determined from the storage modulus (green), the loss modulus (blue), and tan delta (brown).
